## **2004 REGIONAL BEACH MONITORING PROGRAM**

### **ANNUAL REPORT**

**SANDAG  
2004 REGIONAL BEACH  
MONITORING PROGRAM**

April 2005

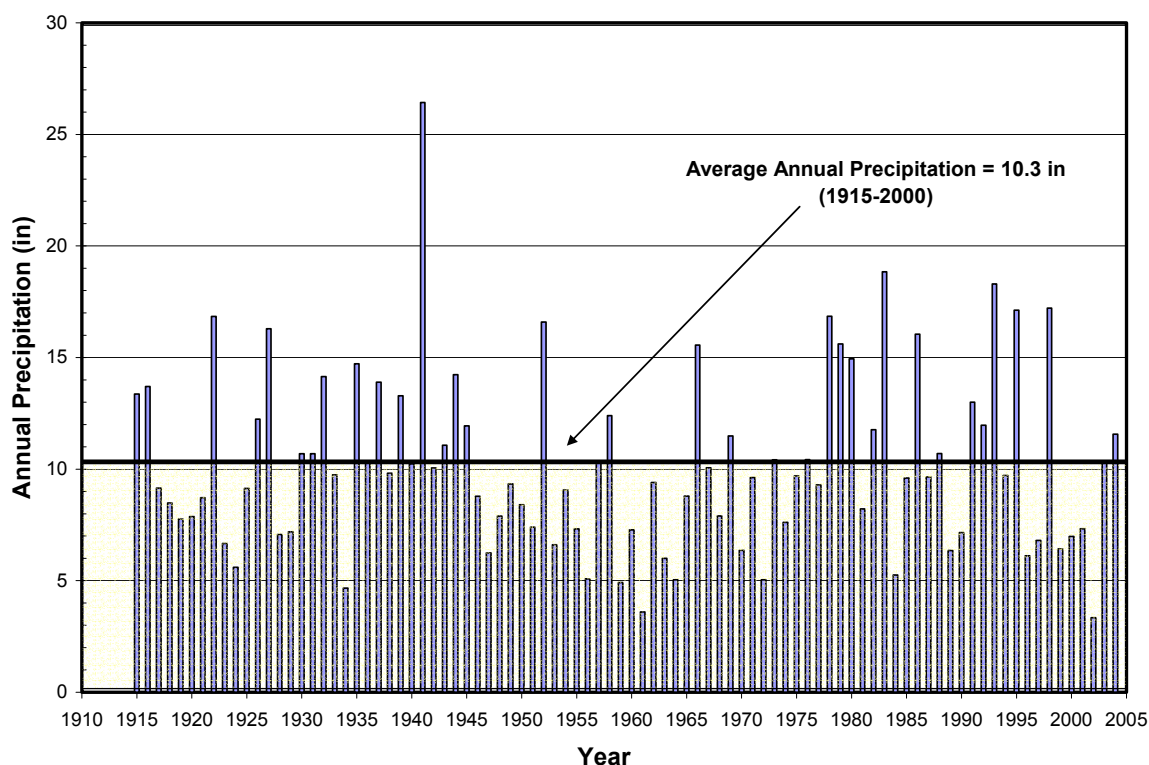
**Figure 2. Annual Precipitation at Lindberg Field, 1915-2004**

The precipitation during the 2004 Monitoring Year, 11.6 inches, slightly exceeded the long-term average. However, the majority of this precipitation was attributable to a single storm event that occurred in late October 2004. The precipitation for October 2004 (6.4 inches) exceeded the long-term average (0.5 inches) and the previously recorded maximum (3.7 inches) for the month. The storm that accounted for the abnormally high precipitation occurred following the completion of the Fall 2004 Survey. As a result, the beach and lagoon entrance conditions documented by the survey do not reflect the influence of this event.

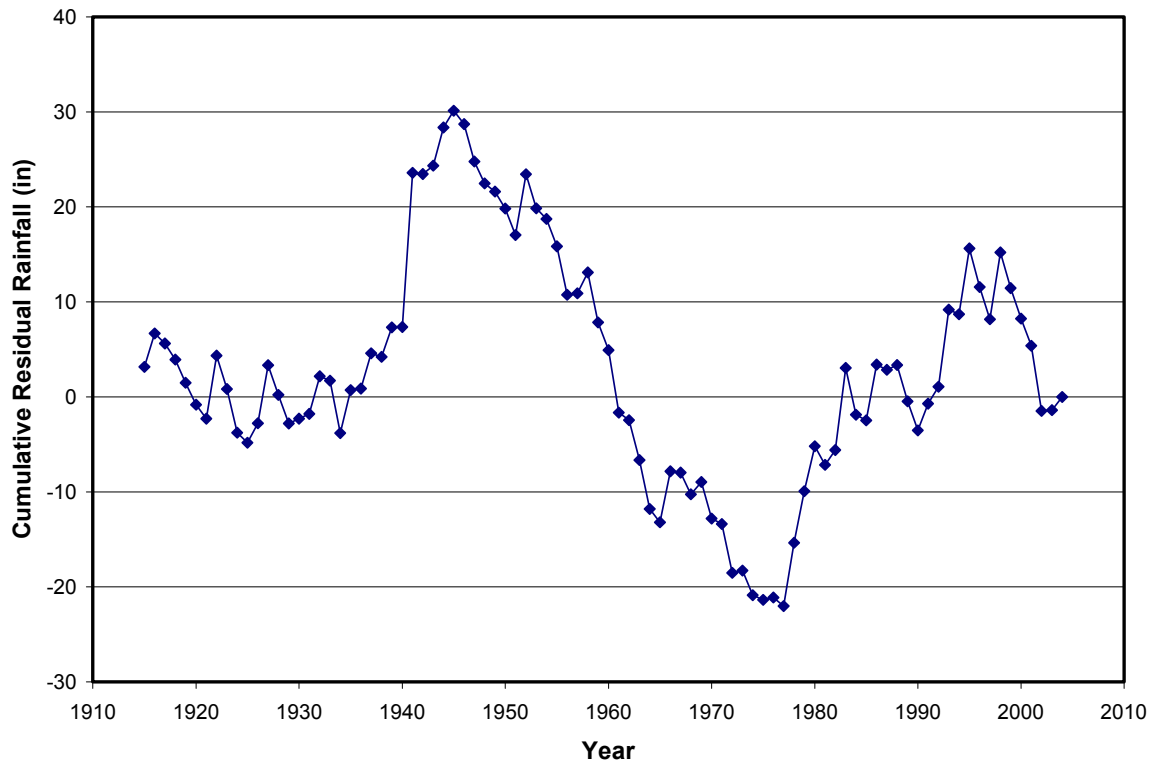
**Figure 3. Cumulative Residual Rainfall at Lindberg Field, 1915-2004**

The cumulative residual rainfall at Lindberg Field is shown in Figure 3. Residual rainfall represents the difference between the rainfall observed in a particular year and the average annual rainfall. When the residual values are summed over extended periods of time, the resulting cumulative values provide an indication of long-term climatic trends (Inman and Jenkins, 1999). A positive slope to the graph denotes a “wet” period of above-

average precipitation, while a negative slope denotes a “dry” period of below-average precipitation.

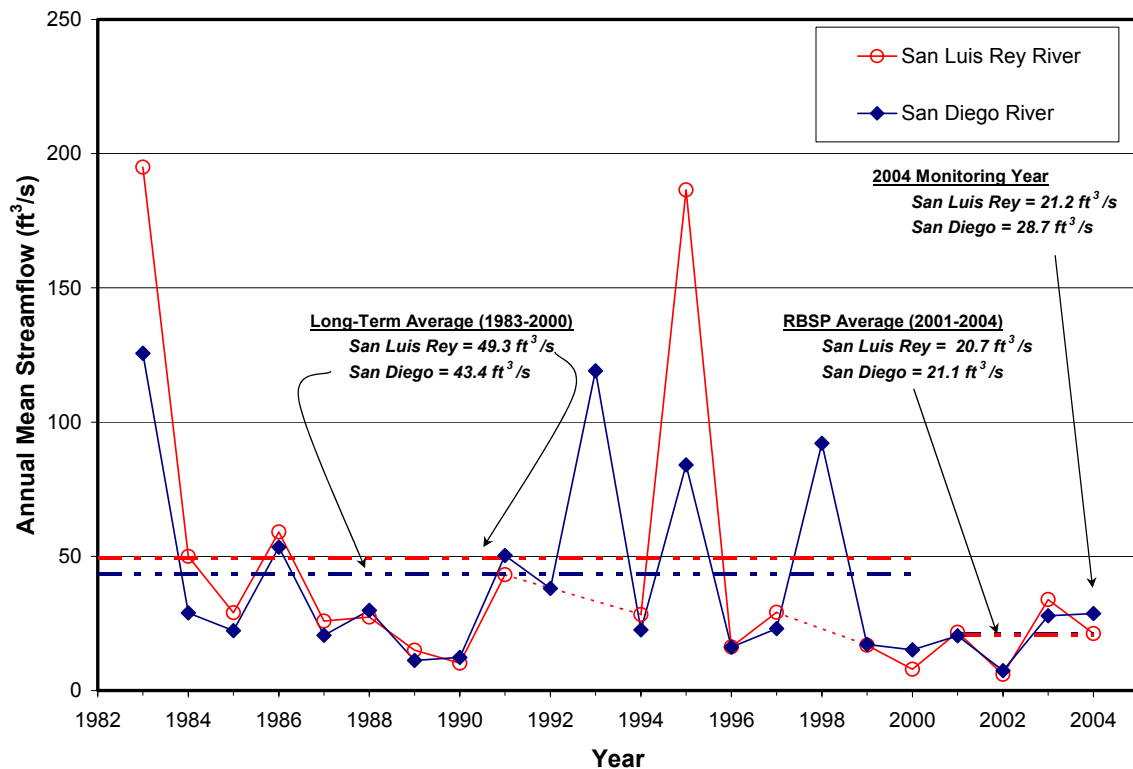
**Figure 4. Annual Mean Streamflow in the San Luis Rey and San Diego Rivers, 1983-2004**

Figure 4 presents the annual mean streamflow measured in each river between 1983 and 2004. Despite average and slightly above-average precipitation each of the last two years (Section 2.1.1), the flow in both rivers has remained below average since the 1997-1998 El Niño event. During the 2004 Monitoring Year, the streamflow in the San Luis Rey River exceeded that recorded in two of the three prior years comprising the RBSP Monitoring Period, while the streamflow in the San Diego River exceeded that recorded in each of the three prior years. It should be noted that two substantial gaps exist in the data for the San Luis Rey: (1) October 1992-August 1993, and (2) November 1997-May 1998. Both of these periods were characterized by high streamflow rates in the San Diego River, suggesting that the true long-term average for the San Luis Rey is higher than that shown in Figure 4.

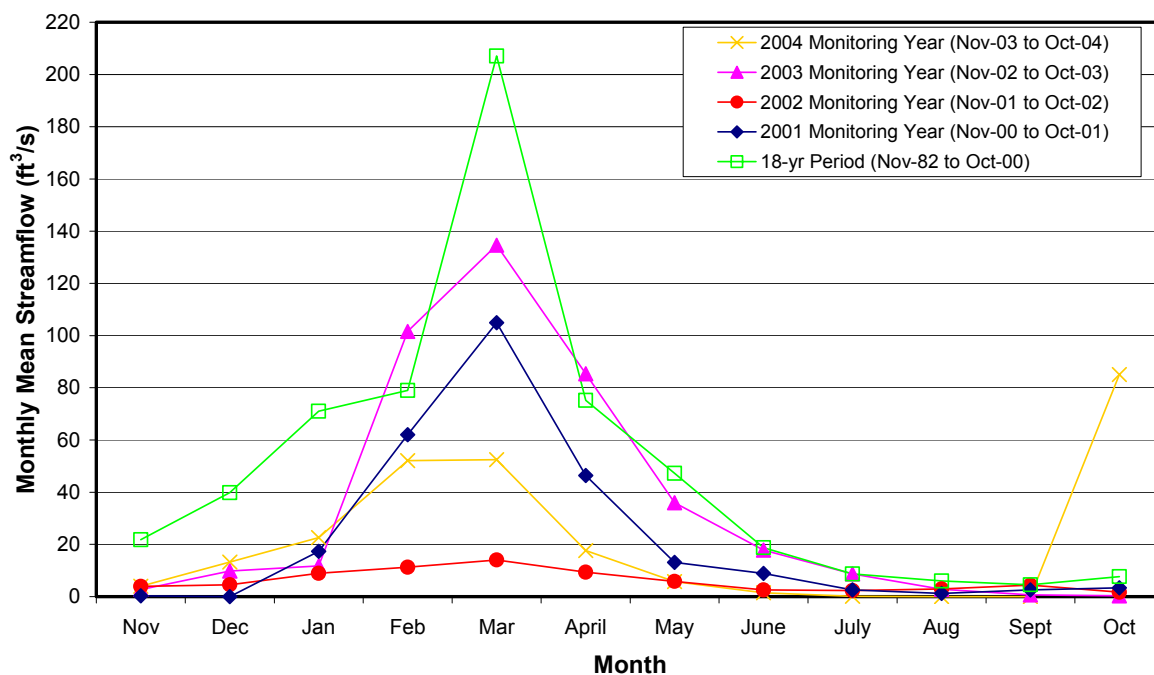
Figure 5. Monthly Mean Streamflow in the San Luis Rey River

Figures 5 and 6 compare the monthly mean streamflow in each river for each year of the RBSP Monitoring Period with the long-term monthly mean values for the 18-yr period between 1983 and 2000. As in the case of the annual data presented in Figure 4, the monthly data indicate that the RBSP Monitoring Period has been characterized by below-average streamflow rates. The most notable exception occurred in October 2004, when the

flows in the San Luis Rey and San Diego Rivers were 11 to 24 times greater than the long-term average values, respectively. It should be noted, however, that the long-term monthly values for the San Luis Rey would be higher than those shown in Figure 5 were it not for the two data gaps identified above.

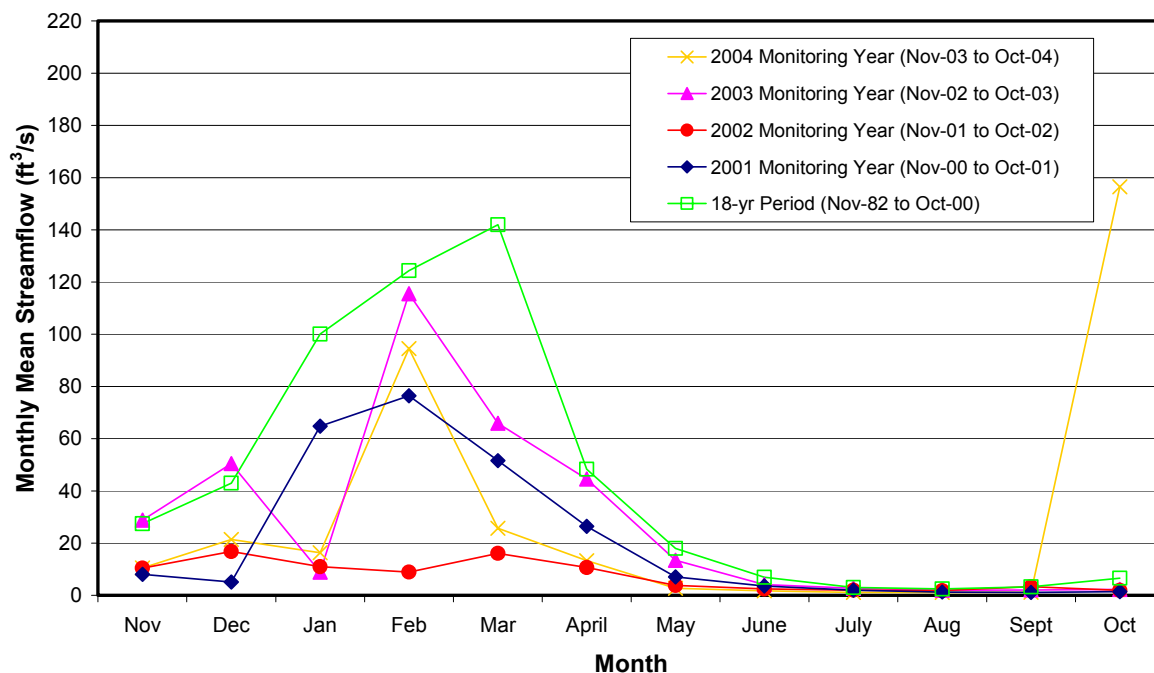
Figure 6. Monthly Mean Streamflow in the San Diego River

The high streamflow values for October 2004 correspond to the record high precipitation for the month discussed previously. As noted in Section 2.2.1, the storm that accounted for the abnormally high precipitation and streamflows occurred following the completion of the Fall 2004 Survey. As a result, the beach and lagoon entrance conditions documented by the survey do not reflect the influence of this event.

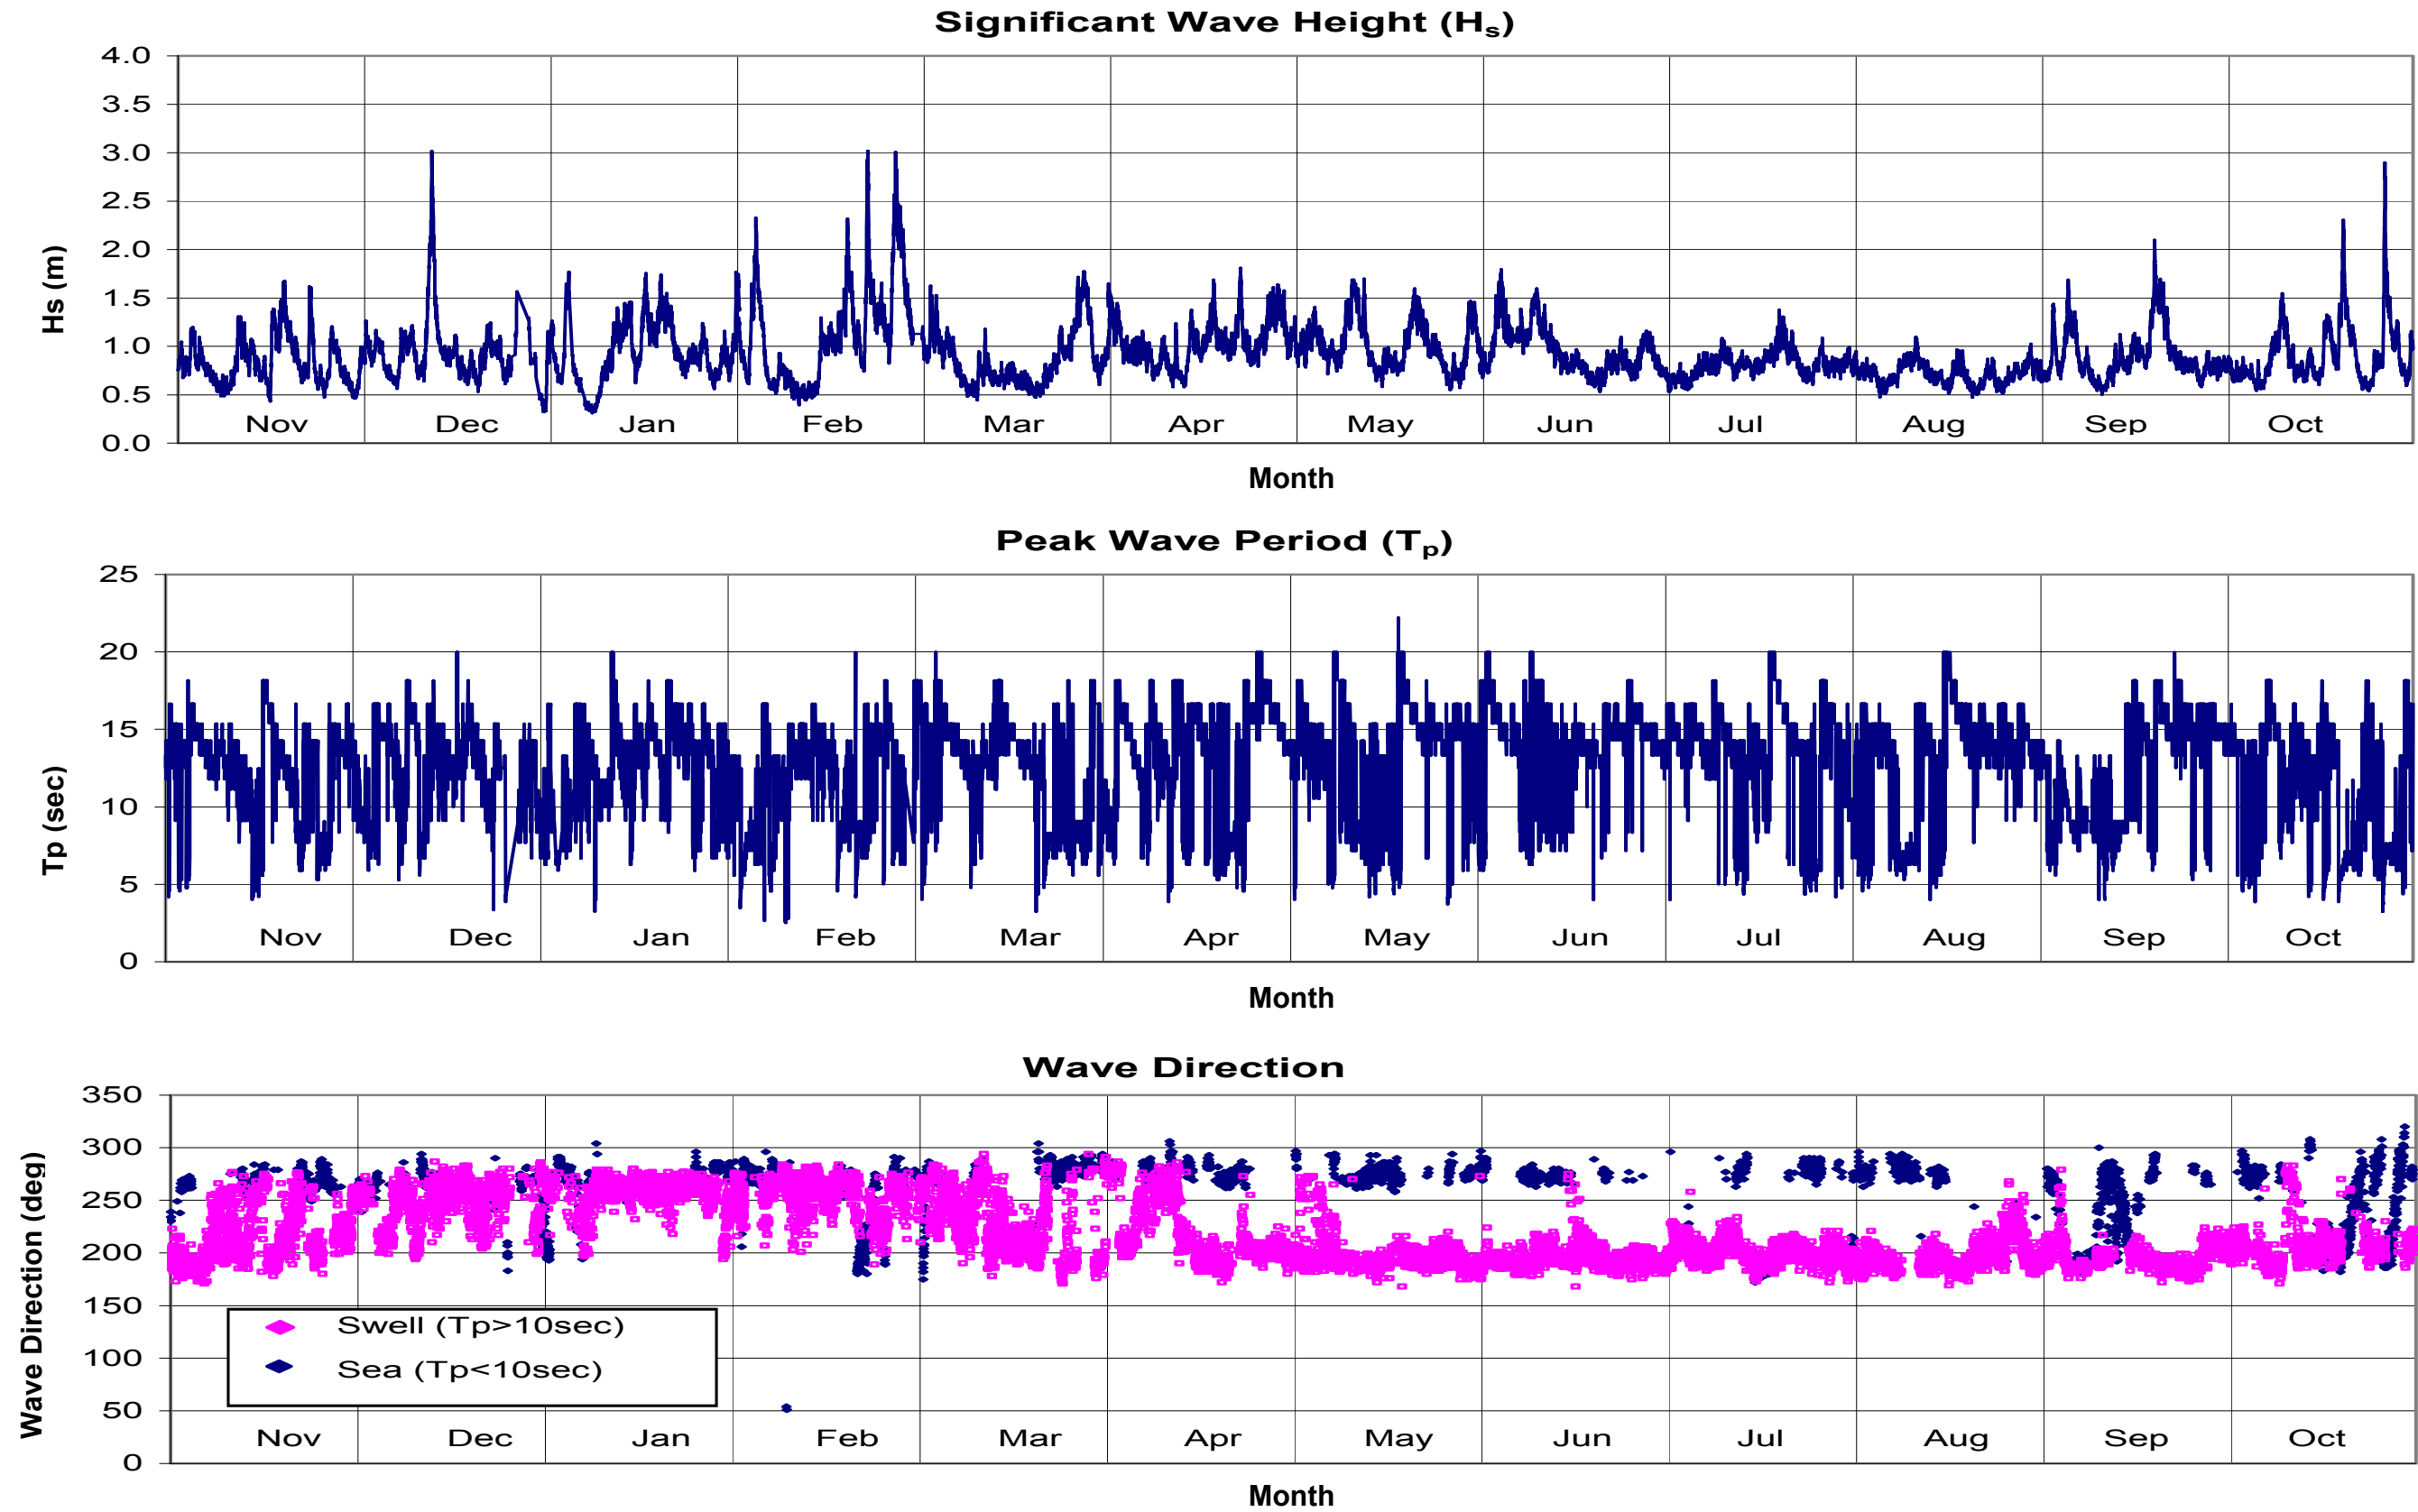
Figure 7. Wave Characteristics at the Oceanside Buoy, 2004 Monitoring Year

$$P \sim H_s^2 T_p \quad (1)$$

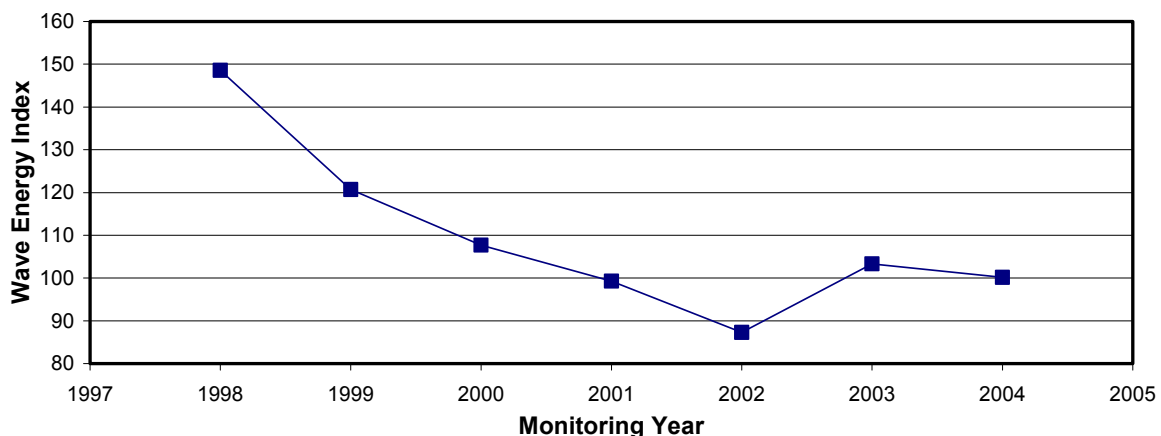
**Figure 8. Relative Incident Energy Index at the CDIP Oceanside Buoy, 1998-2004**

The computed values of  $E_r$  are shown in Figure 8. Gaps in the Oceanside Buoy data were accounted for by assuming that the average wave power during the remainder of the year prevailed during the periods lacking measurements. The highest Energy Index, with a value of 149, occurred during the 1998 El Niño year. The index then decreased during each of the next four years, attaining a minimum value of 87 in 2002 before increasing to 103 in 2003. In 2004 the index was 100, a modest decrease from 2003 and a relatively low value compared to the prior years.

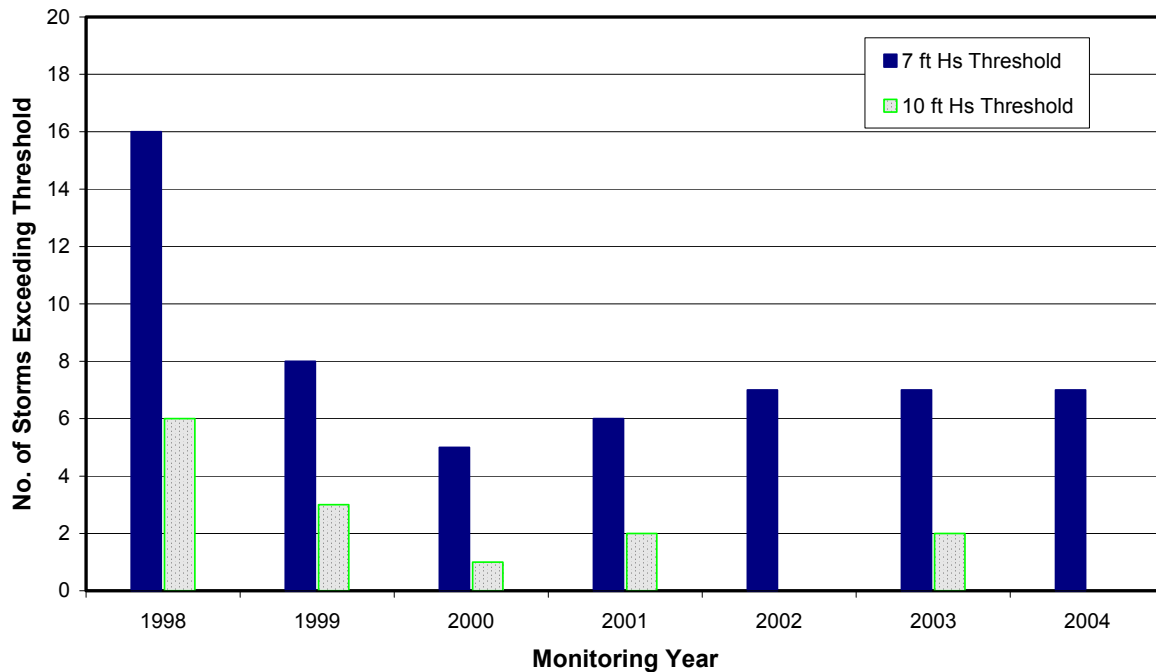
**Figure 9. Storm Events per Year with Significant Wave Heights Exceeding 7 ft and 10 ft, 1998-2004**

Figure 9 displays the number of storms per year with  $H_s$  exceeding threshold values of 7 ft (2.1 m) and 10 ft (3.0 m). As in the case of the Relative Incident Energy Index, the storm frequency data indicate that the most severe conditions occurred in 1998, when  $H_s$  exceeded 7 ft on sixteen occasions and 10 ft on six occasions. During the four years encompassing the RBSP Monitoring Period (2001 to 2004),  $H_s$  surpassed 7 ft between six and seven times per year, and surpassed 10 ft between zero and two times per year. During the 2004 Monitoring Year,  $H_s$  surpassed 7 ft on seven occasions, but never exceeded 10 ft. However,  $H_s$  did reach 9.9 ft on three occasions: December 12, 2003 with a peak period of

7.7 sec from the northwest; February 22, 2004 with a peak period of 7.7 sec from the south; and February 27, 2004 with a peak period of 15.4 sec from the west).

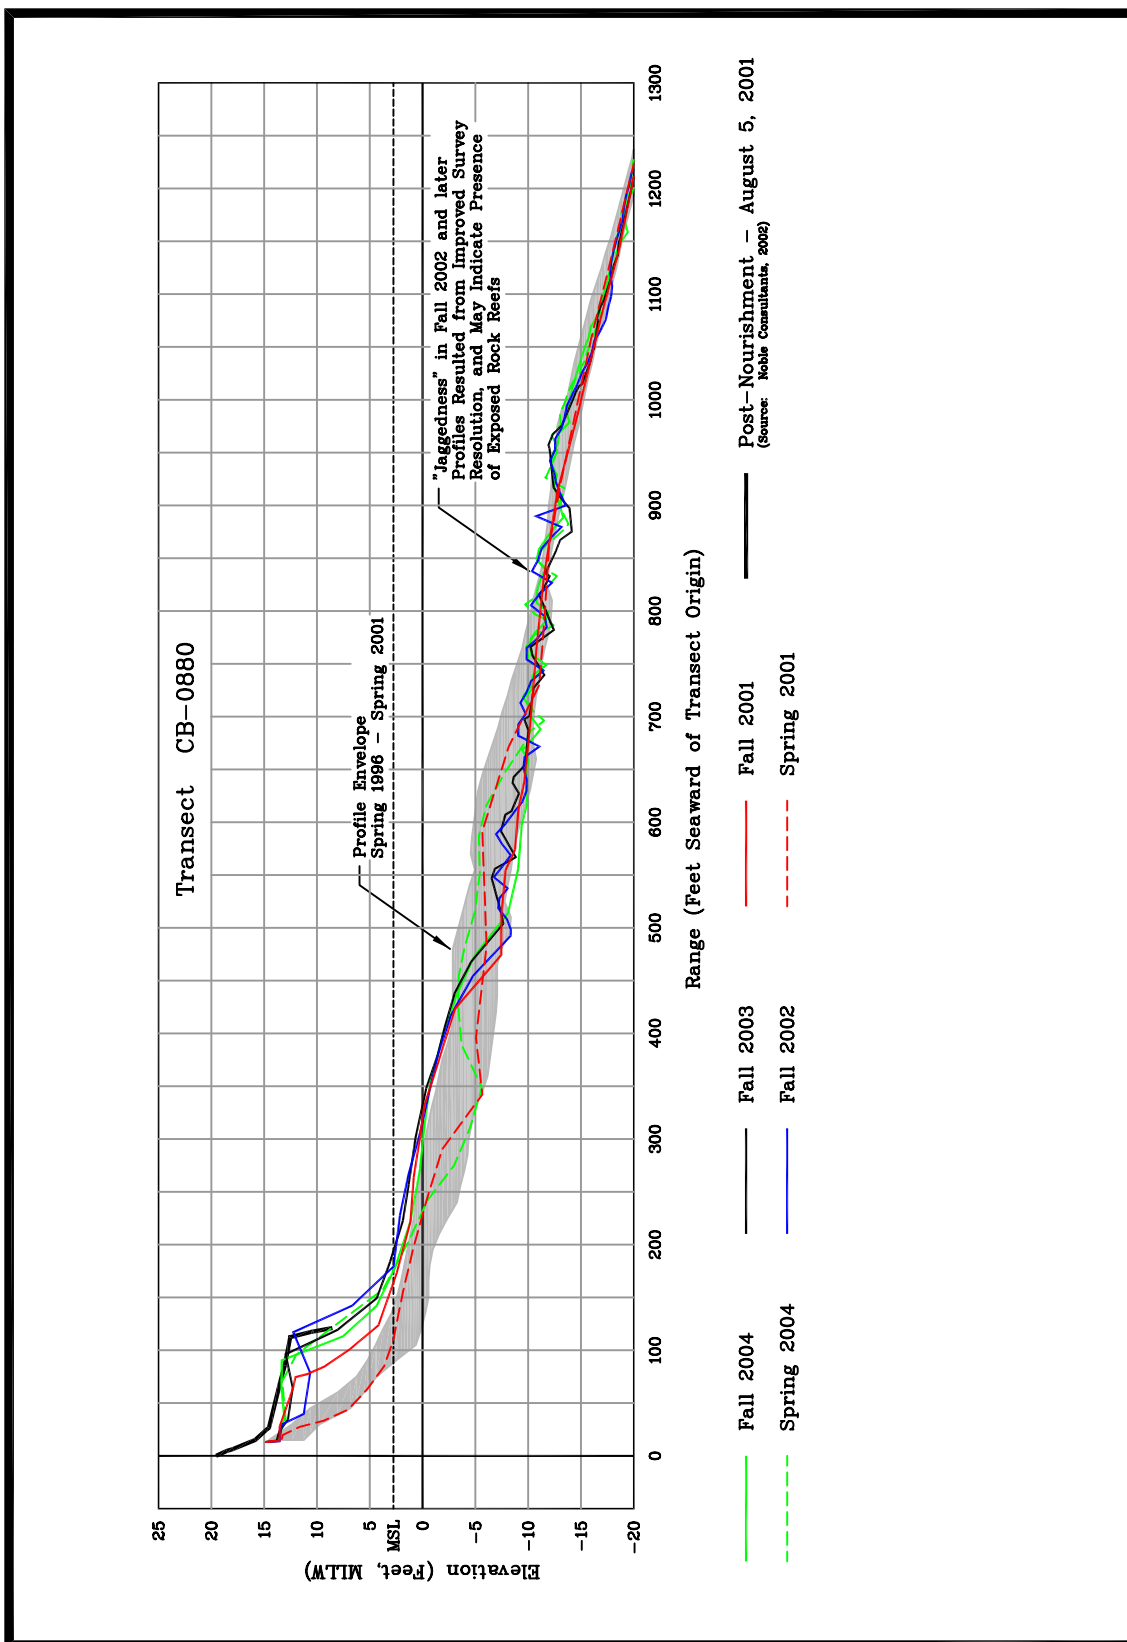
Figure 11. Transect CB-0880 in Carlsbad

Comparing the Spring and Fall profiles provides an indication of seasonal changes, while comparing the four Fall profiles illustrates the nature of inter-annual and long-term changes. A significant difference between the pre-RBSP envelope and one or more of the post-nourishment profiles indicates a material change in the beach condition that may have resulted from the RBSP nourishment activities.

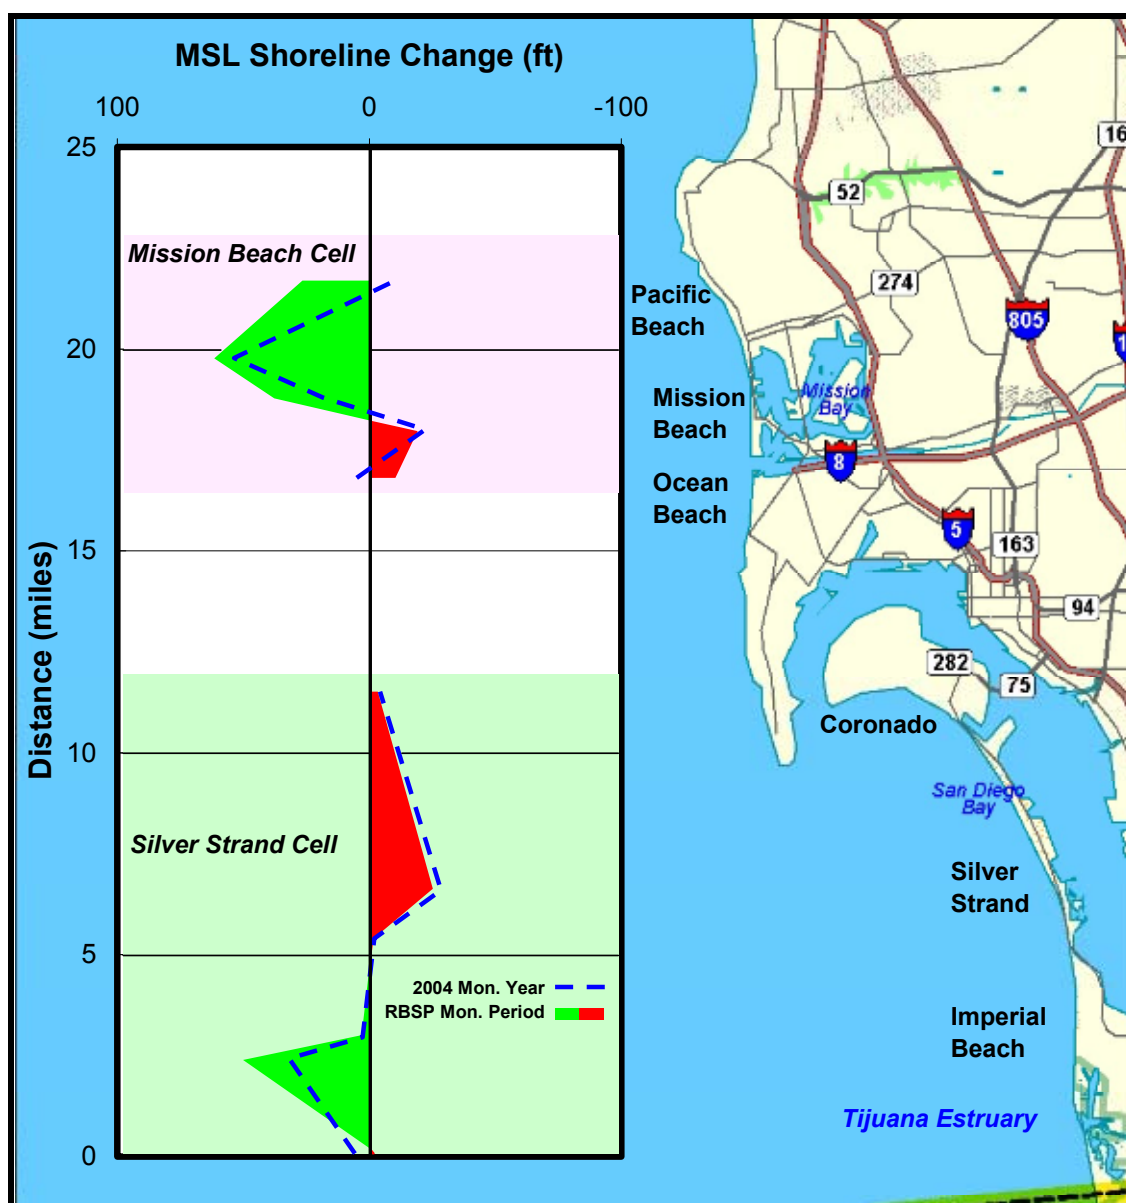
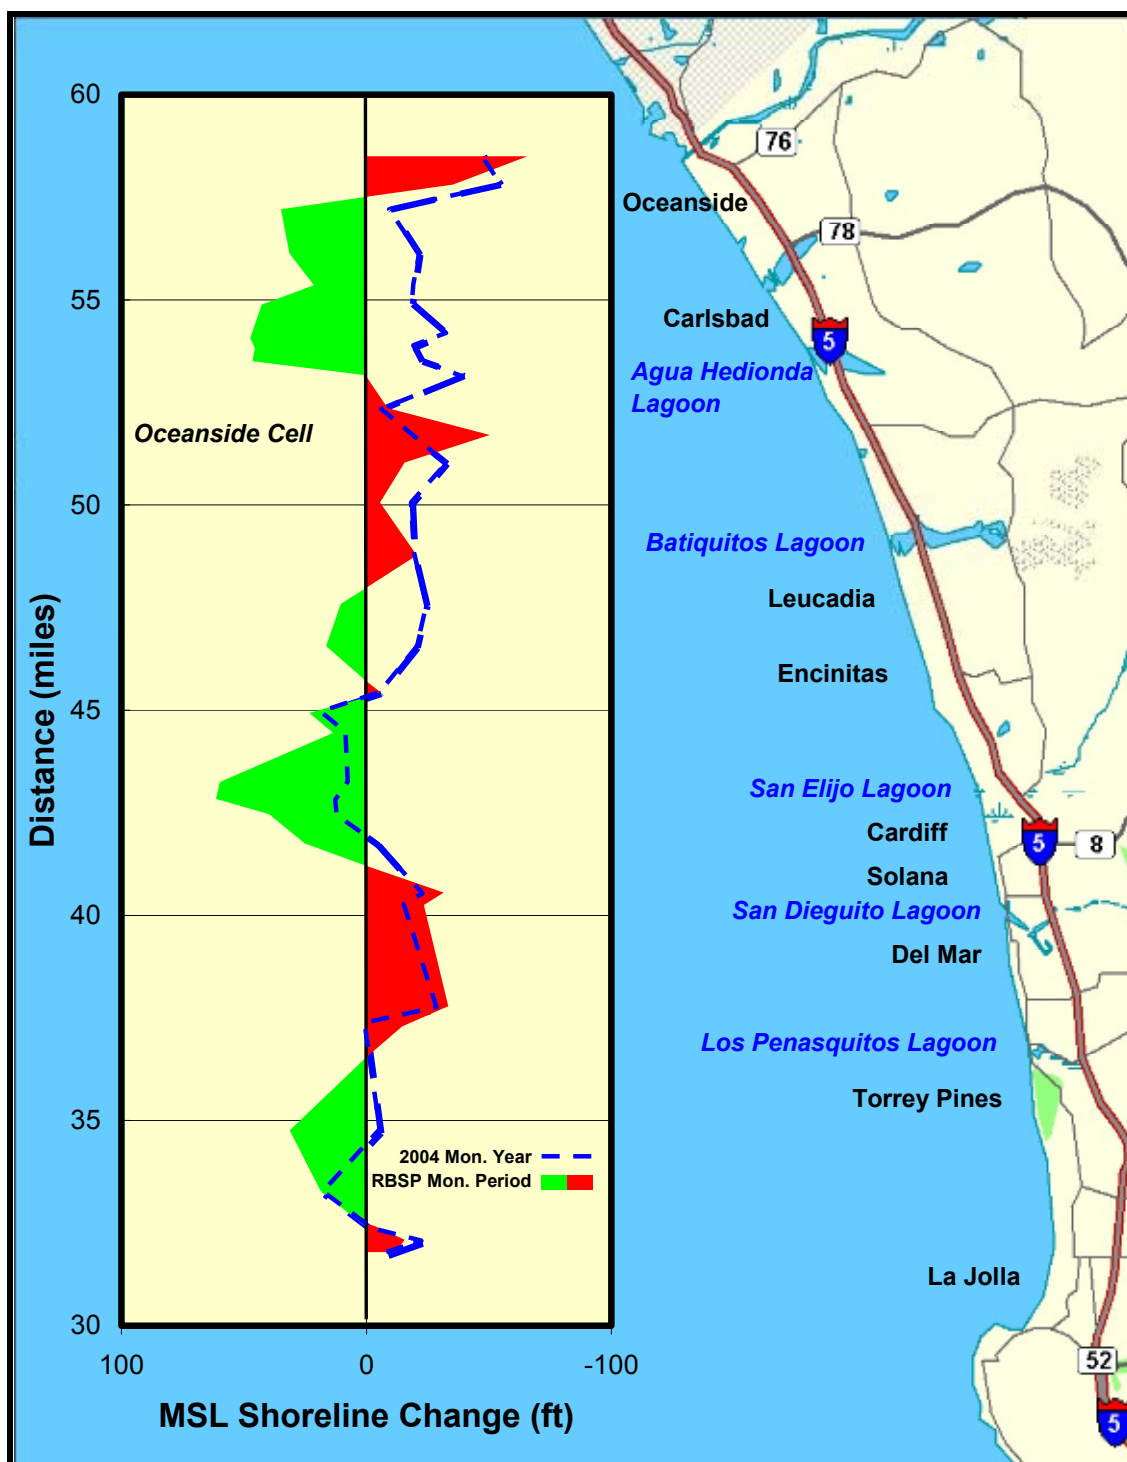
**Figure 12a. MSL Shoreline Changes during the 2004 Monitoring Year and RBSP Monitoring Period in the Silver Strand and Mission Beach Littoral Cells**

The changes in MSL shoreline position that occurred during the 2004 Monitoring Year and the entire RBSP Monitoring Period are summarized in Figures 12a and b and Table 13. Detailed supporting data appear in Appendix E.

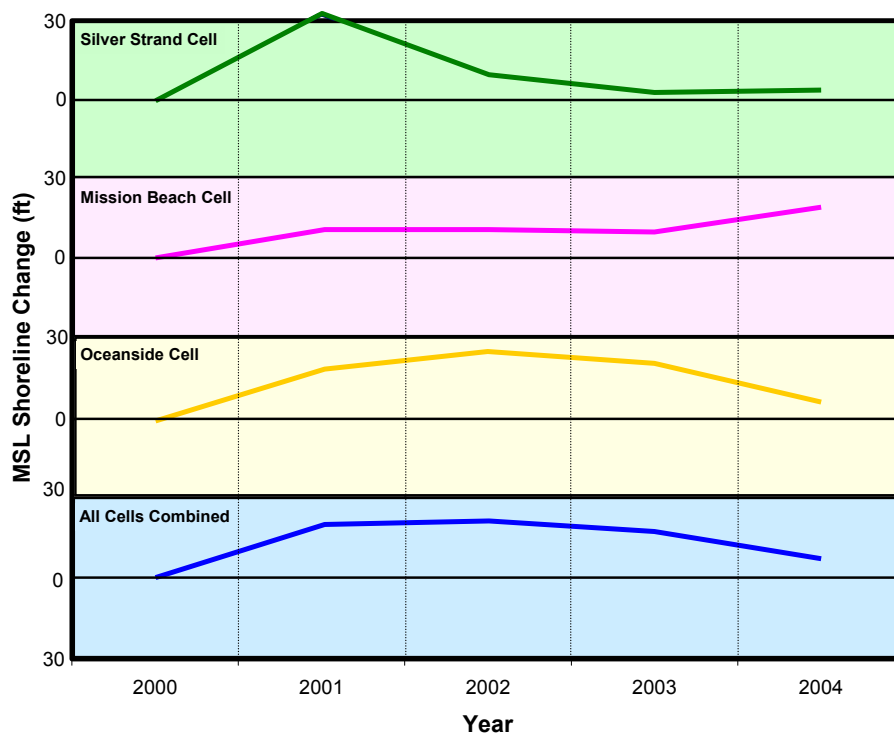
**Figure 13. Time Series of Average MSL Shoreline Change Relative to Pre-RBSP Condition**

Time series of the average shoreline change at the time of the Fall Survey relative to the pre-RBSP condition (Fall 2000) are presented for each littoral cell and the entire region in Figure 13. Substantial shoreline advance occurred in 2001 for each cell in response to the RBSP. In the Oceanside Cell, additional gains were realized in 2002 as the RBSP fill material dispersed alongshore. Shoreline retreat then followed in 2003 and 2004, suggesting ongoing dispersal of the fill material from the subaerial beach. A similar pattern is absent in the Mission Beach and Silver Strand Cells, perhaps due to the relatively small nourishment quantities and the use of only one receiver site in each of these cells. The shoreline gain was short-lived in the Silver Strand Cell, but has persisted in the Mission Beach Cell.
