## **2004 REGIONAL BEACH MONITORING PROGRAM**

### **ANNUAL REPORT**

**SANDAG  
2004 REGIONAL BEACH  
MONITORING PROGRAM**

April 2005

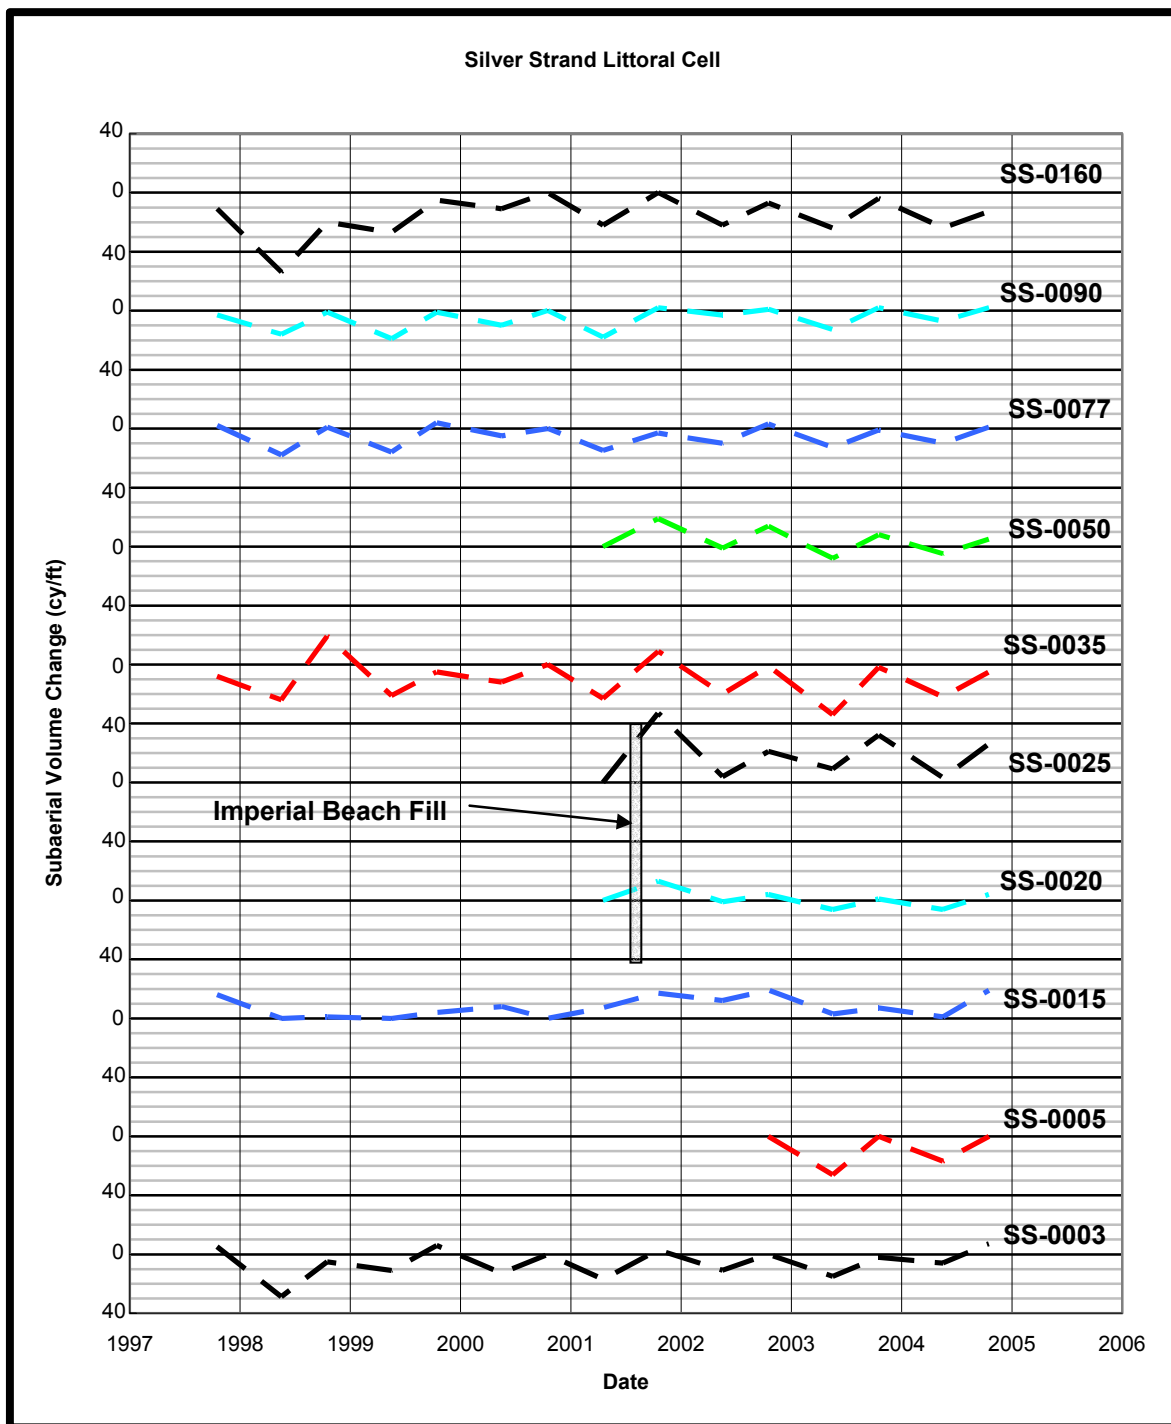
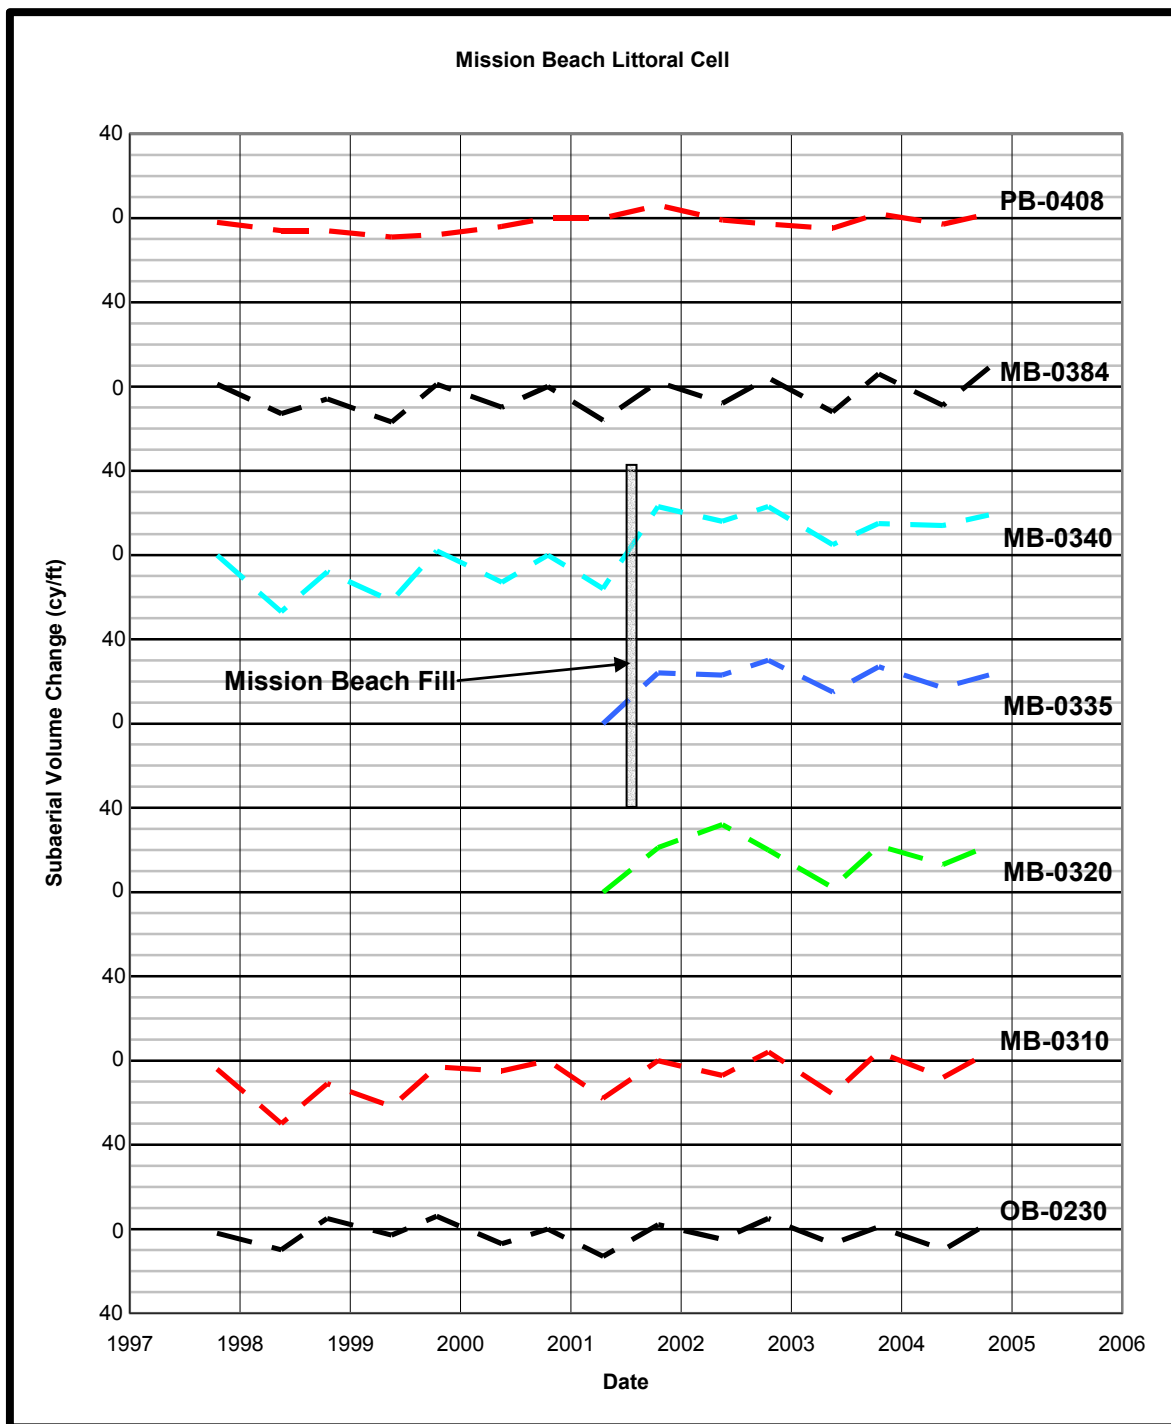
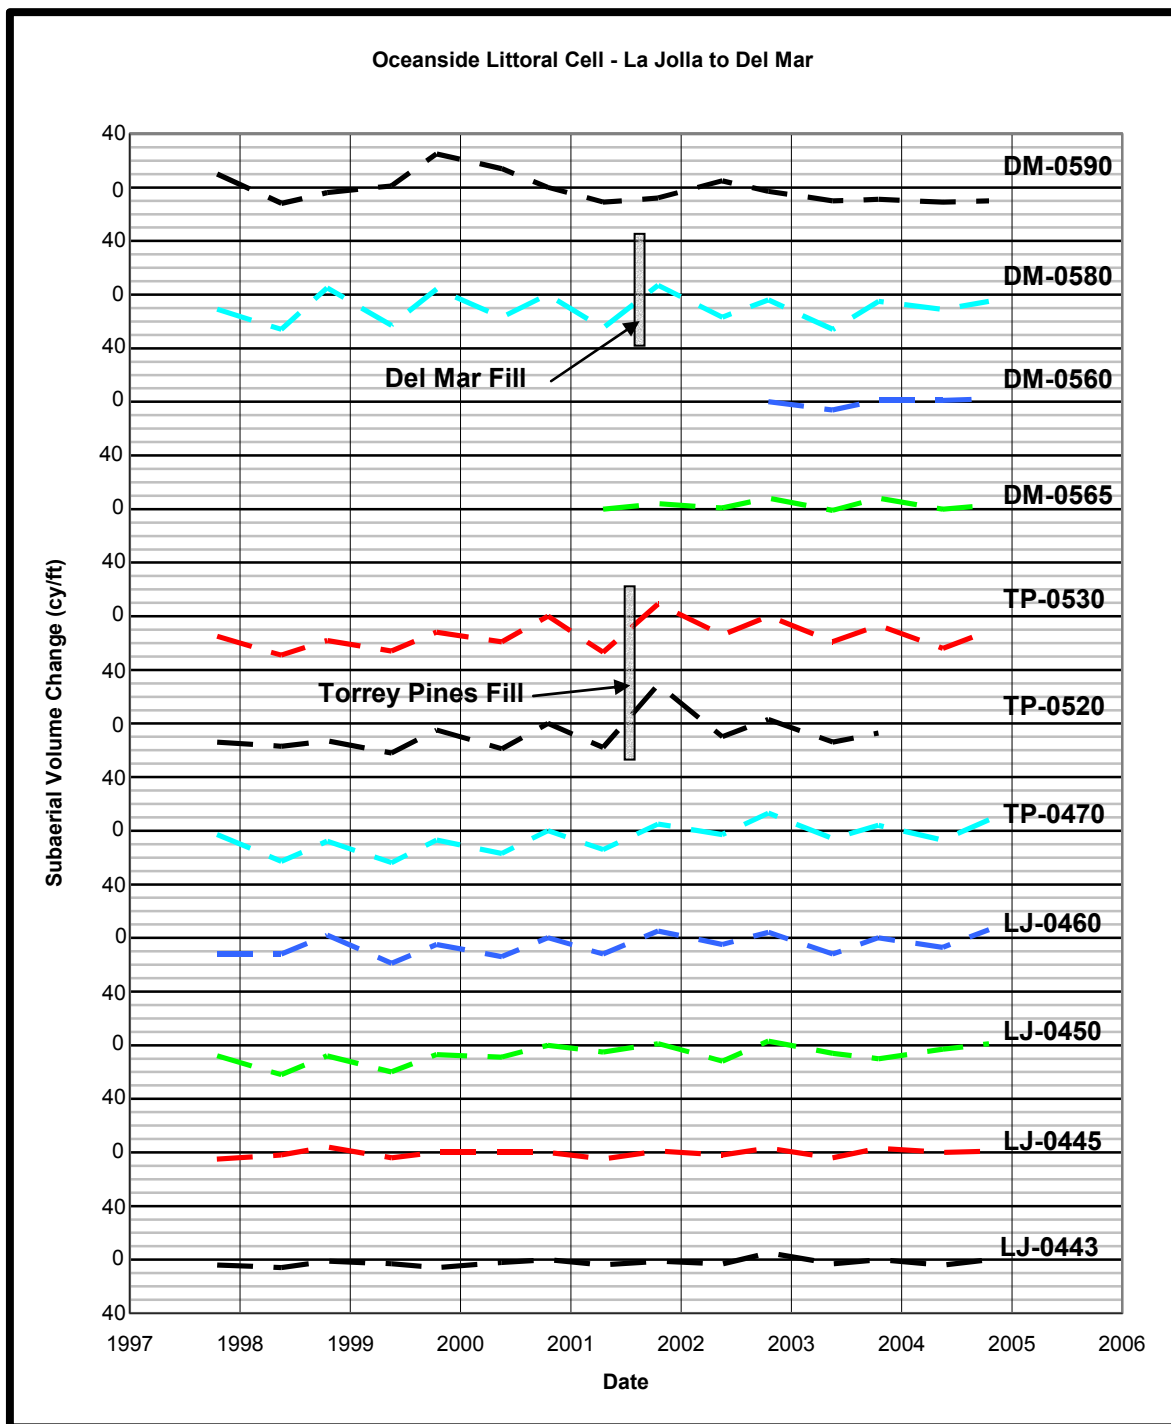
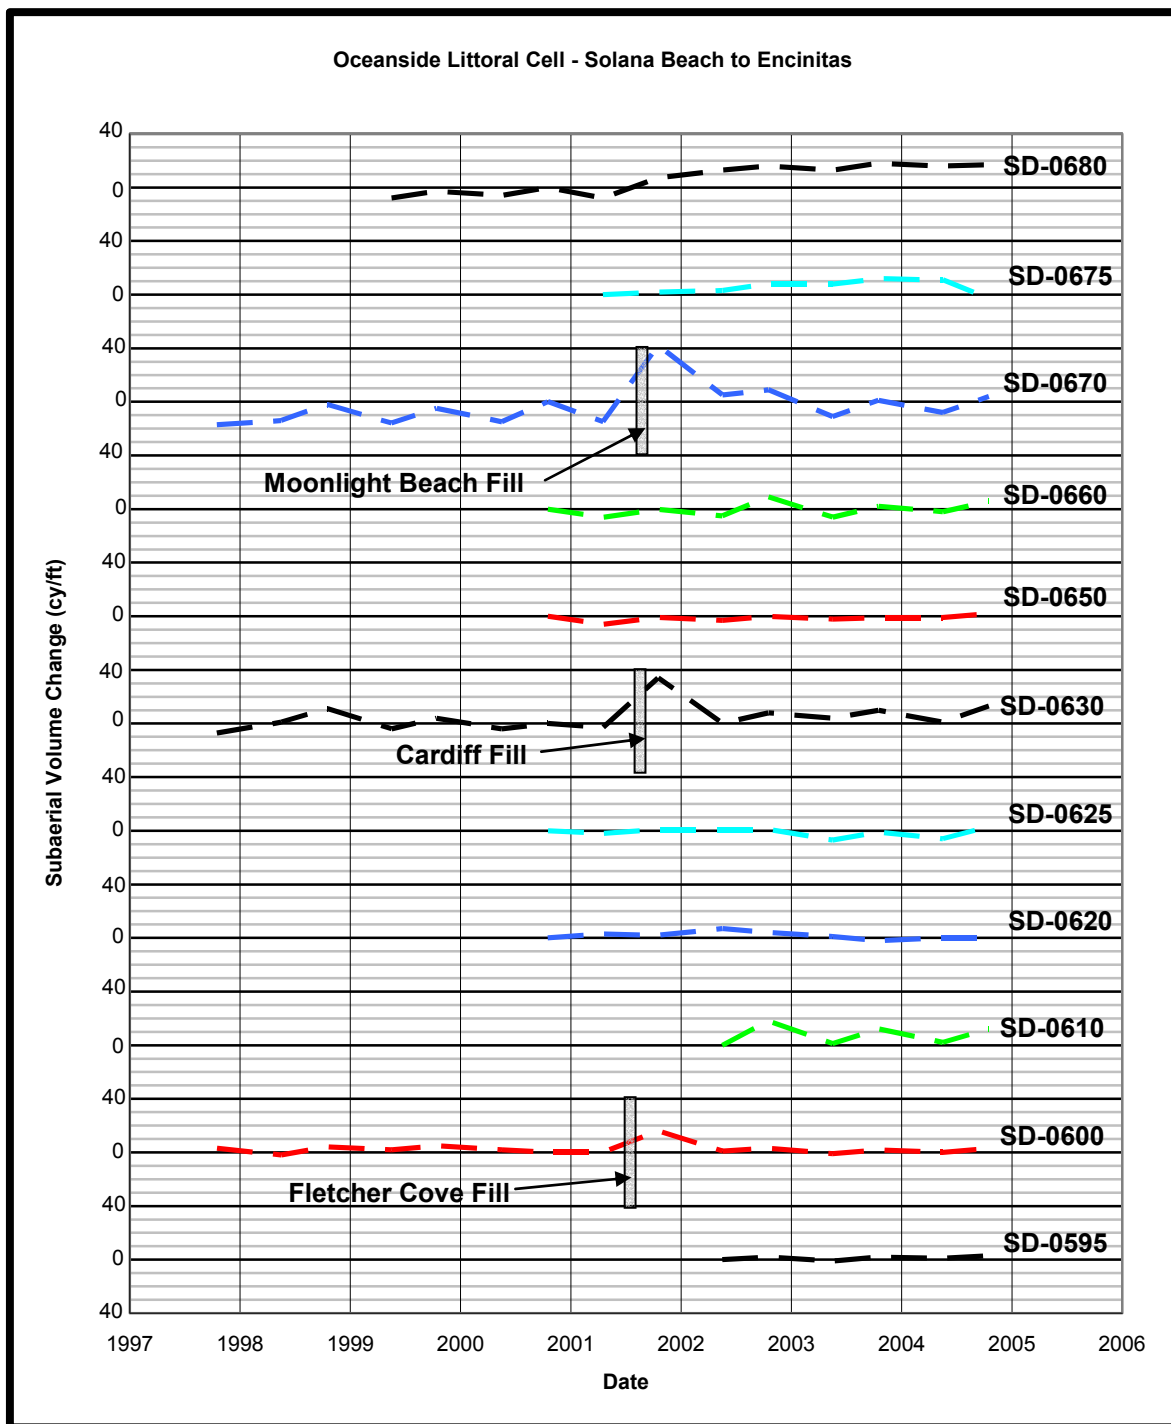
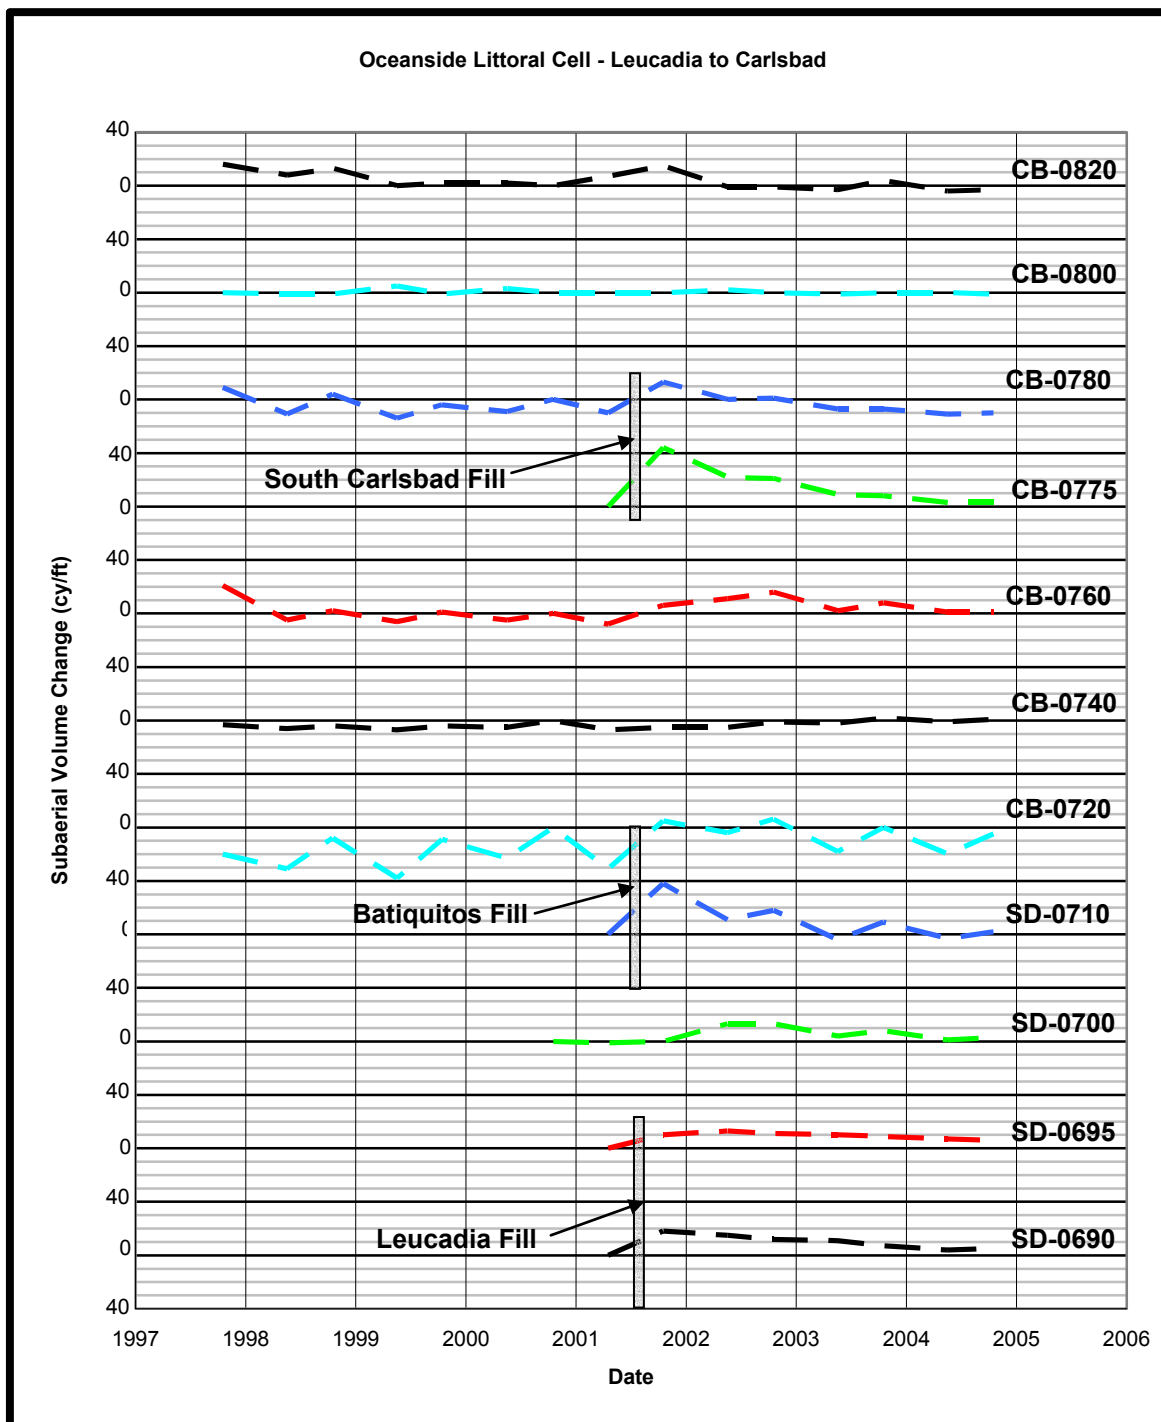
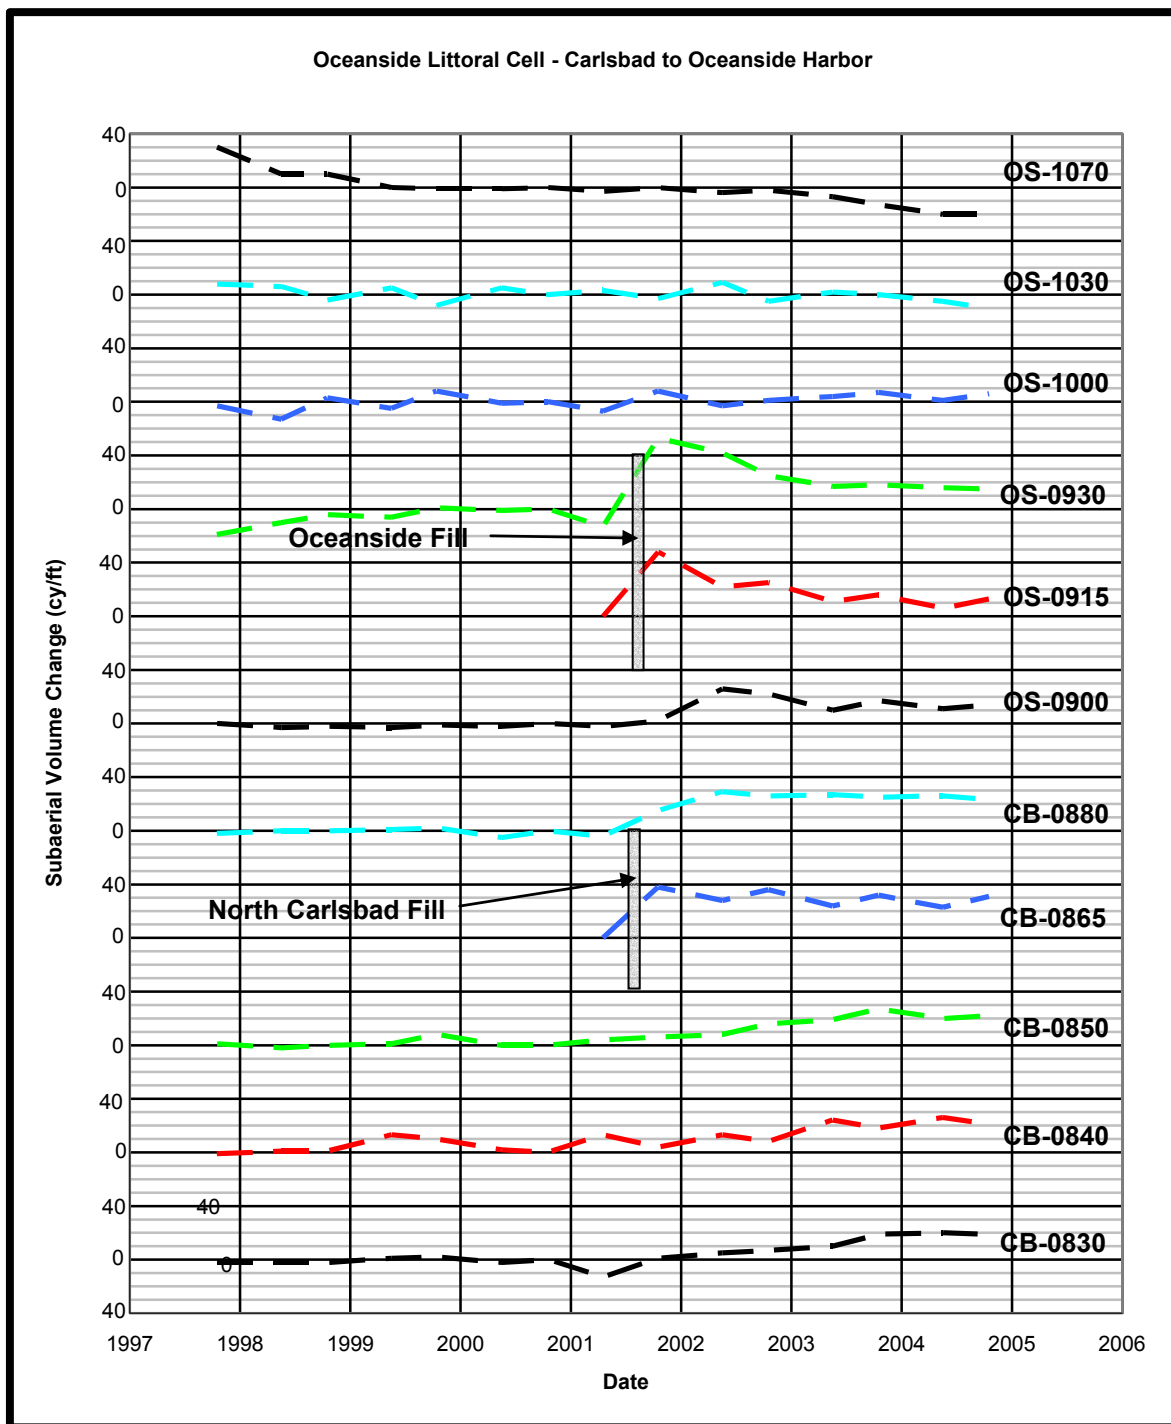
Figures 14a, b, and c present time series of the changes in subaerial sediment volume (above MSL) that occurred between Fall 1997 and Fall 2004. In the case of the 44 transects that pre-dated the RBSP Monitoring Period, the changes were reckoned from the volumes that prevailed at the beginning of that period (Fall 2000). Hence, if the volume change in Fall 2004 exceeds zero, the subaerial volume has increased during the RBSP Monitoring Period. In the case of the 17 transects that were added to the monitoring program after Fall 2000, the changes were reckoned from the volumes that prevailed at the time of the initial survey.

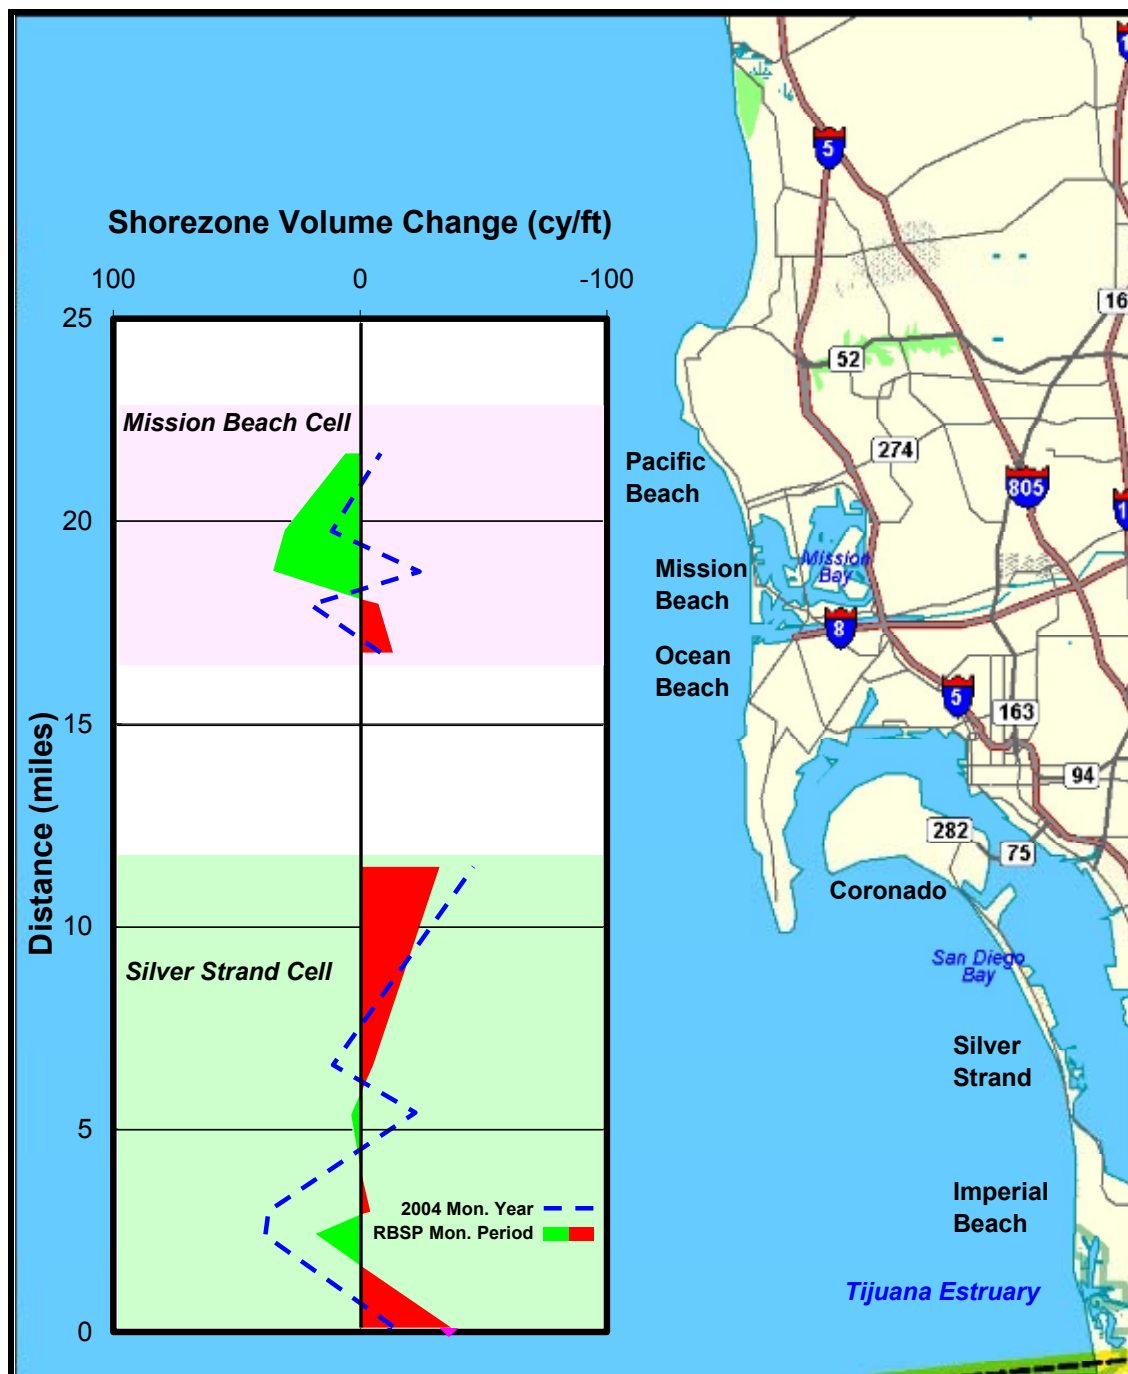
Figure 16a. Shorezone Volume Changes during the 2004 Monitoring Year and RBSP Monitoring Period in the Silver Strand and Mission Beach Littoral Cells

Figures 16a and b and Table 14 present the volume changes that occurred in the shorezone (inside the range of closure) during the 2004 Monitoring Year and the entire RBSP Monitoring Period. The supporting data are provided in Appendix F.

During the 2004 Monitoring Year, gains and losses in shorezone volume were equally balanced among the 44 transects that pre-dated the RBSP Monitoring Period. The net result was an average loss of 1 cy/ft in the Silver Strand Cell and an average gain of 1 cy/ft in each of the Mission Beach and Oceanside Cells. This finding is not surprising considering that in the absence of nourishment activities, major rainstorms, and severe storm events, significant quantities of material were neither added to nor removed from the shorezone.

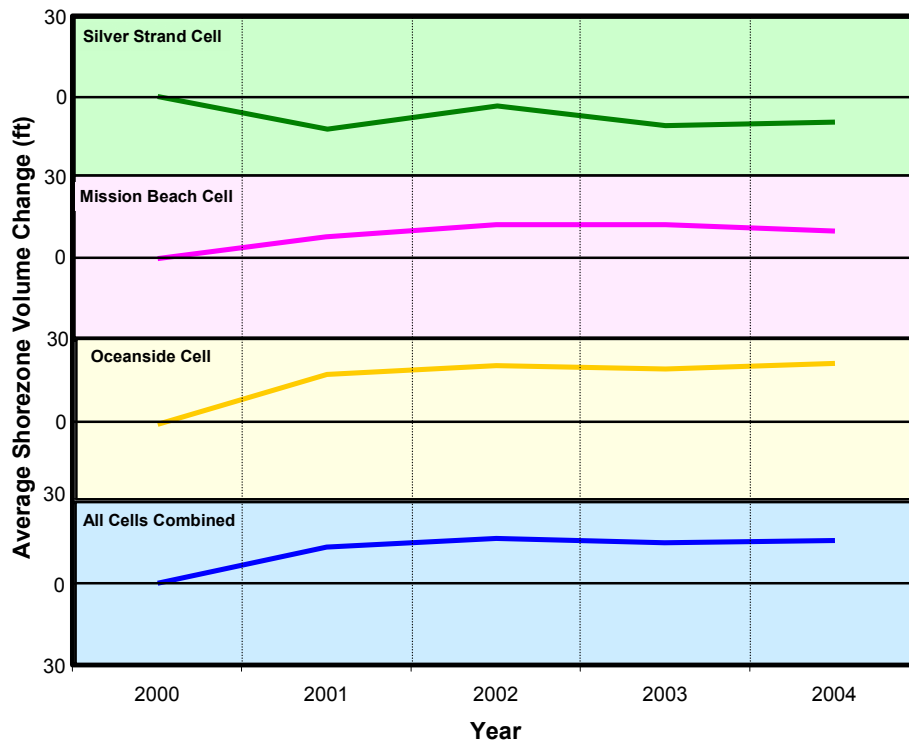
**Figure 17. Time Series of Average MSL Shorezone Volume Change Relative to Pre-RBSP Condition**

Time series of the average shorezone volume change at the time of the Fall Survey relative to the pre-RBSP condition (Fall 2000) are presented for each littoral cell and the entire region in Figure 17. The sediment volume gains that occurred in the Oceanside and Mission Beach Cells following the RBSP persisted with minimal change through 2004. In the Silver Strand Cell, shorezone volumes decreased following the RBSP, and never exceeded the 2000 condition. Although unexpected, this finding may reflect the fact that the two transects located within the Imperial Beach fill do not pre-date the RBSP Monitoring Period. Hence the volume changes at these transects were not included in the statistics. In addition, the 120,000 cy RBSP fill was only modestly larger than the average historical nourishment rate of 73,000 cy/yr (Table 8).

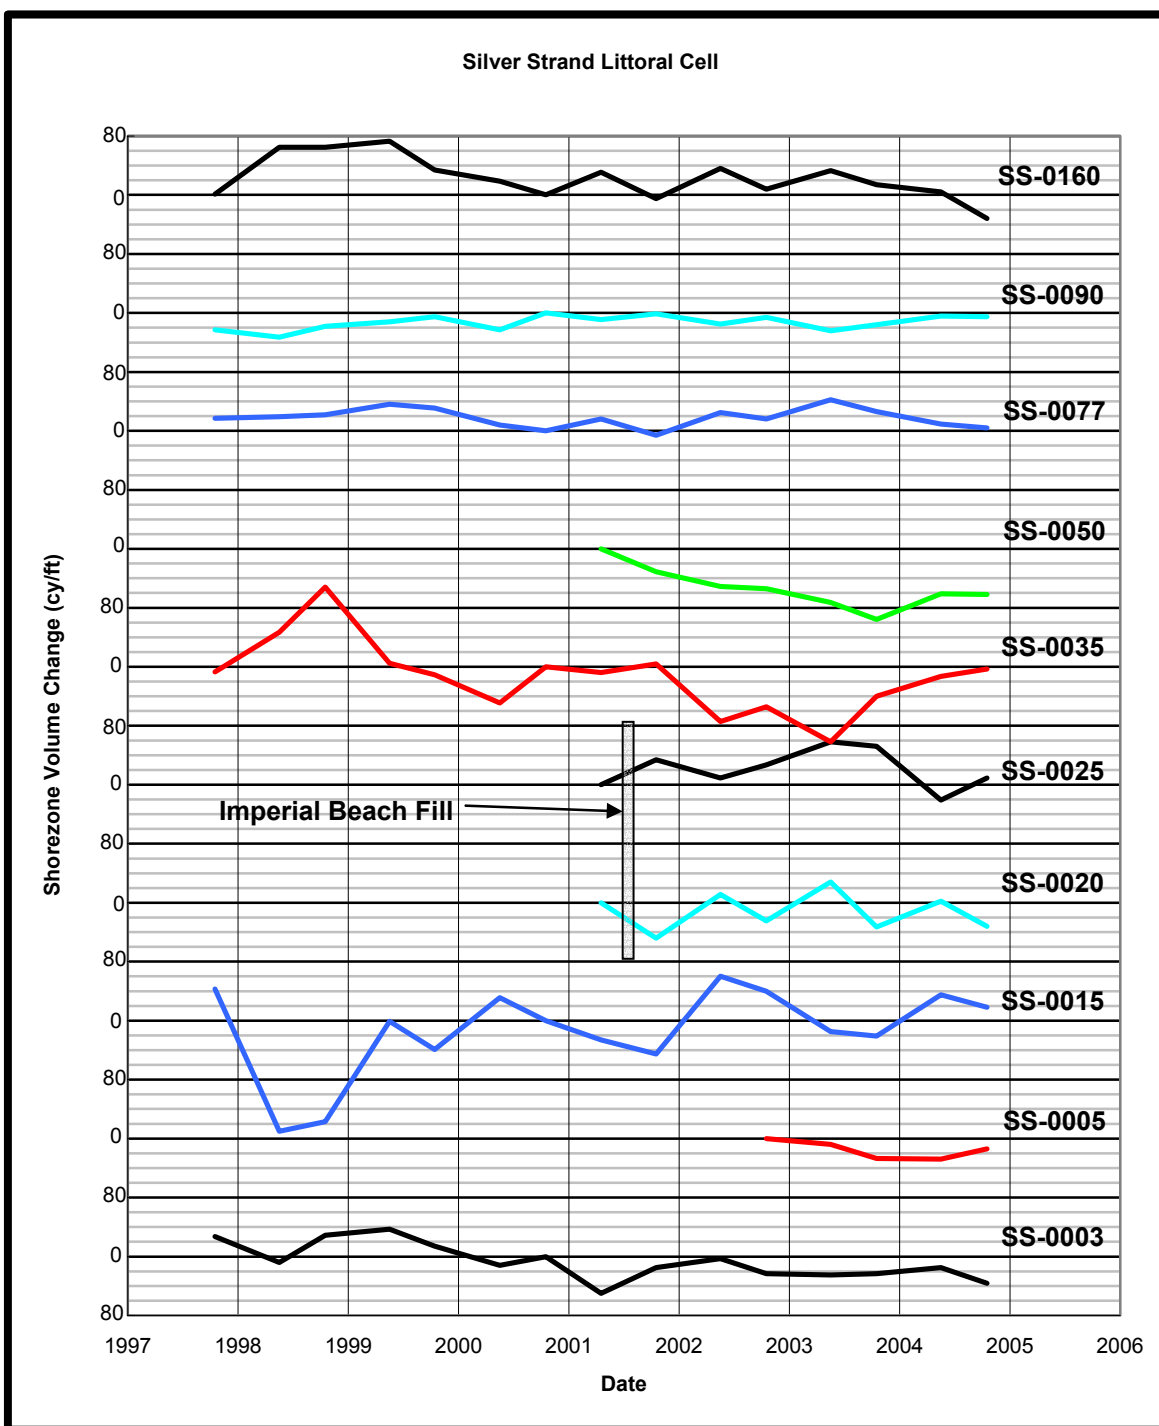
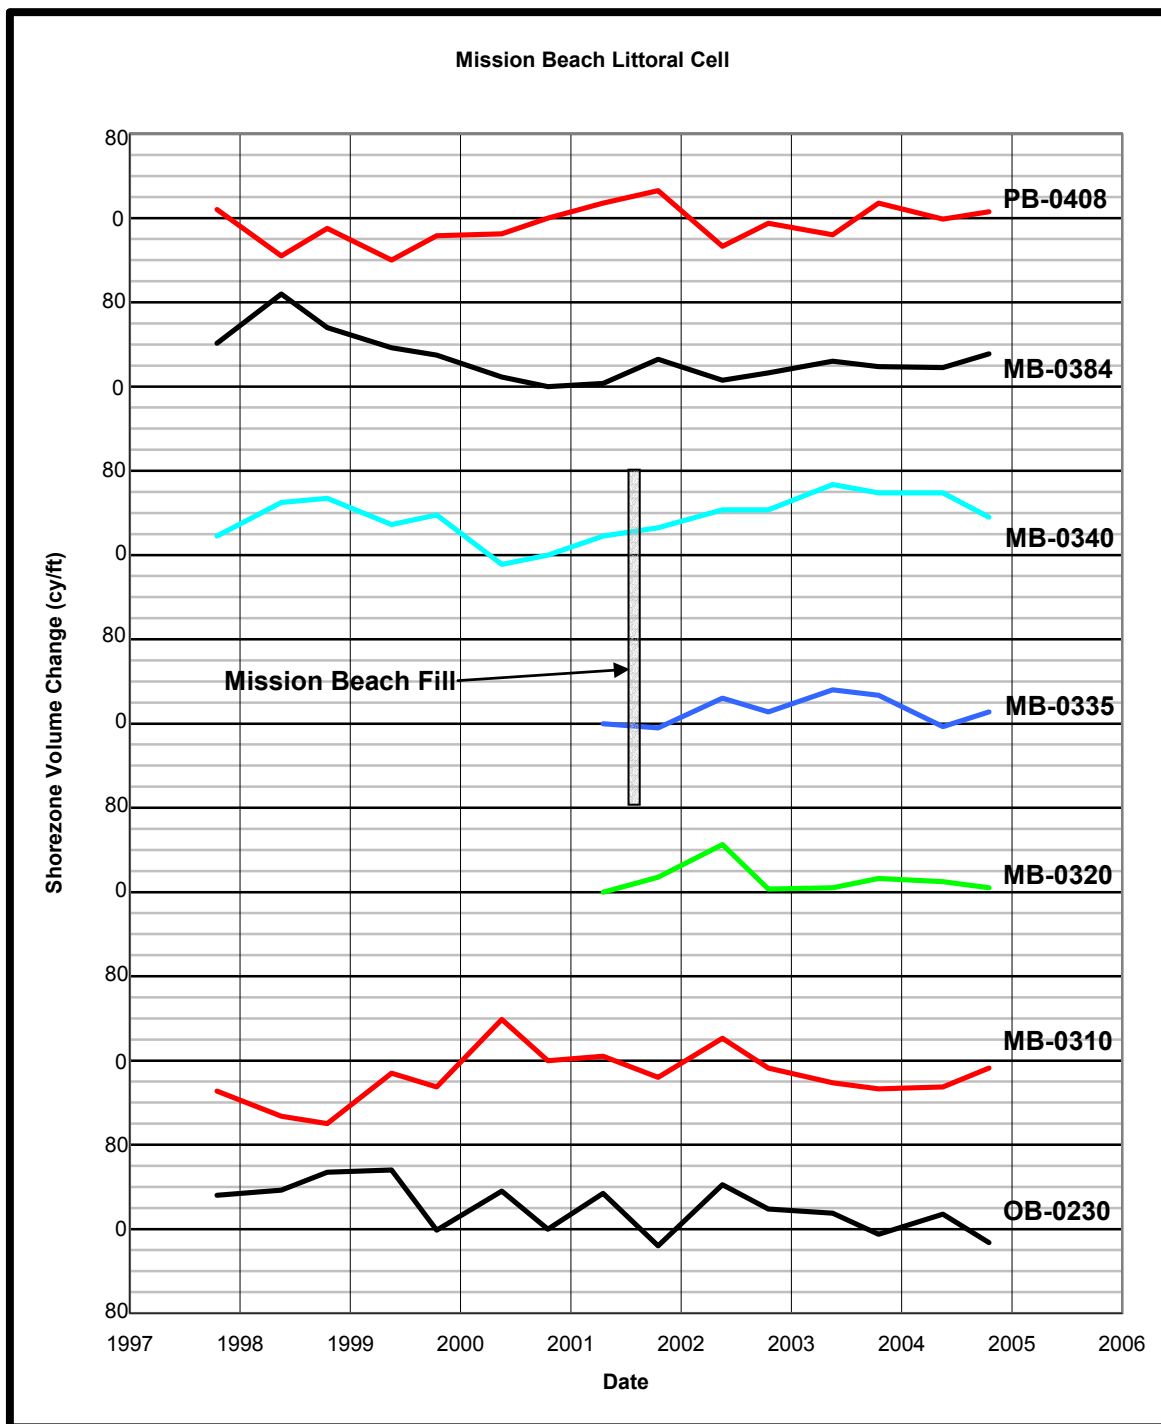
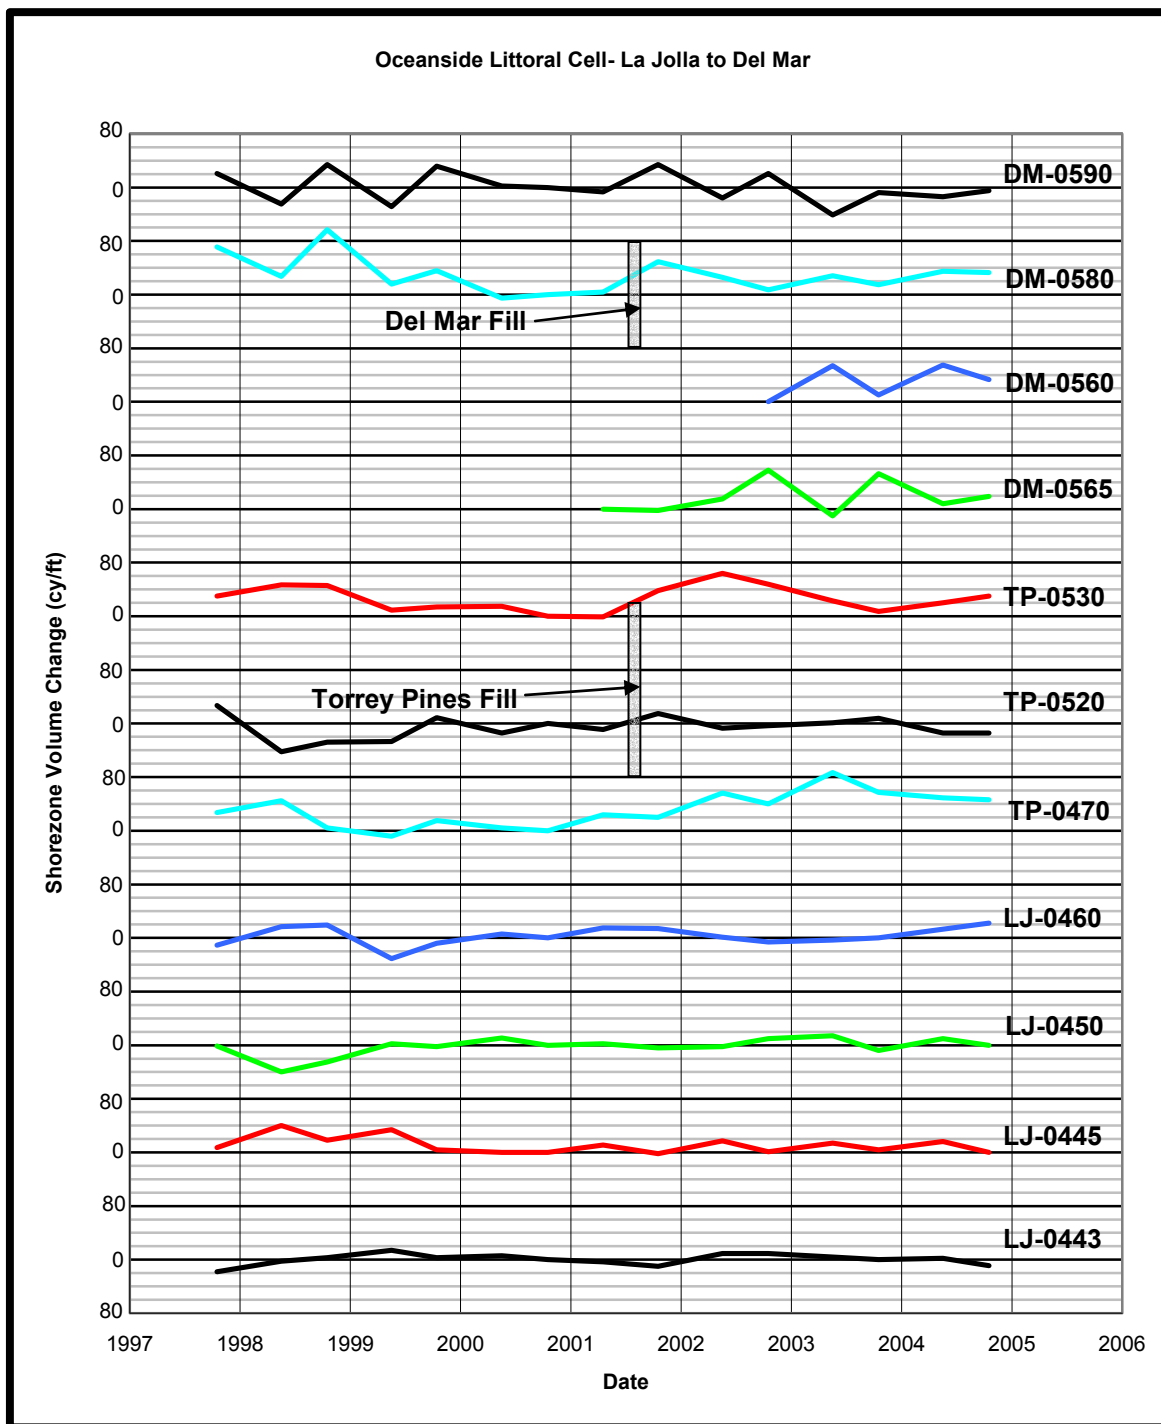
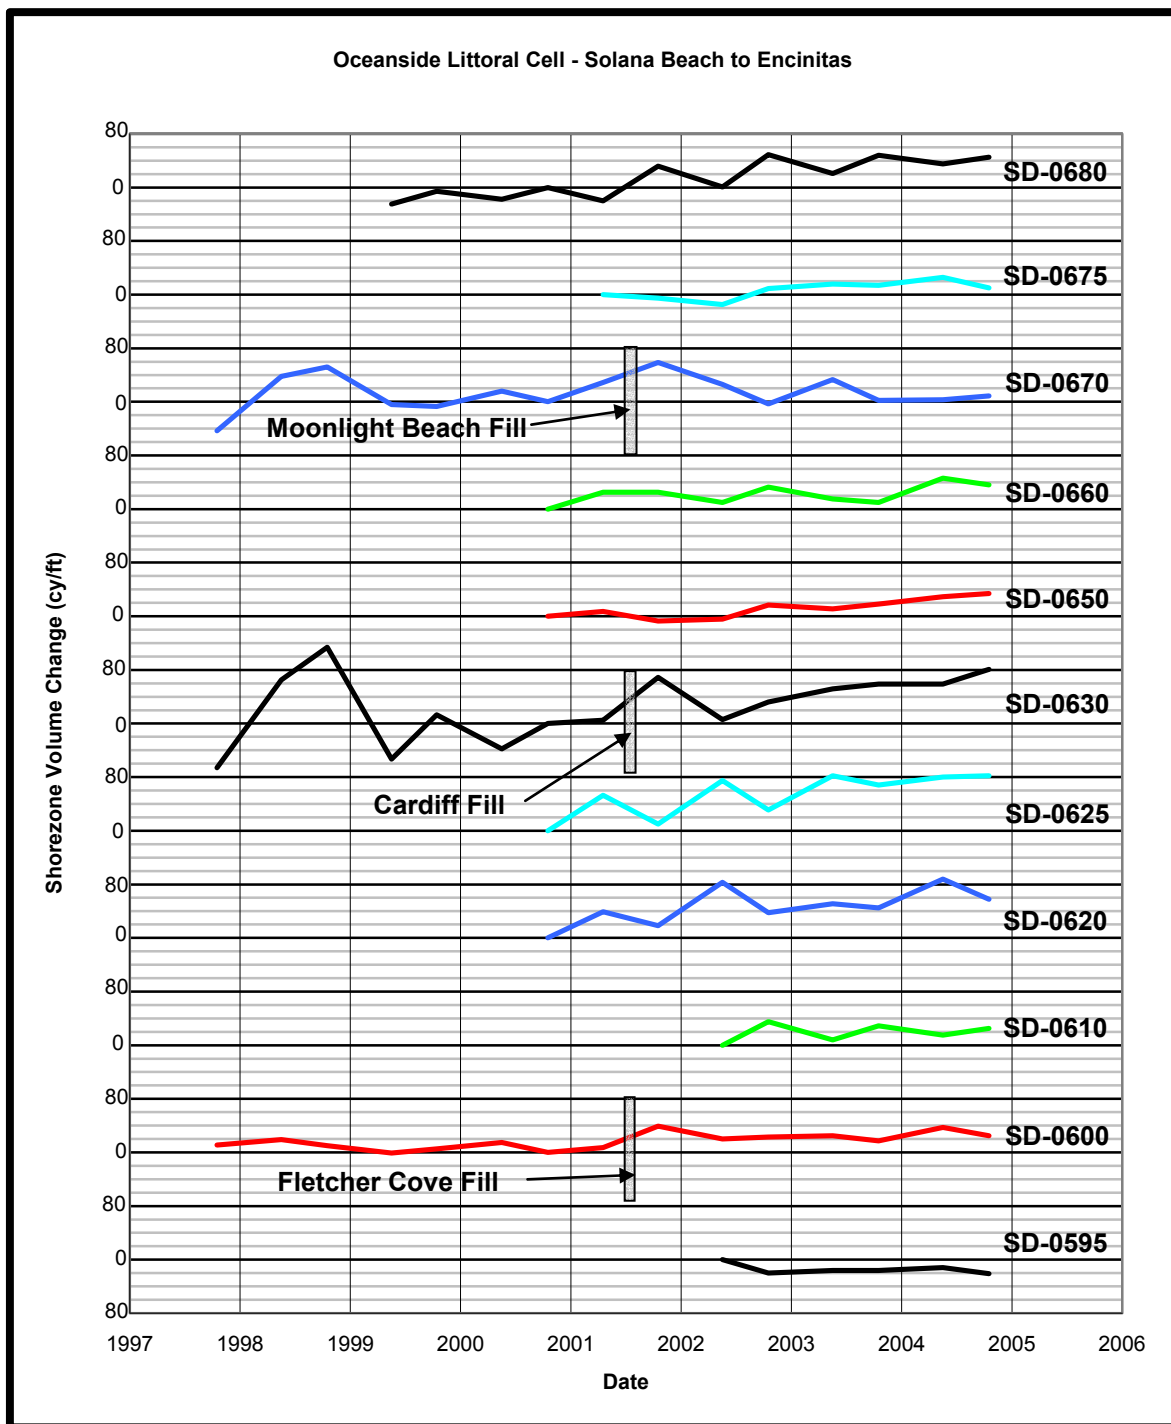
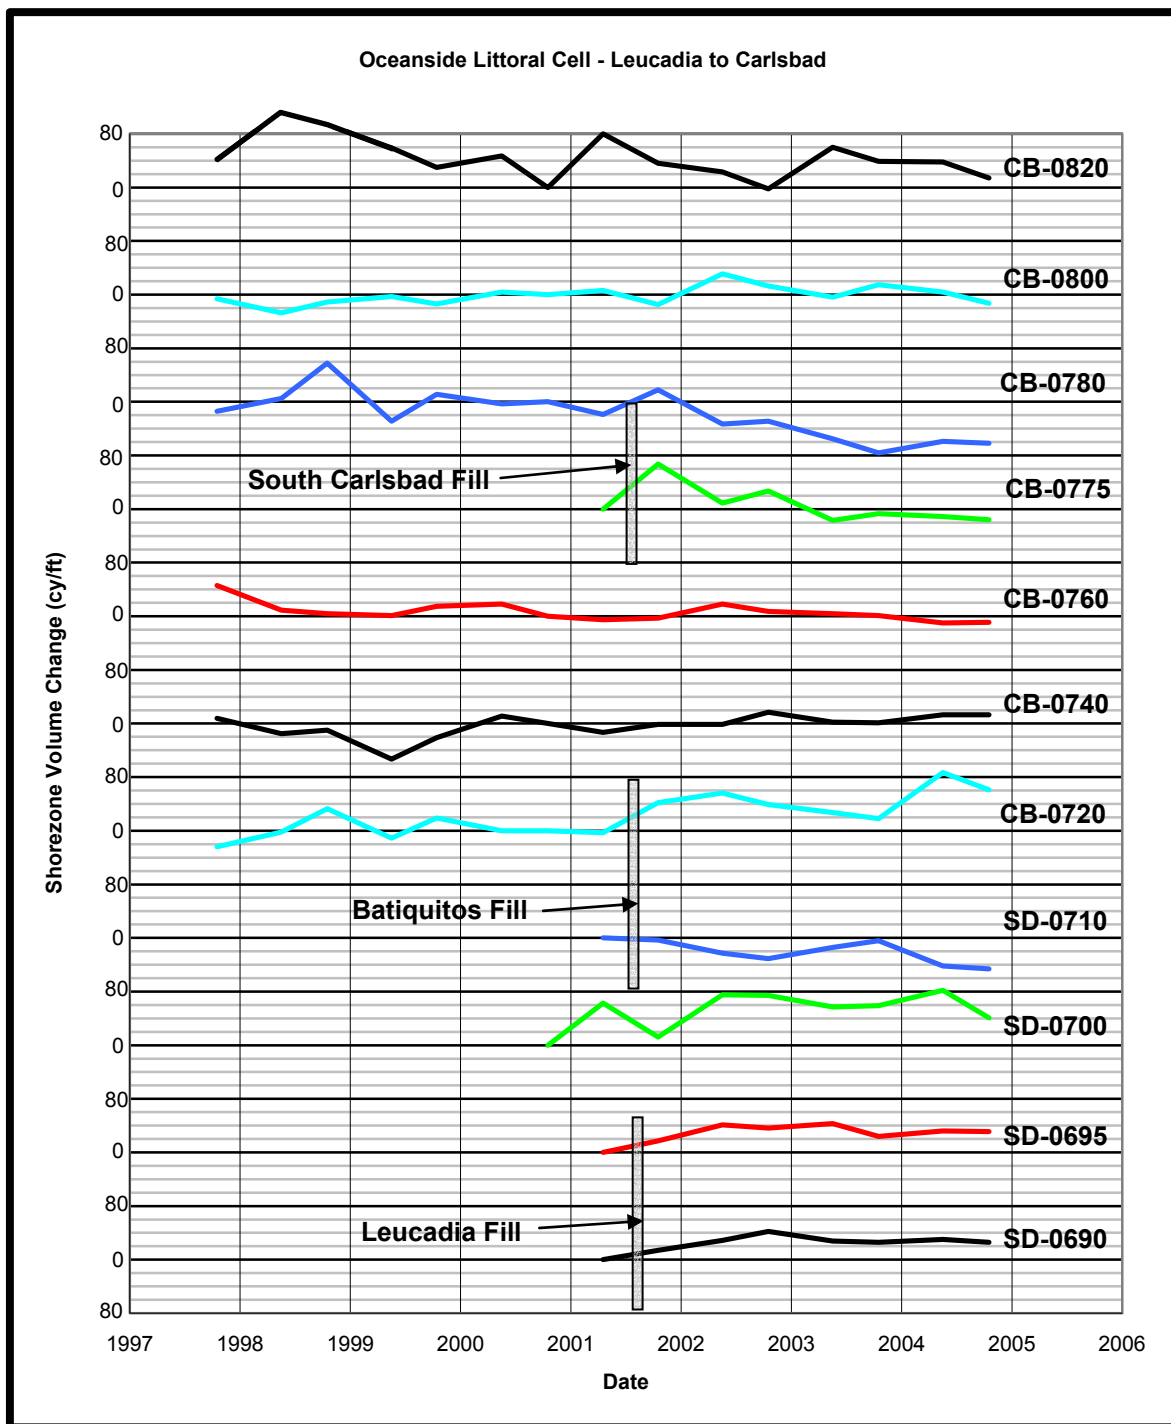
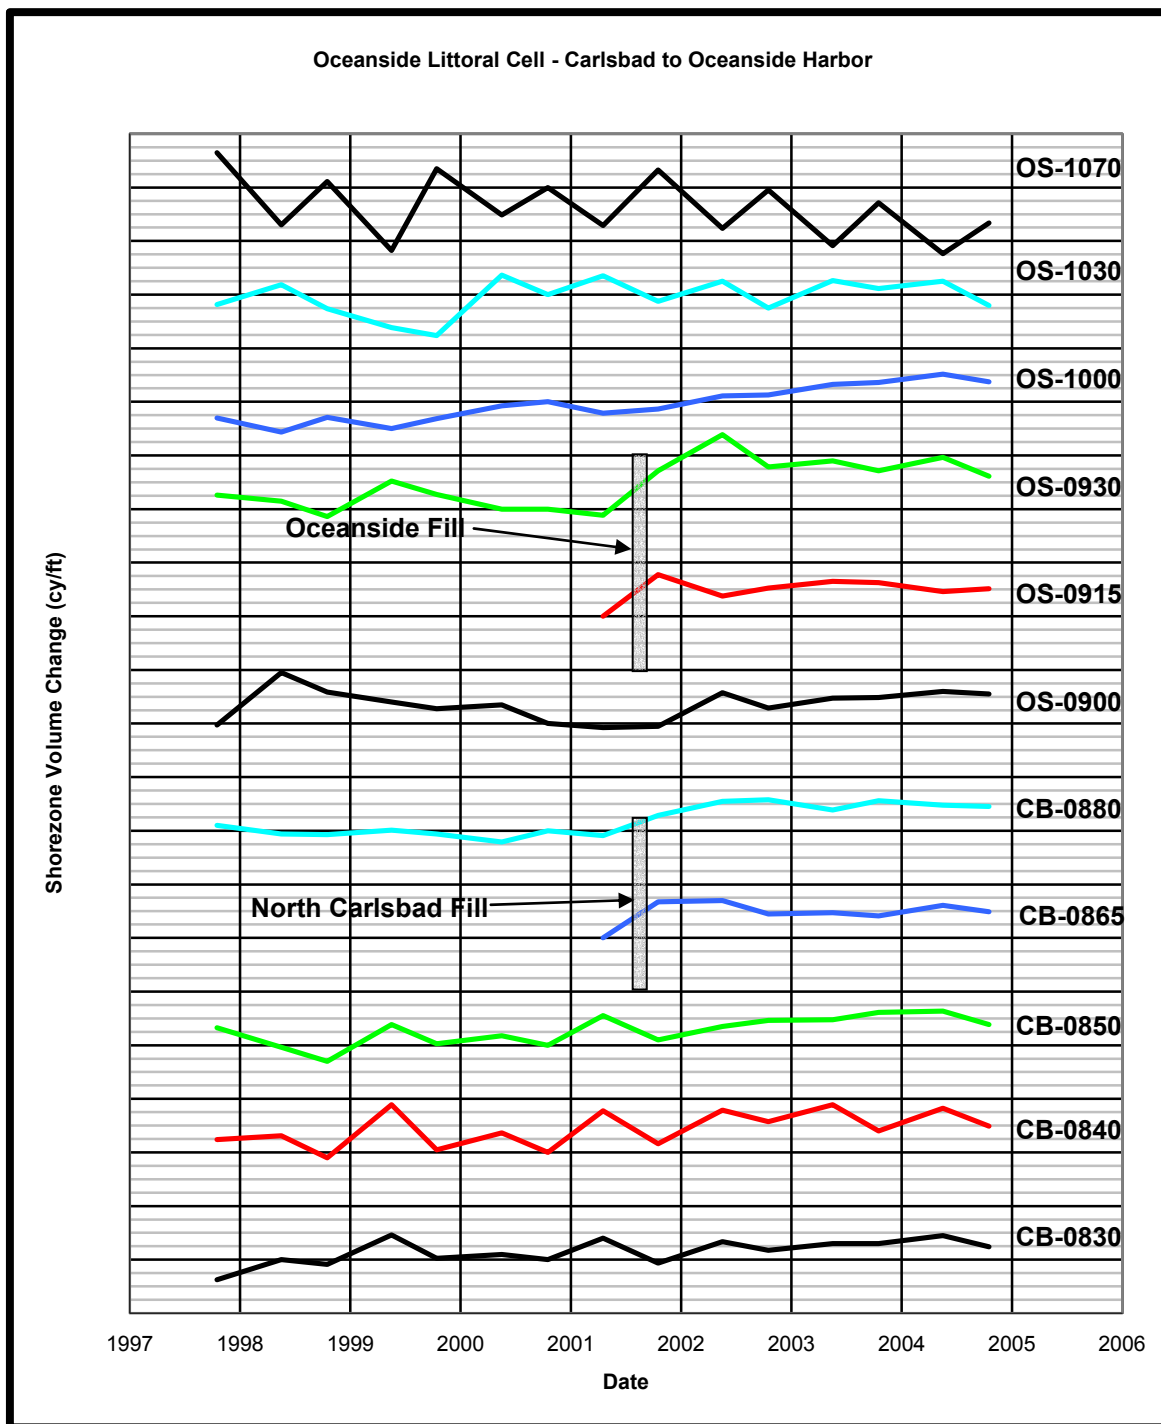
Figures 18a, b, and c present time series of the changes in shorezone sediment volume that occurred between Fall 1997 and Fall 2004. As in the case of Figures 13a, b, and c, the changes were reckoned from the volumes that prevailed at the beginning of the
