## **2004 REGIONAL BEACH MONITORING PROGRAM**

### **ANNUAL REPORT**

**SANDAG  
2004 REGIONAL BEACH  
MONITORING PROGRAM**

April 2005

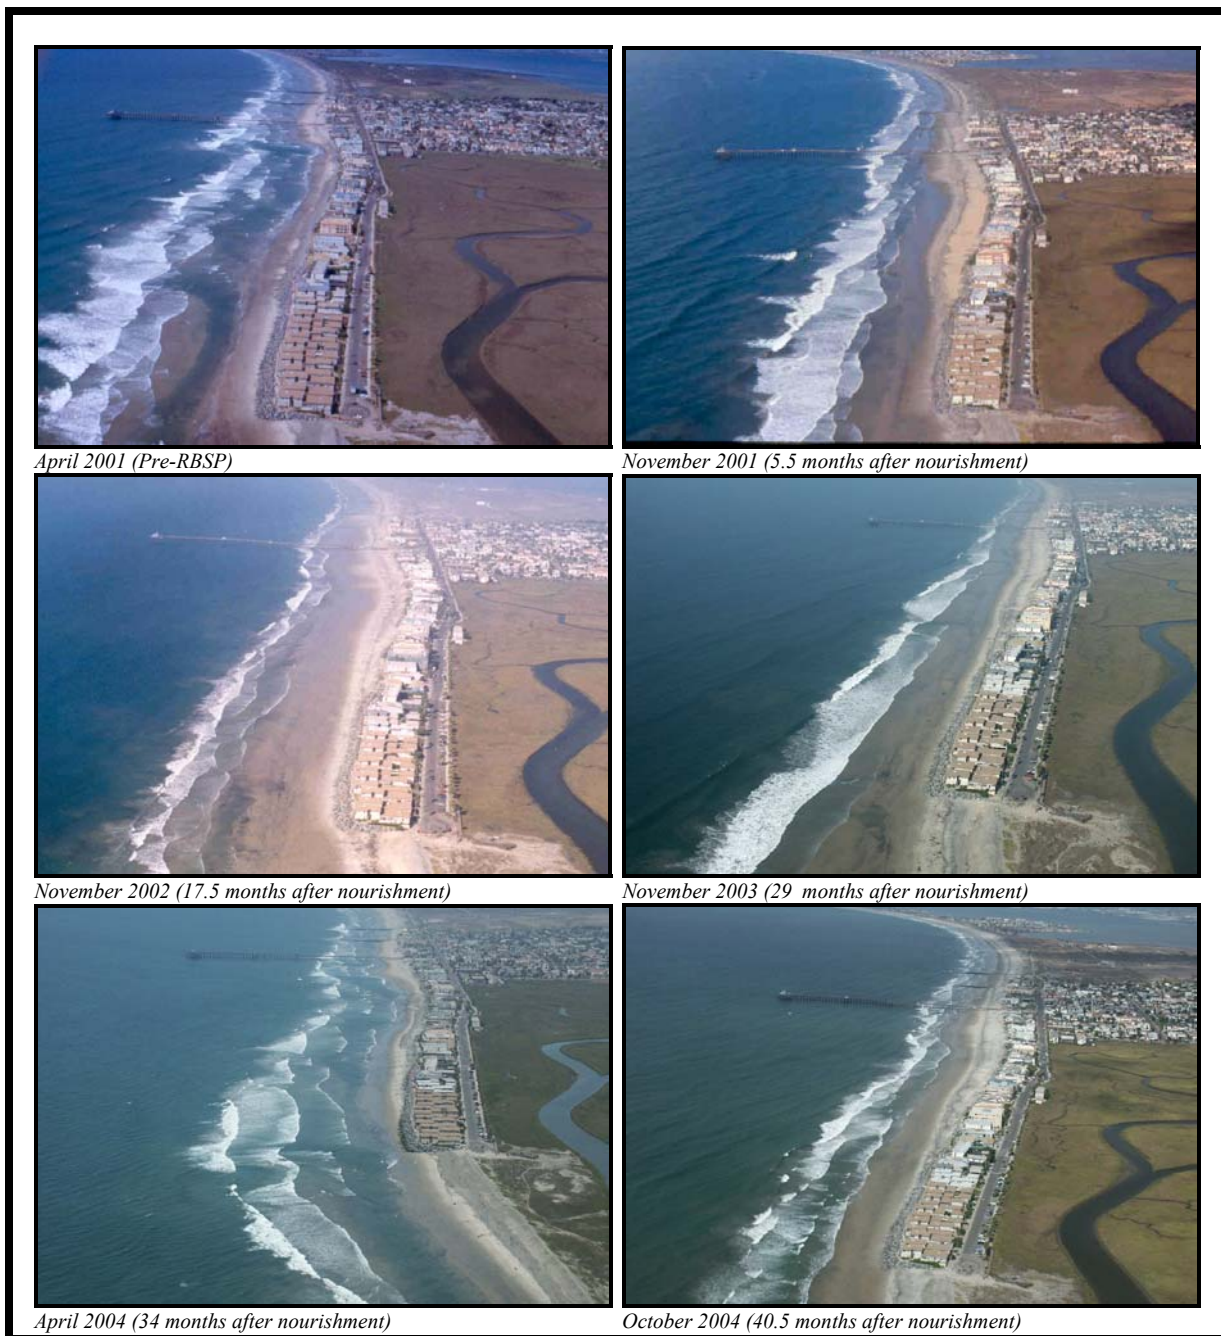
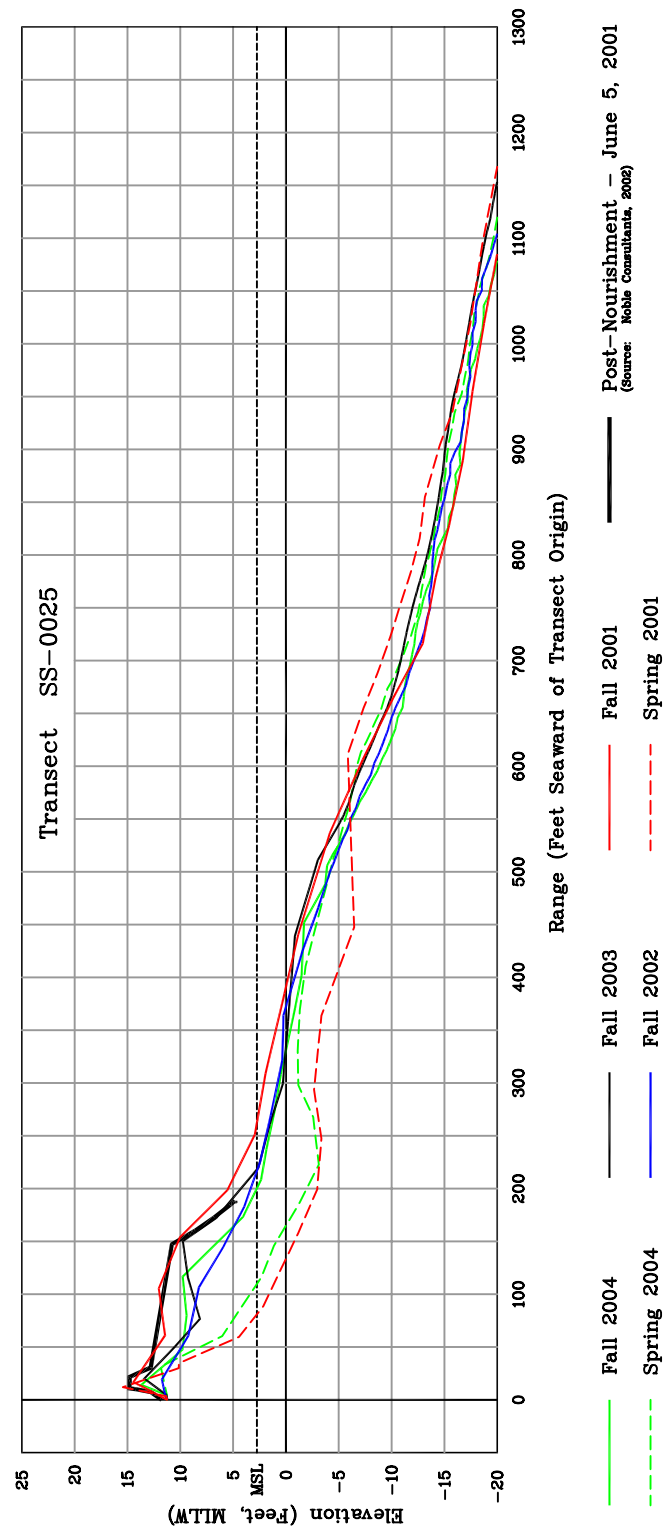
**Plate 1. Imperial Beach Receiver Site, April 2001 through October 2004**

the over steepened beach face adjusted to a more stable configuration, evidenced by above-water erosion and profile flattening. Substantial above-water accretion is evident in the Fall 2003 profile, but this trend was reversed in 2004. The profile changes during the 2004 Monitoring Year were consistent with the anticipated seasonal trends in cross-shore transport: offshore in winter and onshore in summer.

Note: 120,000 cy of nourishment ( $d_{50} = 0.24\text{--}0.52\text{ mm}$ ) was provided from May 22 to June 6, 2001.

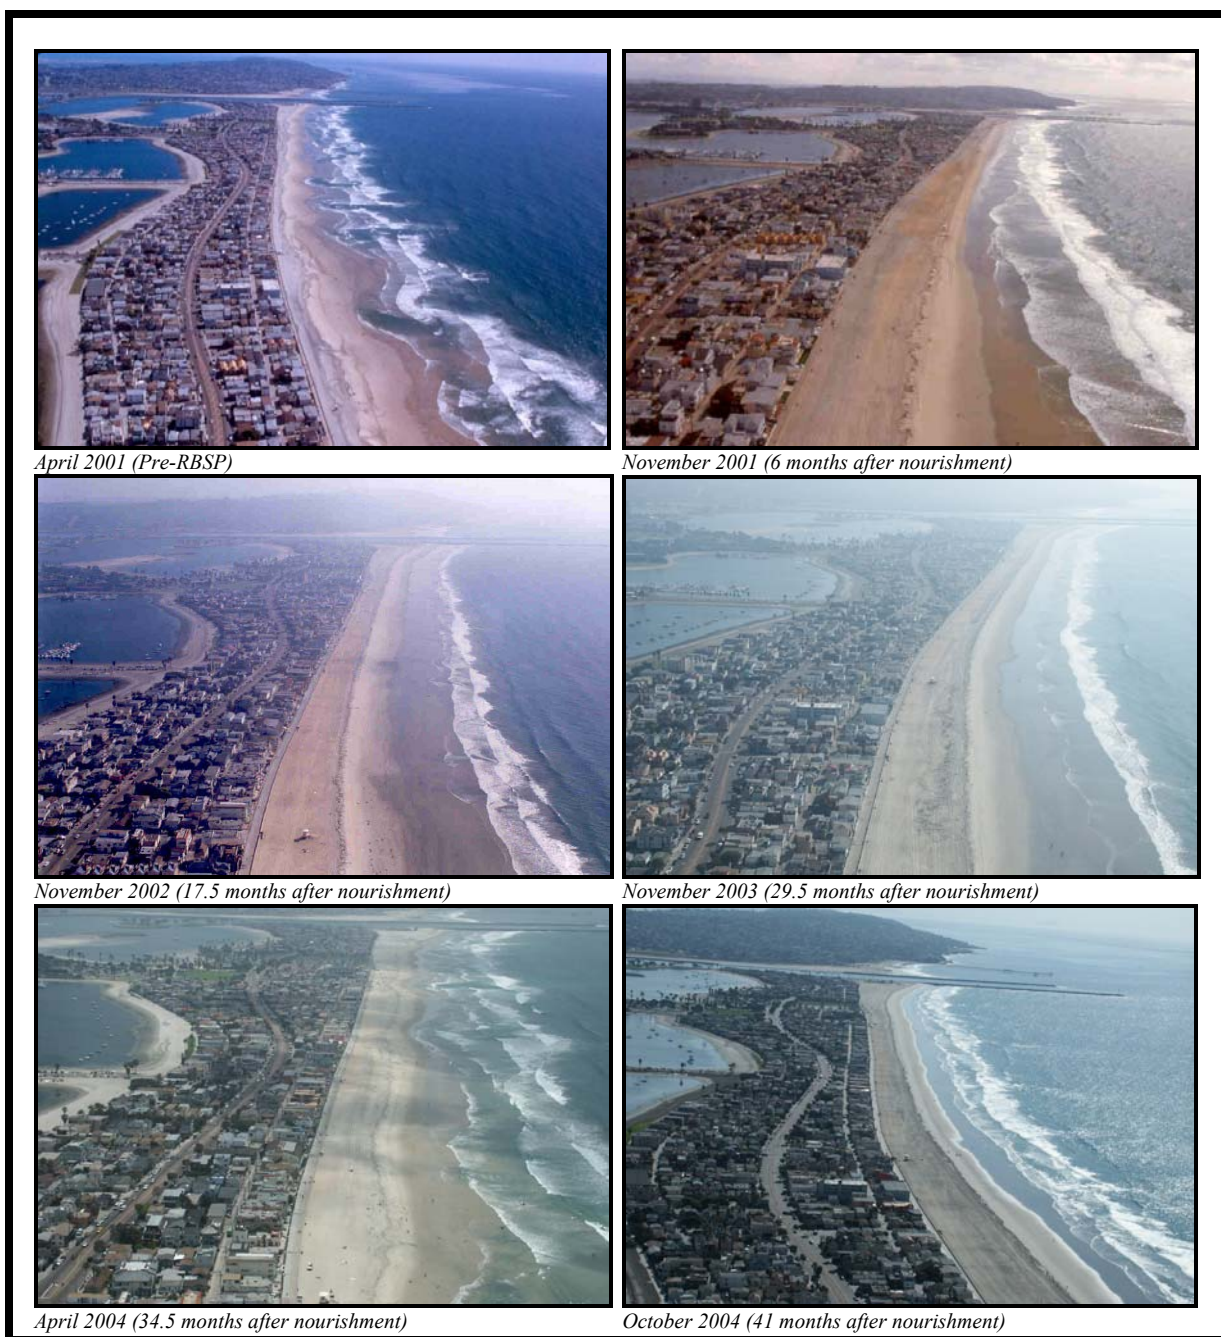
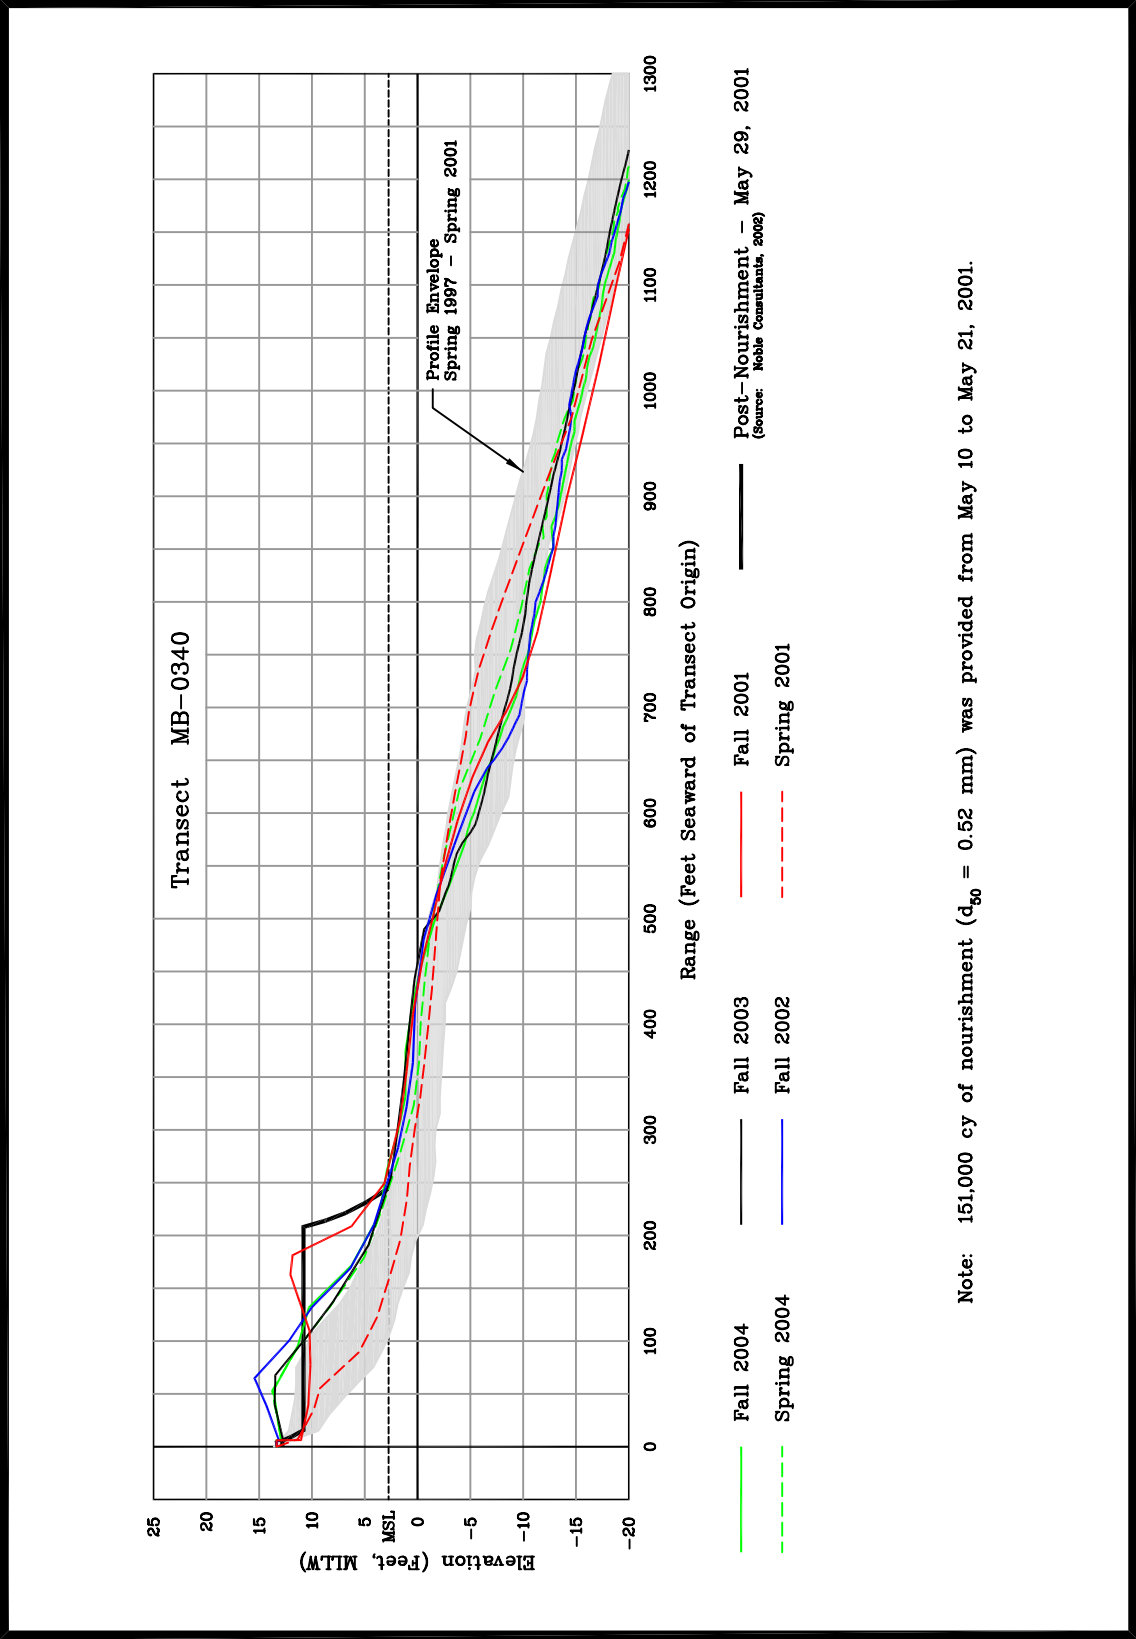
**Plate 2. Mission Beach Receiver Site, April 2001 through October 2004**

after nourishment. Despite seasonal fluctuations, the subaerial volume gains have persisted at both locations, representing a significant improvement over the pre-nourishment condition. When the entire shorezone is considered (Figure 18b), both transects exhibit a trend of steadily increasing volume from Fall 2001 to Spring 2003. This trend was reversed following the Spring 2003 Survey. Similar trends are not evident on adjacent transects, suggesting that alongshore dispersal of the fill material has been modest.

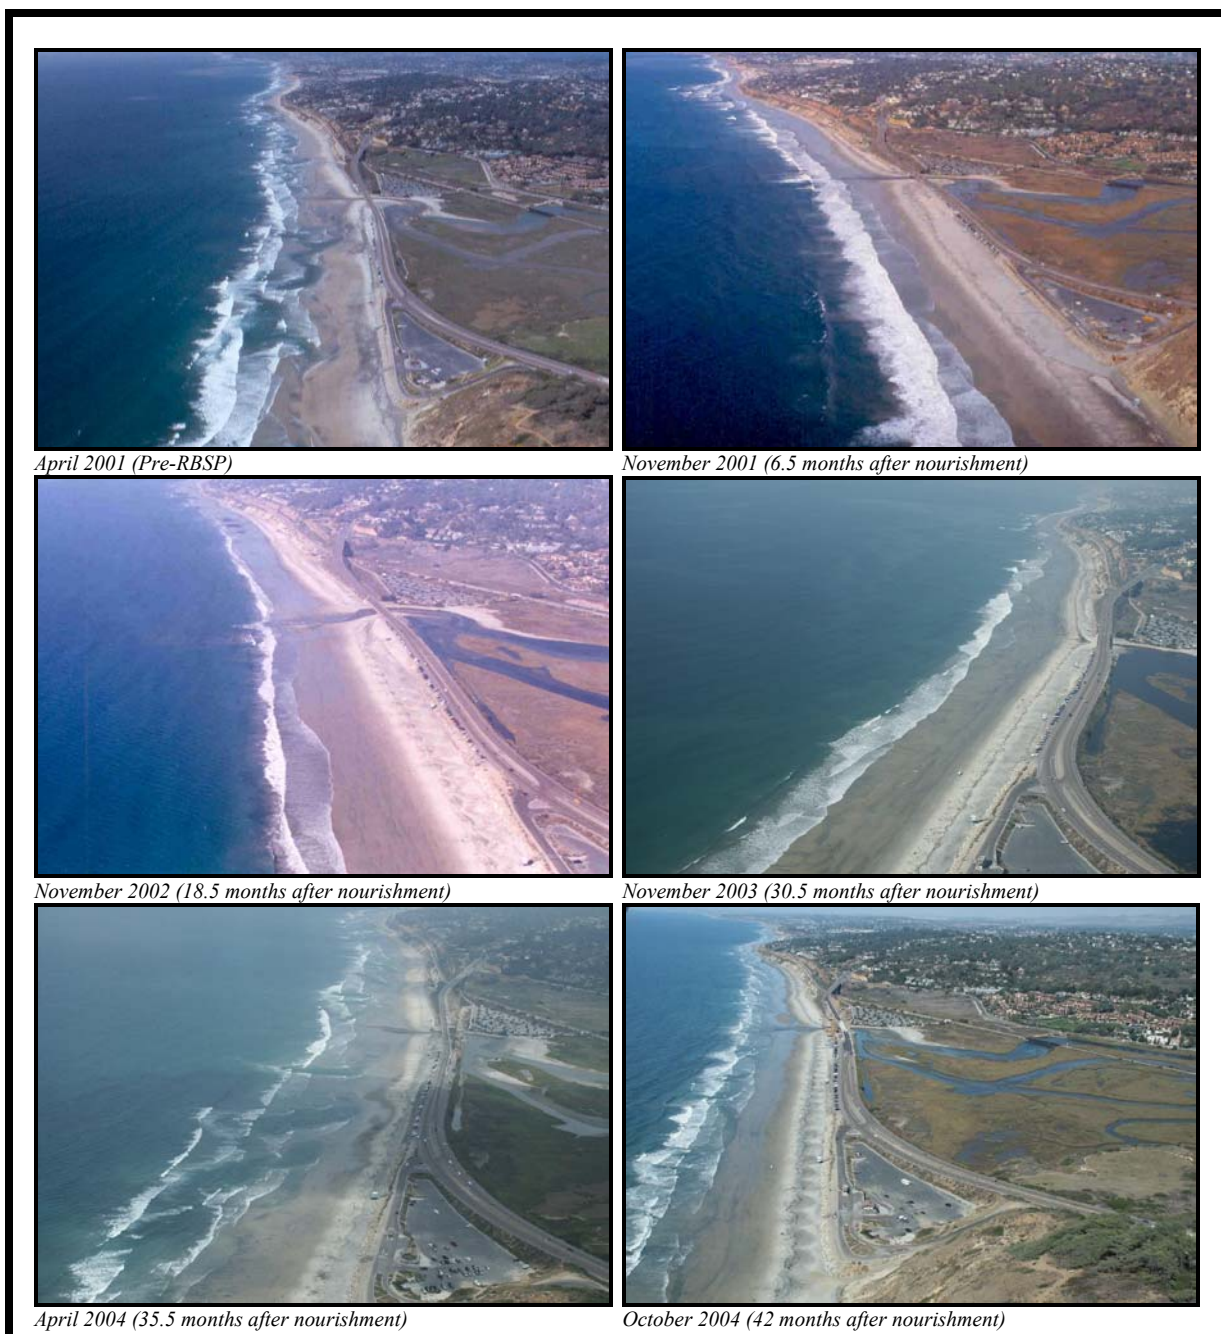
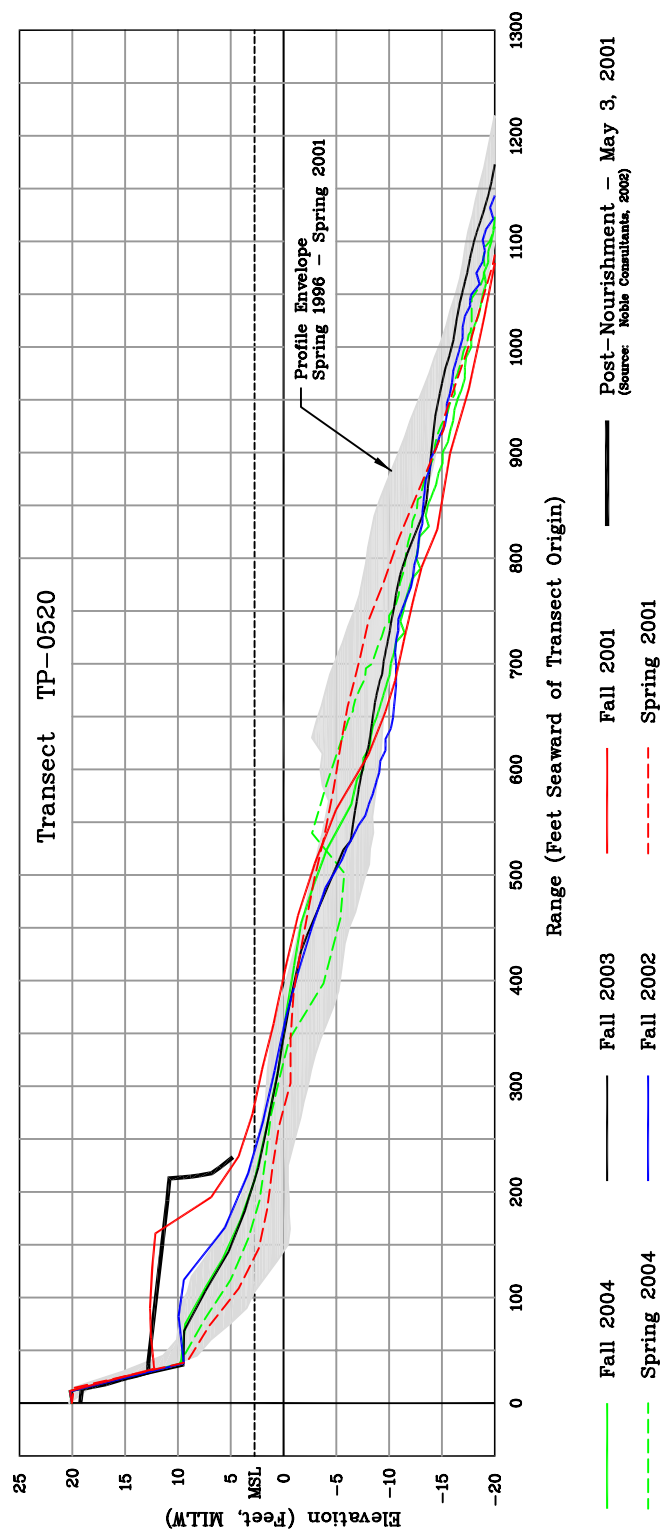
**Plate 3. Torrey Pines Receiver Site, April 2001 through October 2004**

At Torrey Pines, the beach fill was composed of 245,000 cy of fine sand placed from April 6 to April 27, 2001. Among the twelve RBSP fills, this quantity was exceeded only by the 421,000 cy supplied at Oceanside. Pre- and post-nourishment photographs are provided in Plate 3, while successive profiles on Transect TP-0520 are shown in Figure 27.

Note: 245,000 cy of nourishment ( $d_{50} = 0.14$  mm) was provided from April 6 to April 27, 2001.

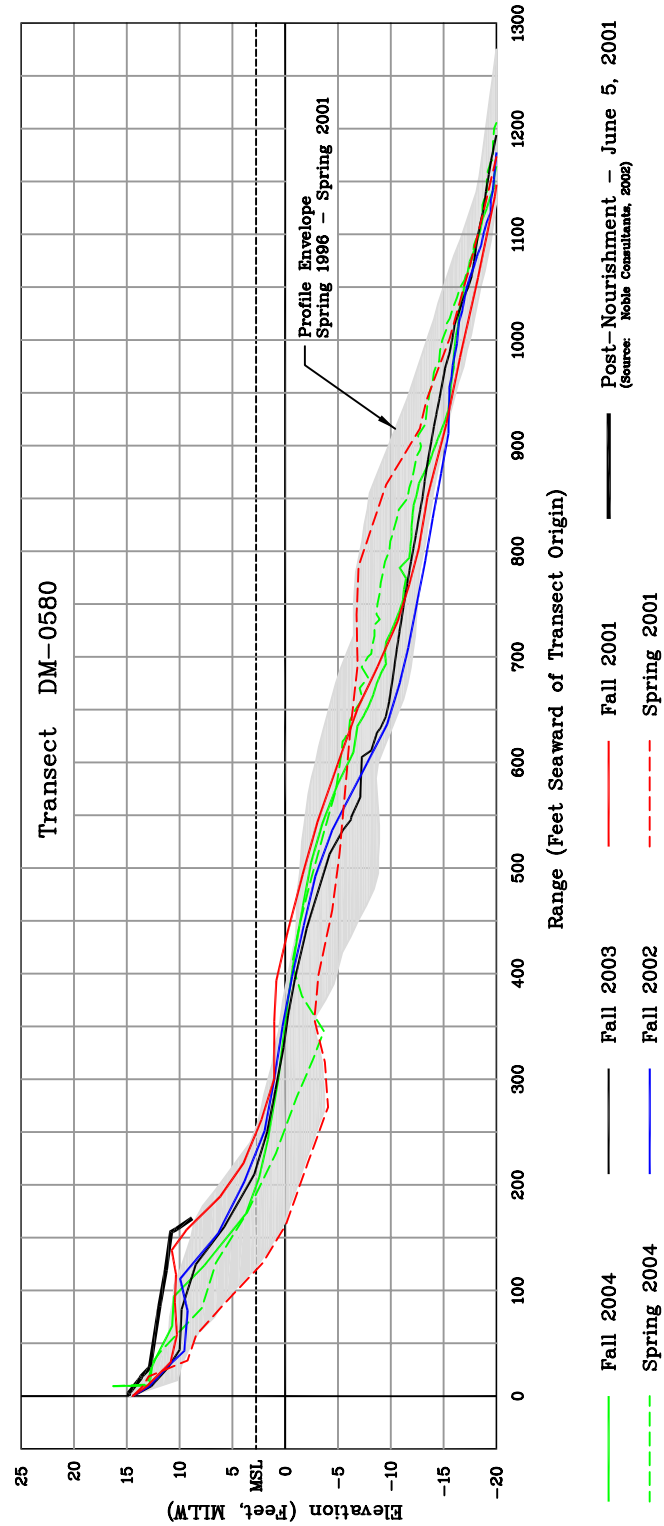
Figure 28. Transect DM-0580 at Del Mar Receiver Site

Note: 183,000 cy of nourishment ( $d_{50} = 0.14$  mm) was provided from April 27 to May 10, 2001.

As suggested by the profile data, the shorezone volume at Transect DM-0580 (Figure 18c) experienced a relatively minor gain immediately after placement of the RBSP nourishment material. The volume then decreased as the fill material was dispersed, before becoming relatively stable during the 2003 and 2004 Monitoring Years. Approximately 3,400 ft south of the receiver site, at Transect DM-0565, a trend of increasing shorezone

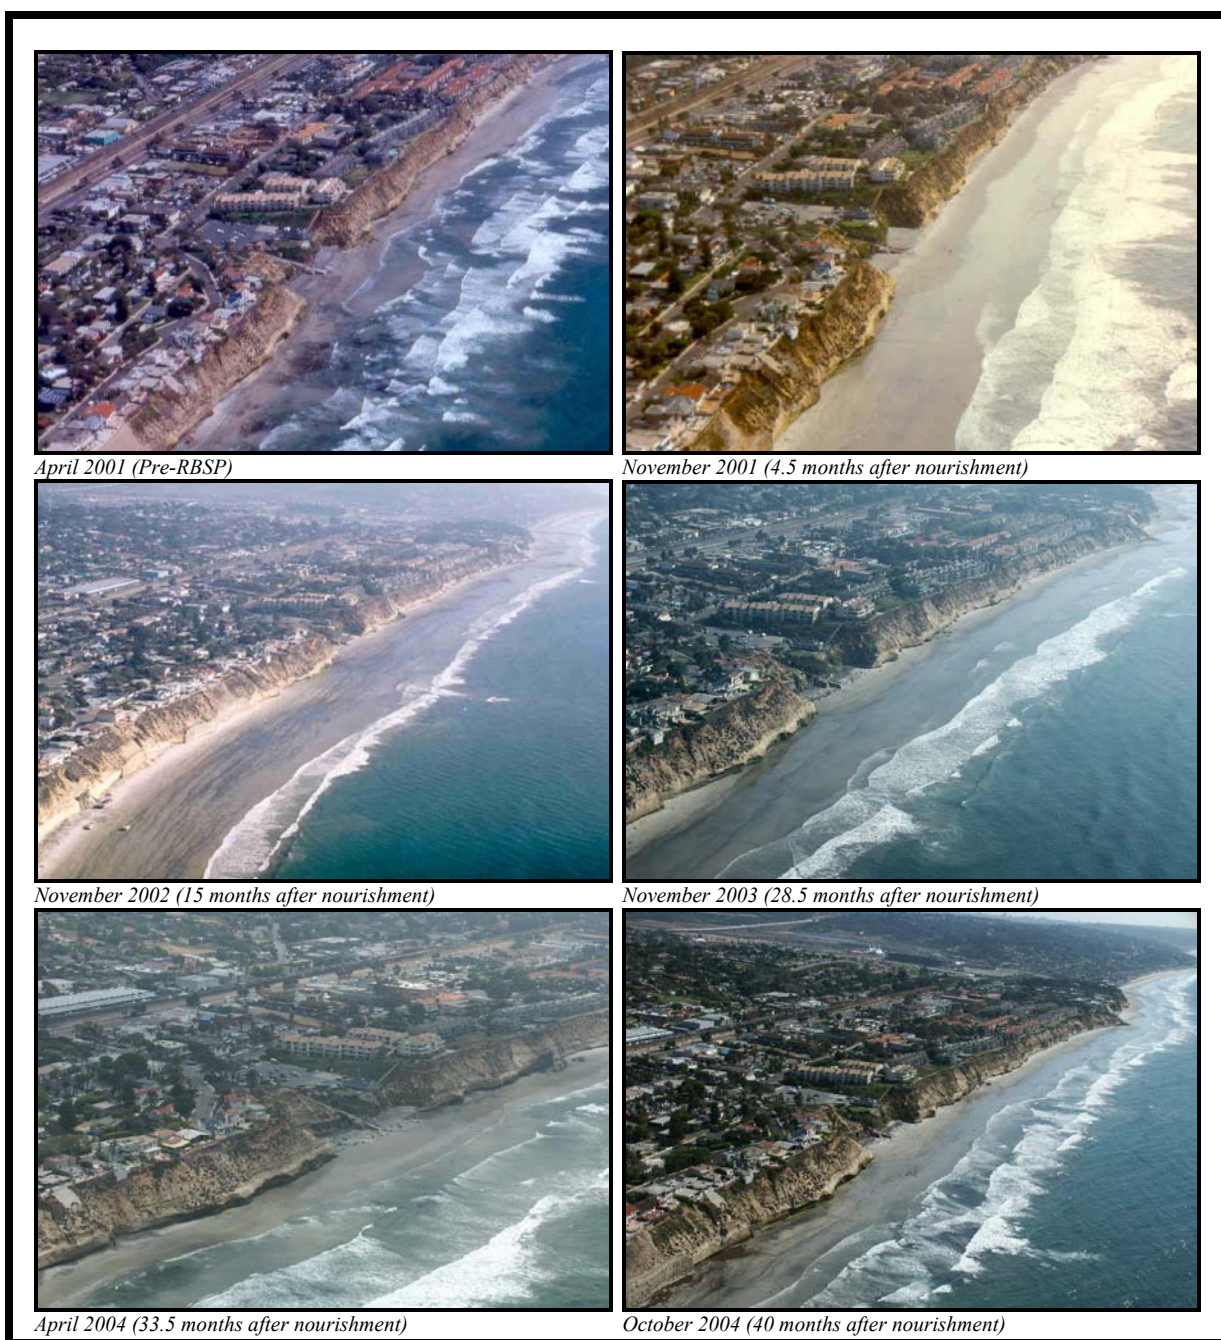
**Plate 5. Fletcher Cove Receiver Site, April 2001 through October 2004**

The Fletcher Cove fill, placed from June 15 to 24, 2001, consisted of 146,000 cy of fine sand. Pre-and post nourishment photographs are provided in Plate 5. Figure 29 displays the Spring 2001 and Post-Nourishment profiles on Transect SD-0600, along with the profiles acquired in Fall 2001, Fall 2002, Fall 2003, Spring 2004, and Fall 2004.

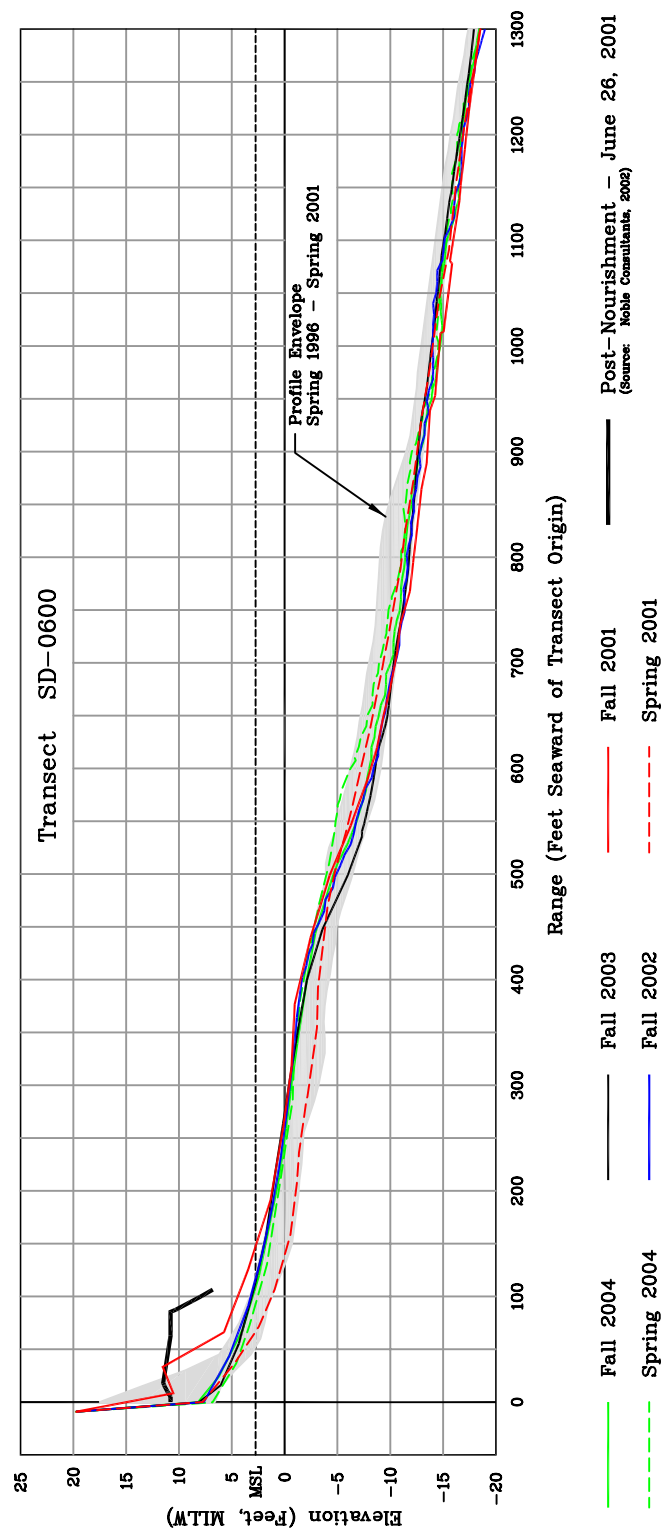
Figure 29. Transect SD-0600 at Fletcher Cove Receiver Site

Note: 146,000 cy of nourishment ( $d_{50} = 0.14$  mm) was provided from June 15 to June 24, 2001.

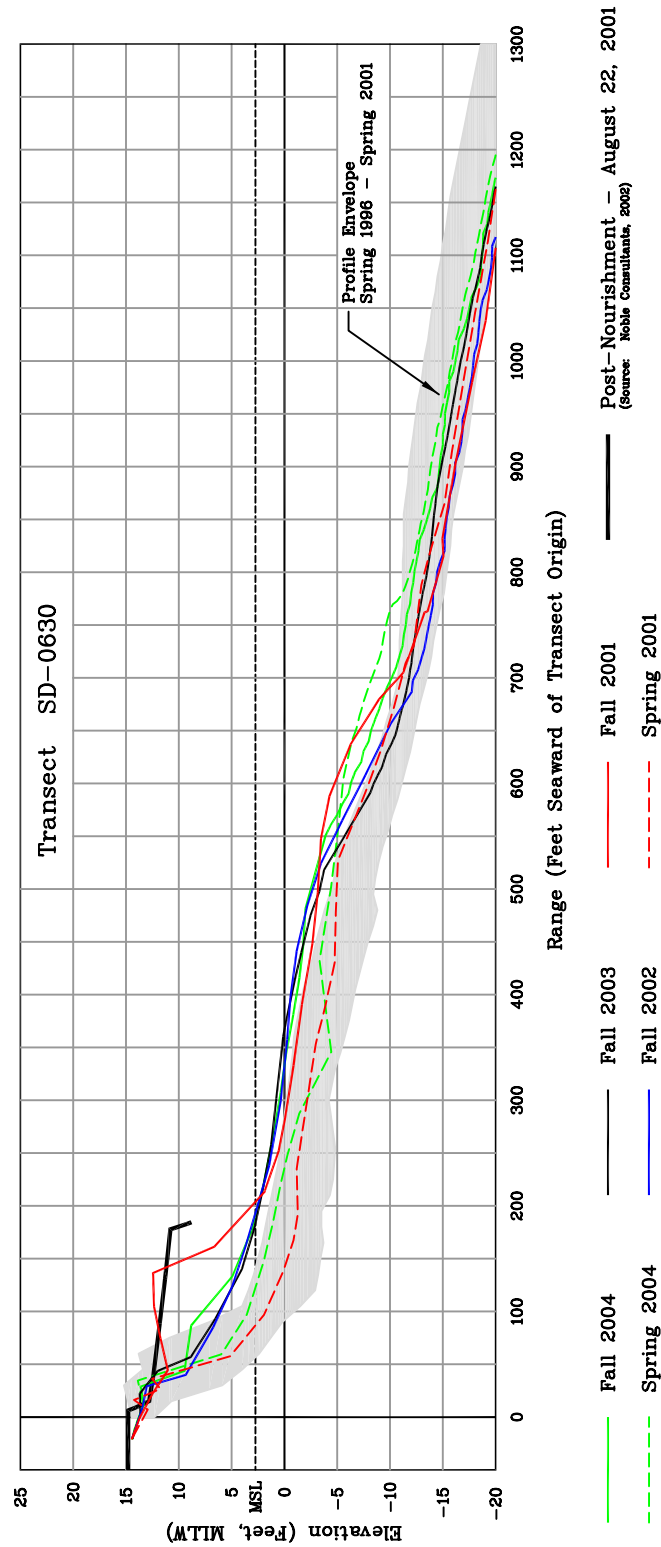
Figure 30. Transect SD-0630 at Cardiff Receiver Site

Note: 101,000 cy of nourishment ( $d_{90} = 0.34$  mm) was provided from August 2 to August 10, 2001.

Between Spring 2001 and Fall 2004, the net result of these profile changes on Transect SD-0630 was a shoreline advance of 104 ft and a shorezone volume increase of 76 cy/ft. The fact that both of these values exceed the respective RBSP averages is surprising when the small size of the fill is taken into consideration.

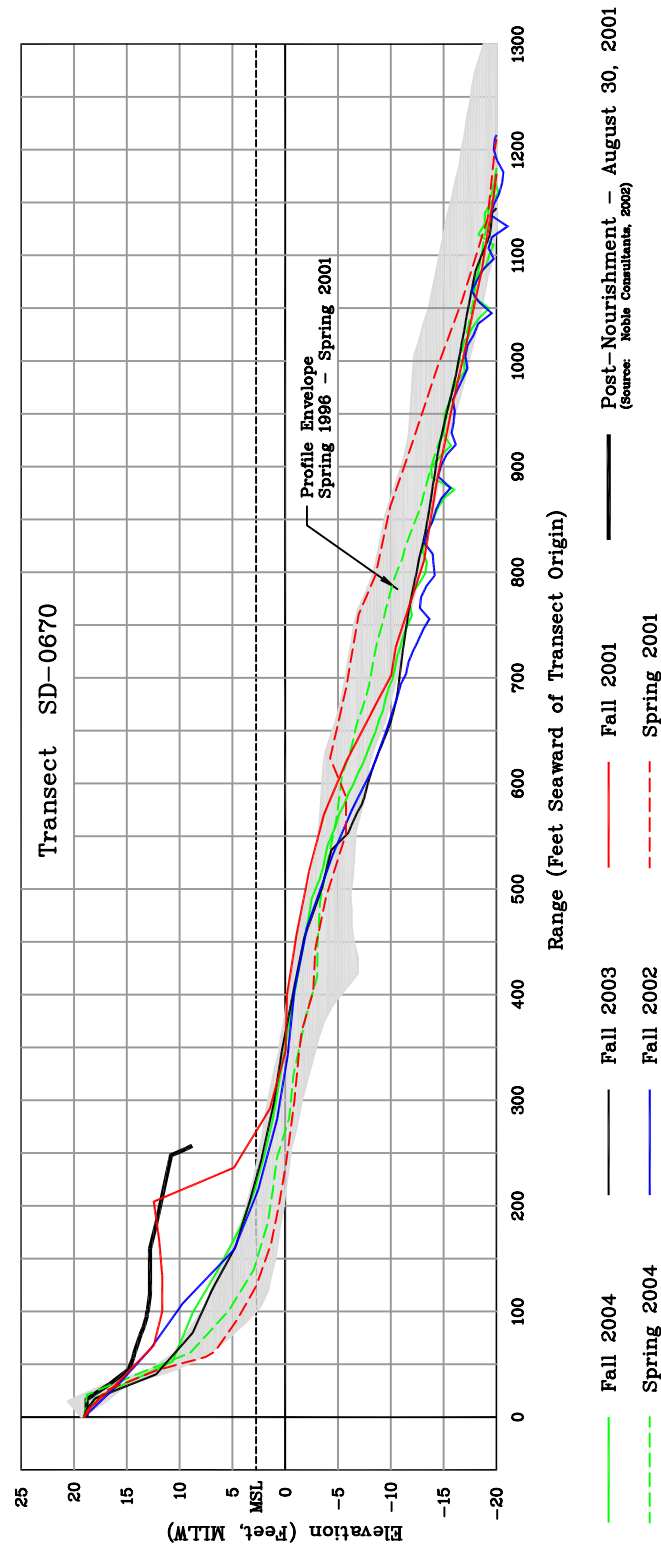
Figure 31. Transect SD-0670 at Moonlight Beach Receiver Site

The successive Fall profiles shown in Figure 31 indicate rapid erosion of the above-water beach and flattening of the beach face between the time of fill placement and Fall 2003. As a result, the subaerial volume gains that occurred at the Moonlight Beach receiver site diminished relatively quickly. The Fall 2004 profile was nearly identical to the Fall 2003 profile, indicating that changes during the 2004 Monitoring Year were modest. At the time of the Fall 2004 Survey, the profile at SD-0670 exceeded the upper boundary of the pre-RBSP on the beach face, but dropped to the lower boundary seaward of the -10 ft isobath. Integrating these changes over the 42-month period between the Spring 2001 and Fall 2004 surveys, the shoreline position advanced 97 ft, but the shorezone volume decreased by 20 cy/ft.

Note: 105,000 cy of nourishment ( $d_{90} = 0.34-0.62$  mm) was provided from August 10 to August 16, 2001.

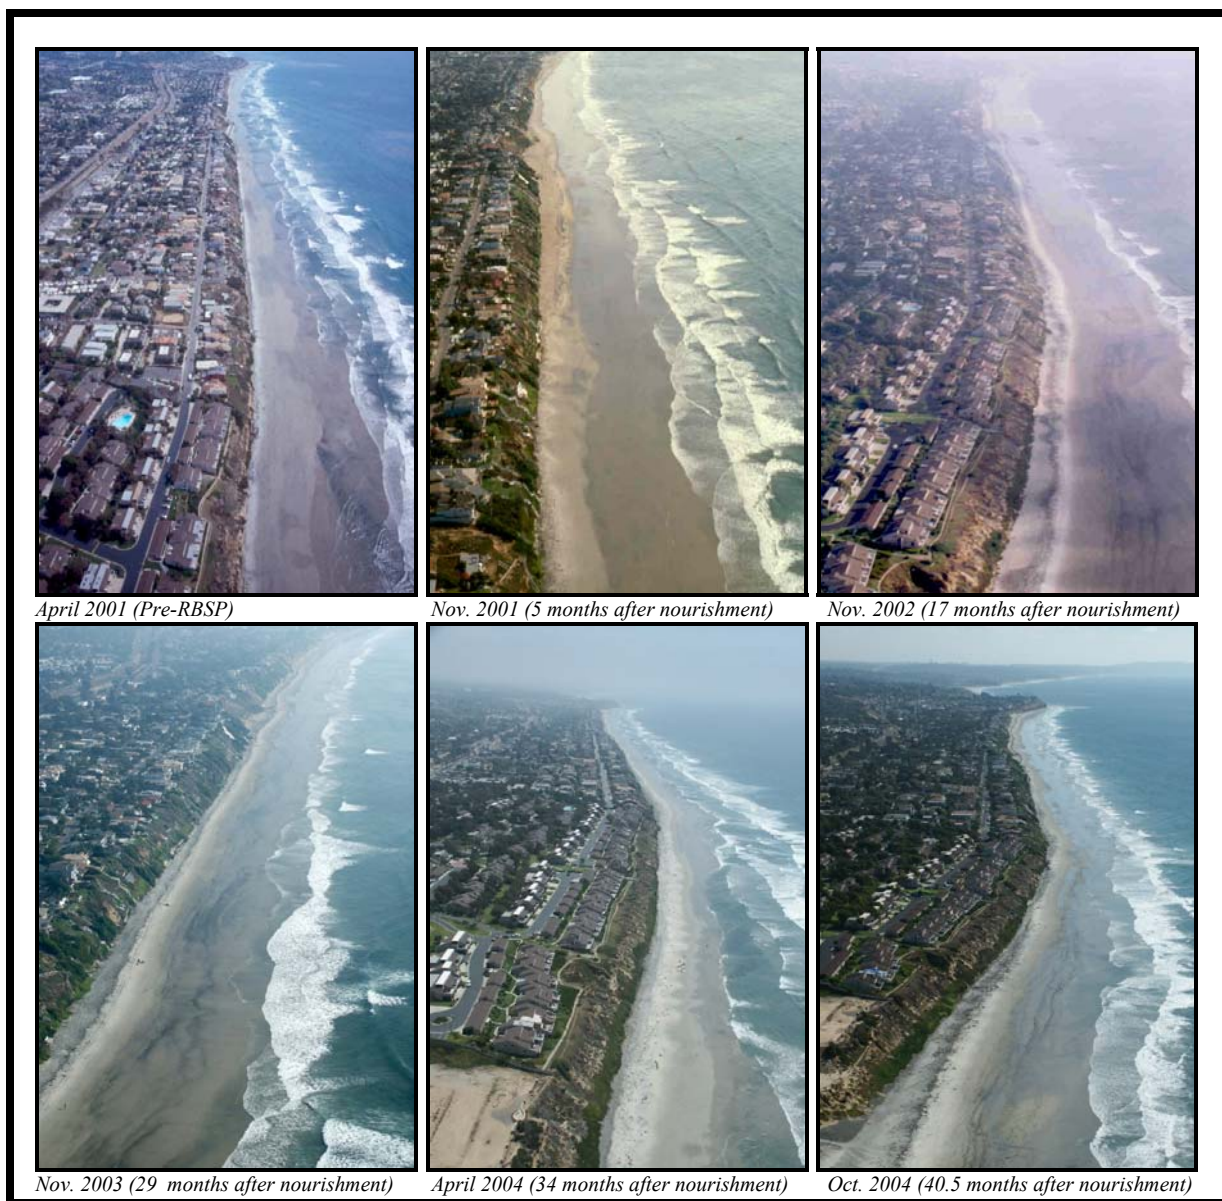
**Plate 8.      Leucadia Receiver Site, April 2001 through October 2004**

The Leucadia fill (Plate 8) consisted of 132,000 cy of coarse sand. A relatively long, narrow fill with a nominal width of 120 ft, it was placed from June 4 to 15, 2001. Survey profiles on Transect SD-0690 are provided in Figure 32.

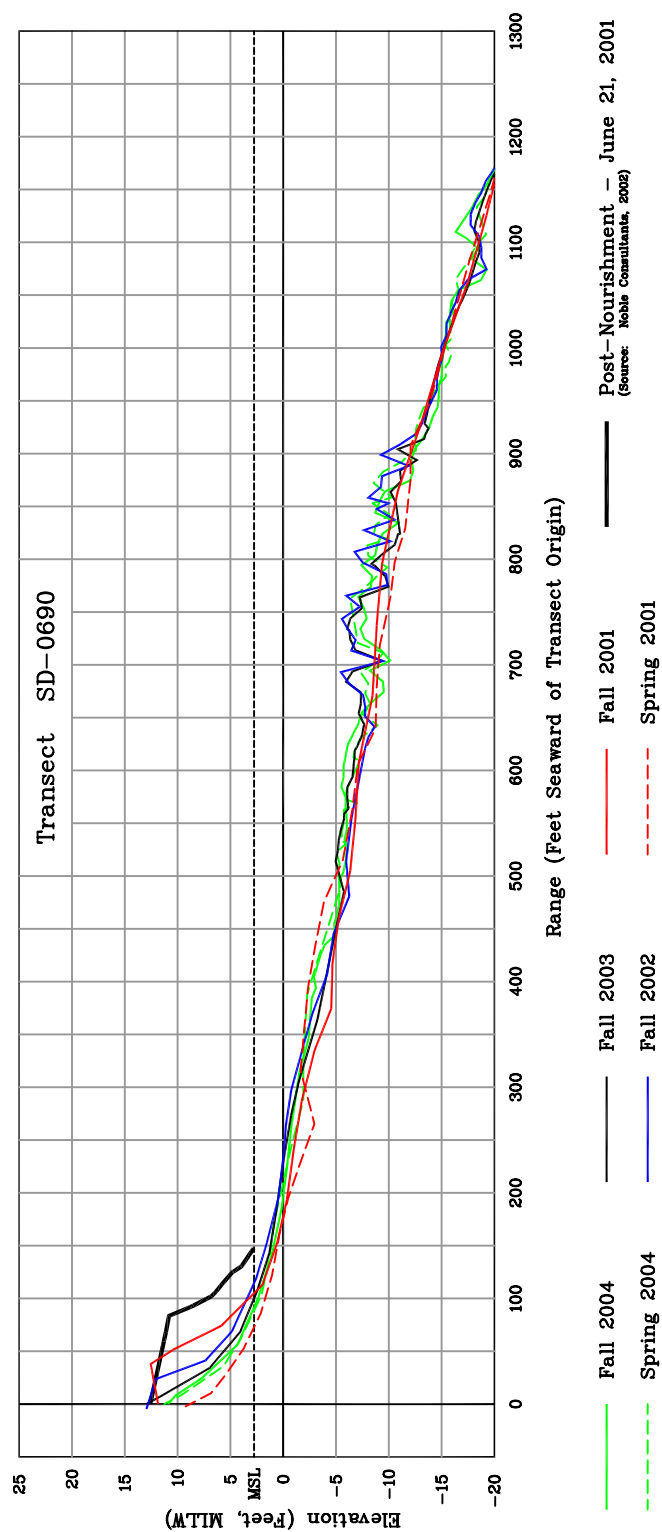
Figure 32. Transect SD-0690 at Leucadia Receiver Site

Note: 132,000 cy of nourishment ( $d_{50} = 0.62$  mm) was provided from June 4 to June 15, 2001.

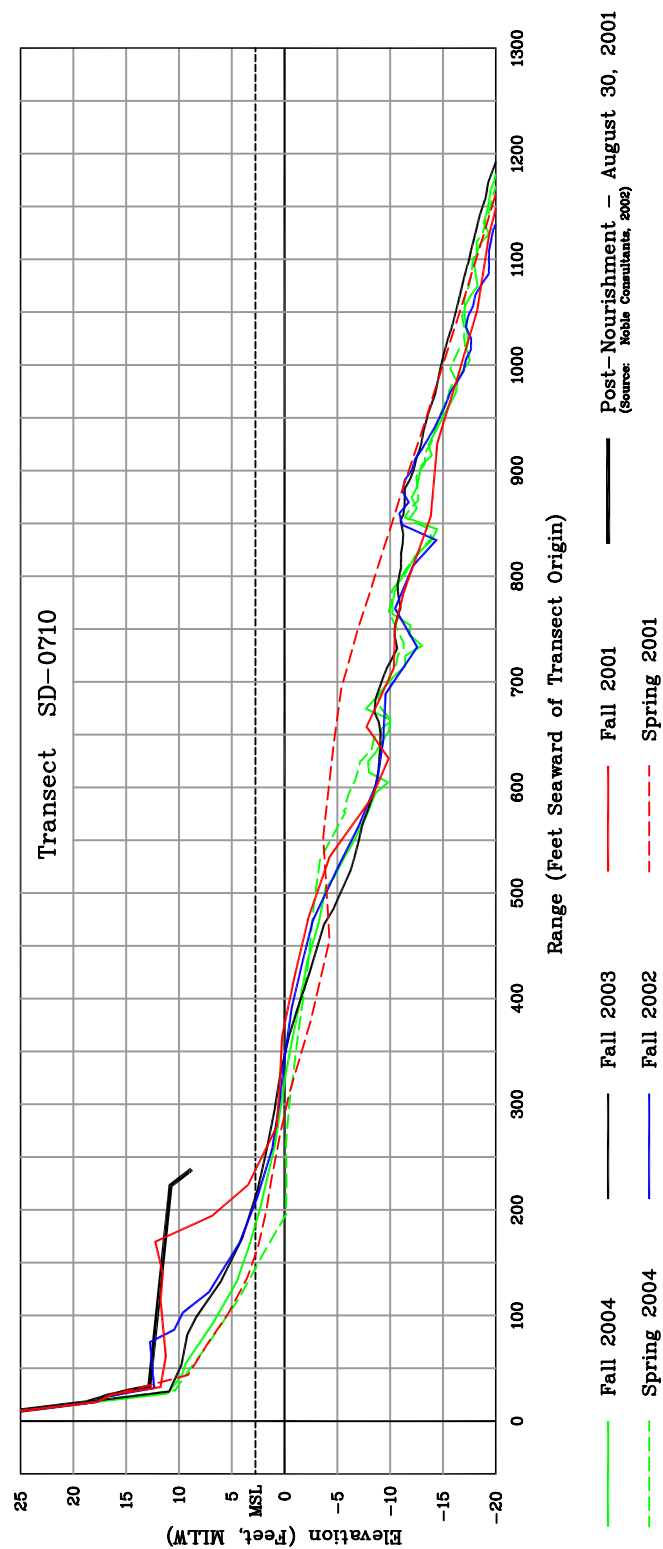
Figure 33. Transect SD-0710 at Batiquitos Receiver Site

The profile data for the Batiquitos fill indicate a sequence of events similar to that recorded at Leucadia: above-water erosion and profile flattening throughout the RBSP Monitoring Period, with a diminishing rate of change each successive year. The net outcome over the 42-month span between Spring 2001 and Fall 2004 was a shoreline advance of 29 ft accompanied by a shorezone volume decrease of 46 cy/ft. The shorezone volume loss was the greatest among the twelve RBSP sites. As in the case of Moonlight Beach, which also registered a decrease in shorezone volume during this period, the loss stemmed from pronounced erosion in water depths of -4 ft to -20 ft.

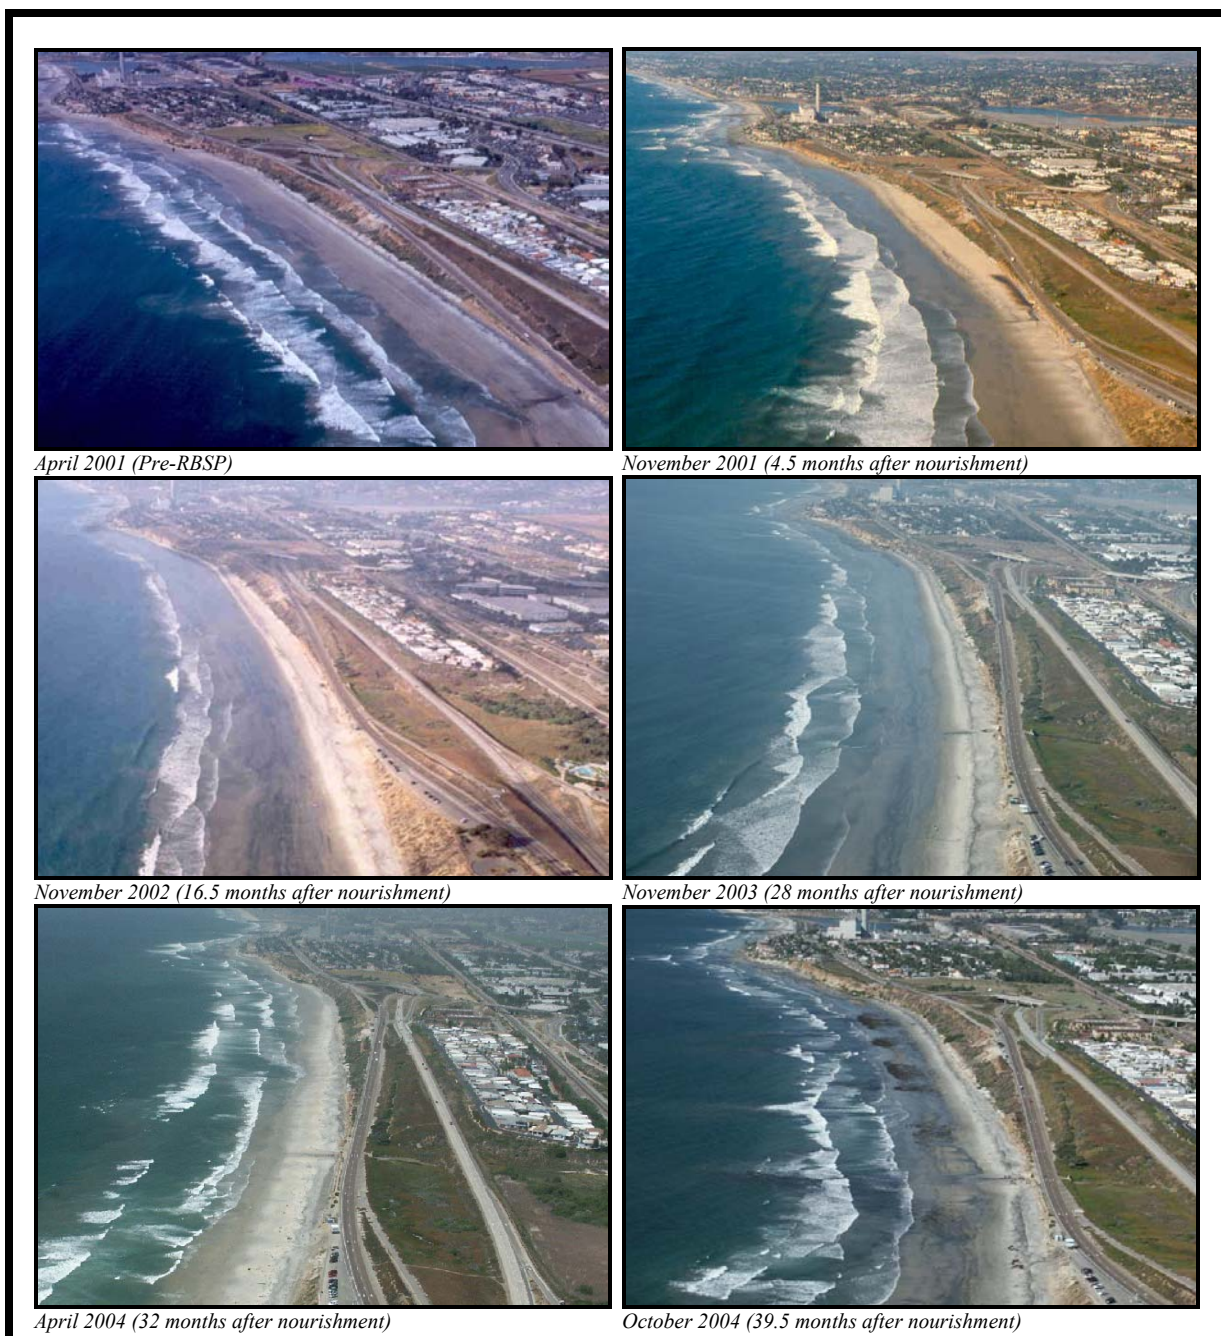
**Plate 10. South Carlsbad Receiver Site, April 2001 through October 2004**

South Carlsbad received 158,000 cy of coarse sand from June 25 to July 6, 2001 (Plate 10). Successive survey profiles obtained between Spring 2001 and Fall 2004 on Transect CB-0775 are shown in Figure 34.

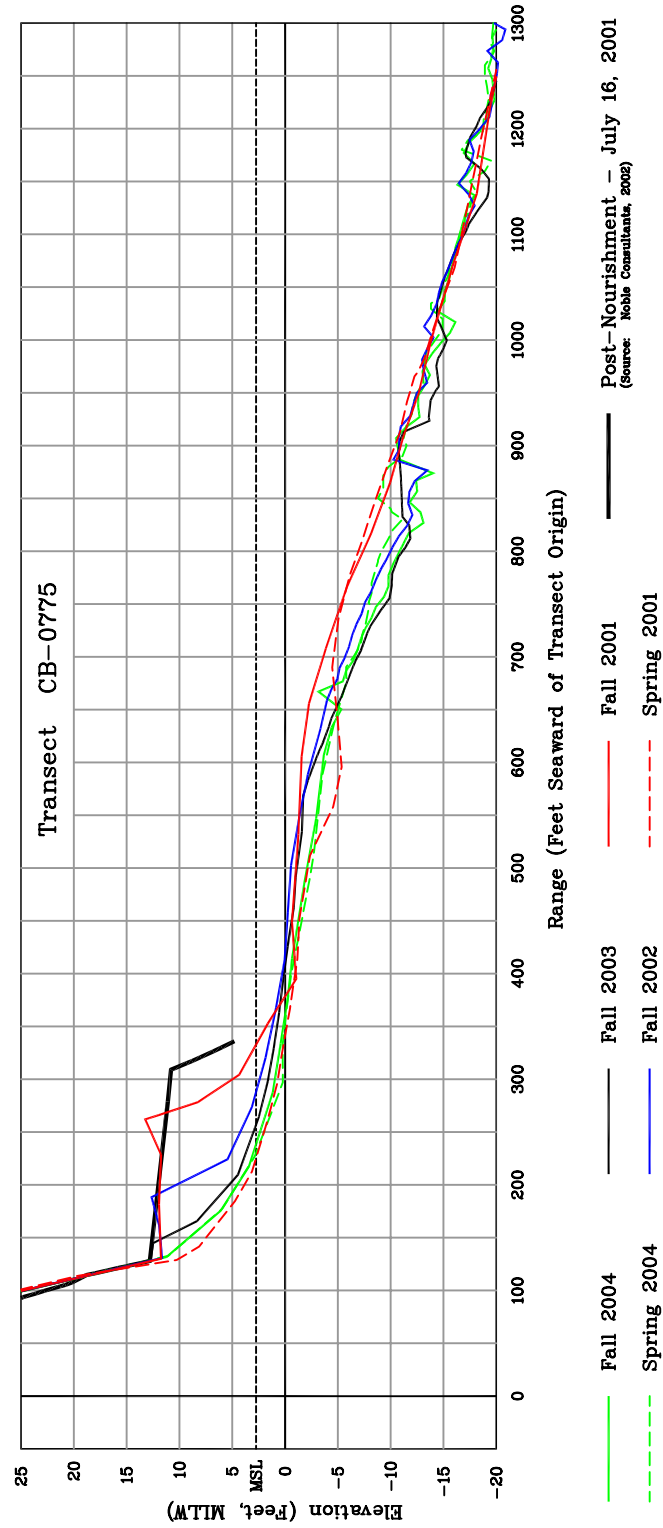
Figure 34. Transect CB-0775 at South Carlsbad Receiver Site

Note: 158,000 cy of nourishment ( $d_{50} = 0.62$  mm) was provided from June 25 to July 6, 2001.
