## **2004 REGIONAL BEACH MONITORING PROGRAM**

### **ANNUAL REPORT**

**SANDAG  
2004 REGIONAL BEACH  
MONITORING PROGRAM**

April 2005

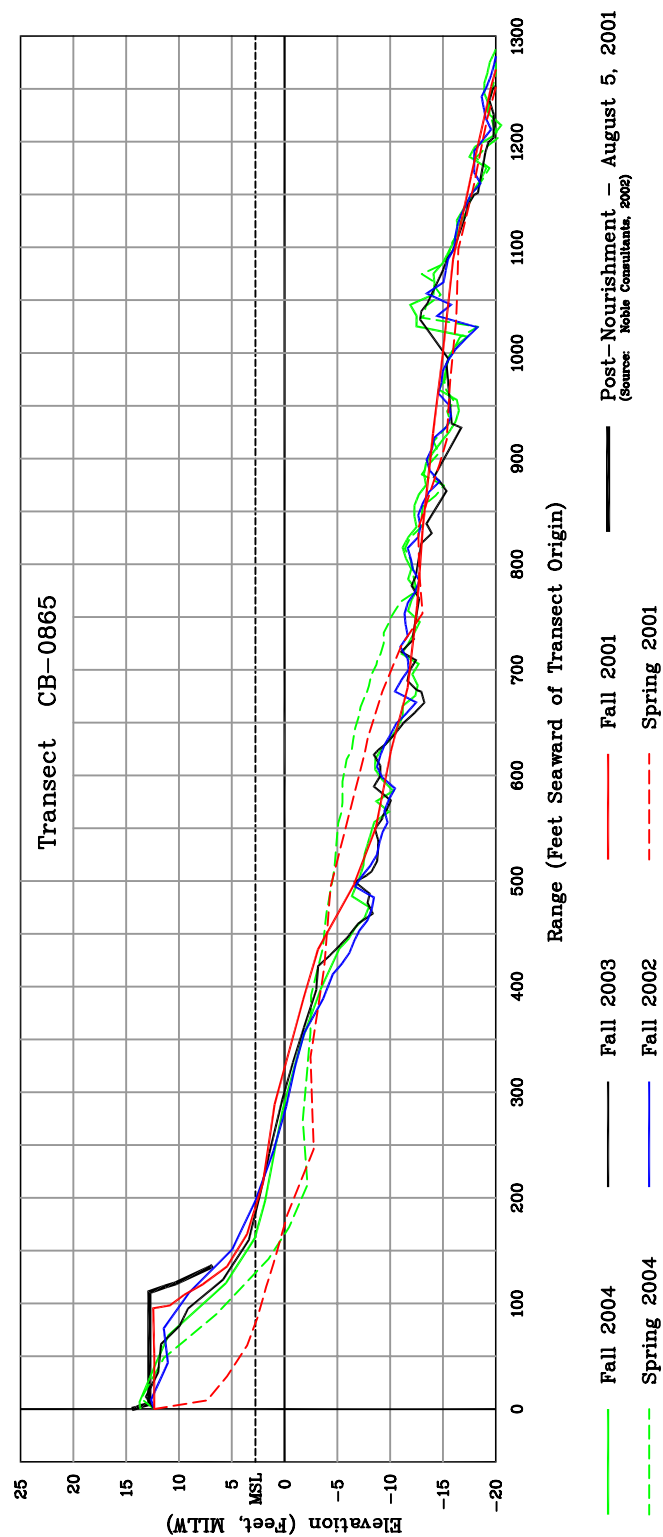
Figure 35. Transect CB-0865 at North Carlsbad Receiver Site

Although the beach face became progressively flatter during the first two years after the RBSP, the above-water erosion at North Carlsbad was modest compared to that which occurred at most of the other receiver sites. The minor differences between the Fall 2003 and Fall 2004 profiles indicate relative stability during the 2004 Monitoring Year. The resulting shoreline advance of 83 ft and shorezone volume increase of 39 cy/ft that occurred between Spring 2001 and Fall 2004 exceed the corresponding RBSP average values.

Note: 225,000 cy of nourishment ( $d_{50} = 0.14\text{--}0.62\text{ mm}$ ) was provided from July 6 to August 2, 2001.

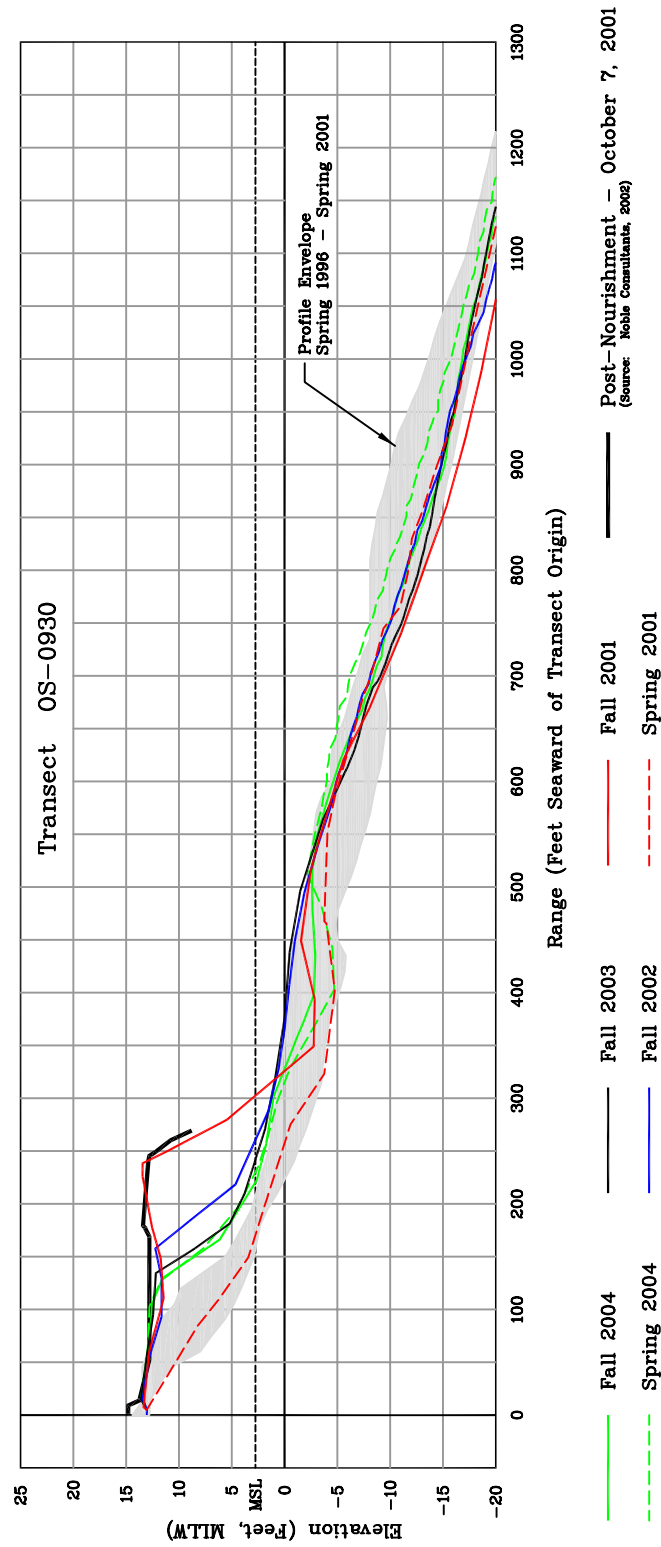
Figure 36. Transect OS-0930 at Oceanside Receiver Site

The Oceanside fill (Plate 12) was the largest (421,000 cy) and longest (4,400 ft) of the RBSP fills. Comprised entirely of coarse sand, it also was the last to be constructed (August 24-September 23, 2001). Profiles obtained on Transect OS-0930 are presented in Figure 36.

Note: 421,000 cy of nourishment ( $d_{50} = 0.62$  mm) was provided from August 24 to September 23, 2001.

Possible reasons for the exemplary performance of the Oceanside fill include the large volume of nourishment and the coarse grain size. In addition, the sand bypassing rate at Oceanside Harbor during the RBSP Monitoring Period has been slightly higher than the pre-RBSP rate (Section 2.3). Hence, this material may be contributing to the improved condition of the beaches in Oceanside and Carlsbad as it moves downcoast.

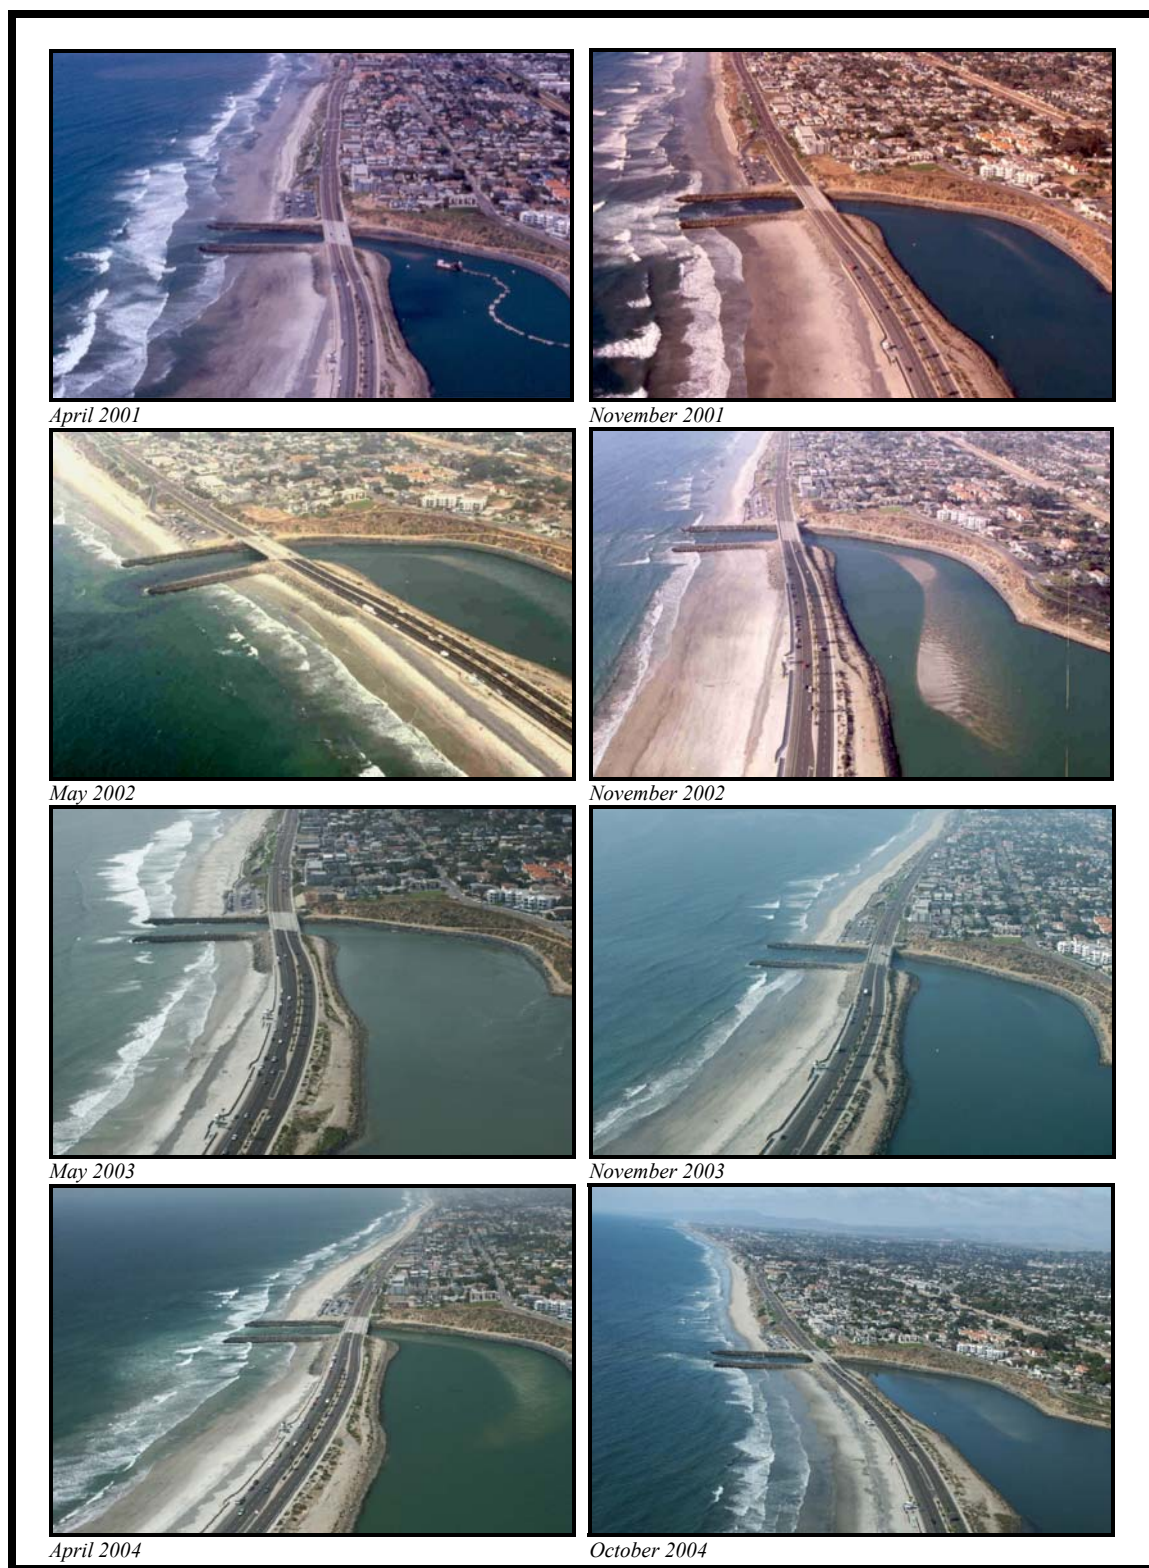
**Plate 13. Agua Hedionda Lagoon North Entrance, April 2001 through October 2004**

Plate 13 displays the condition of the north entrance to Agua Hedionda Lagoon on a semi-annual basis from April 2001 to October 2004. In the April 2001 photo, a dredge is evident removing the flood tide shoal from the region landward of the jetties. The next three photos show the progressive return of the shoal, with the feature fully emergent in November 2002. The shoal is not evident in the May 2003, having been removed during the 2002-2003 dredge program, but reappears and grows larger in the last three photos (November 2003 to October 2004).

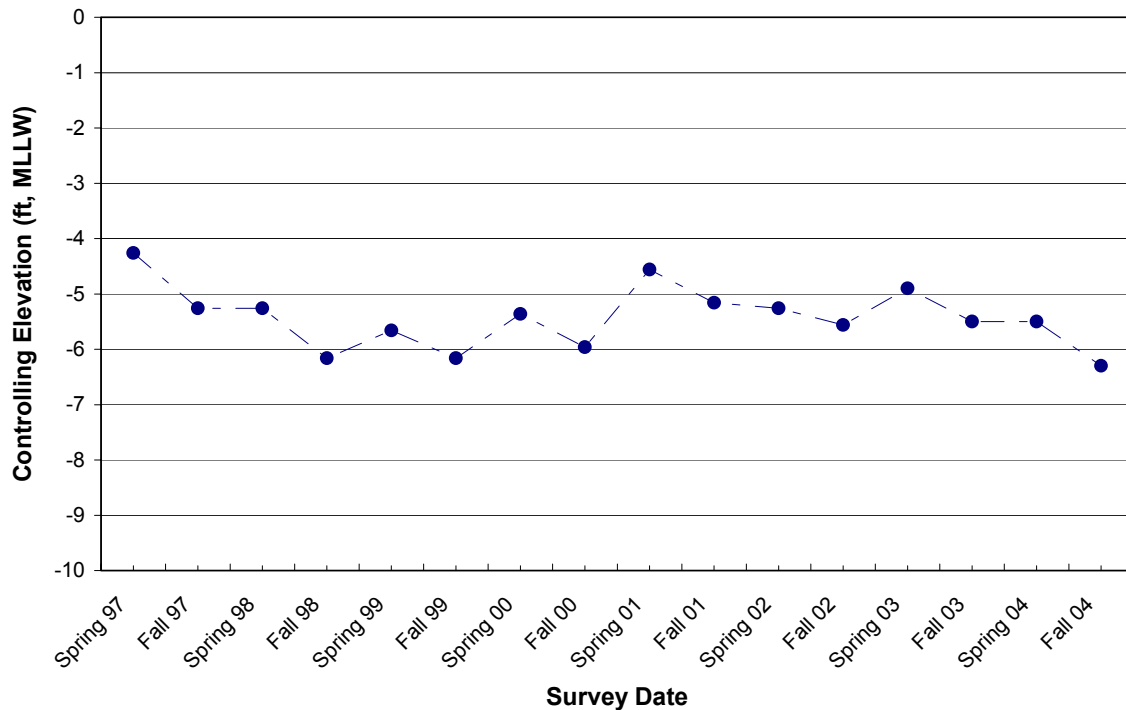
Figure 39. Controlling Elevation for Tidal Exchange in Agua Hedionda Lagoon

Figure 39 presents the controlling elevations that were measured in the north entrance channel on a semi-annual basis from Spring 1997 through Fall 2004. ("controlling elevation" refers to the lowest elevation at which water can pass unobstructed between the ocean and the lagoon.) During the period that preceded the RBSP (Spring 1997-Spring 2001), the controlling elevations ranged from -4.3 to -6.2 ft (MLLW). Subsequent to the nourishment activities (Fall 2001 to Fall 2004), the controlling elevations were comparable: -4.9 to -6.3 ft.

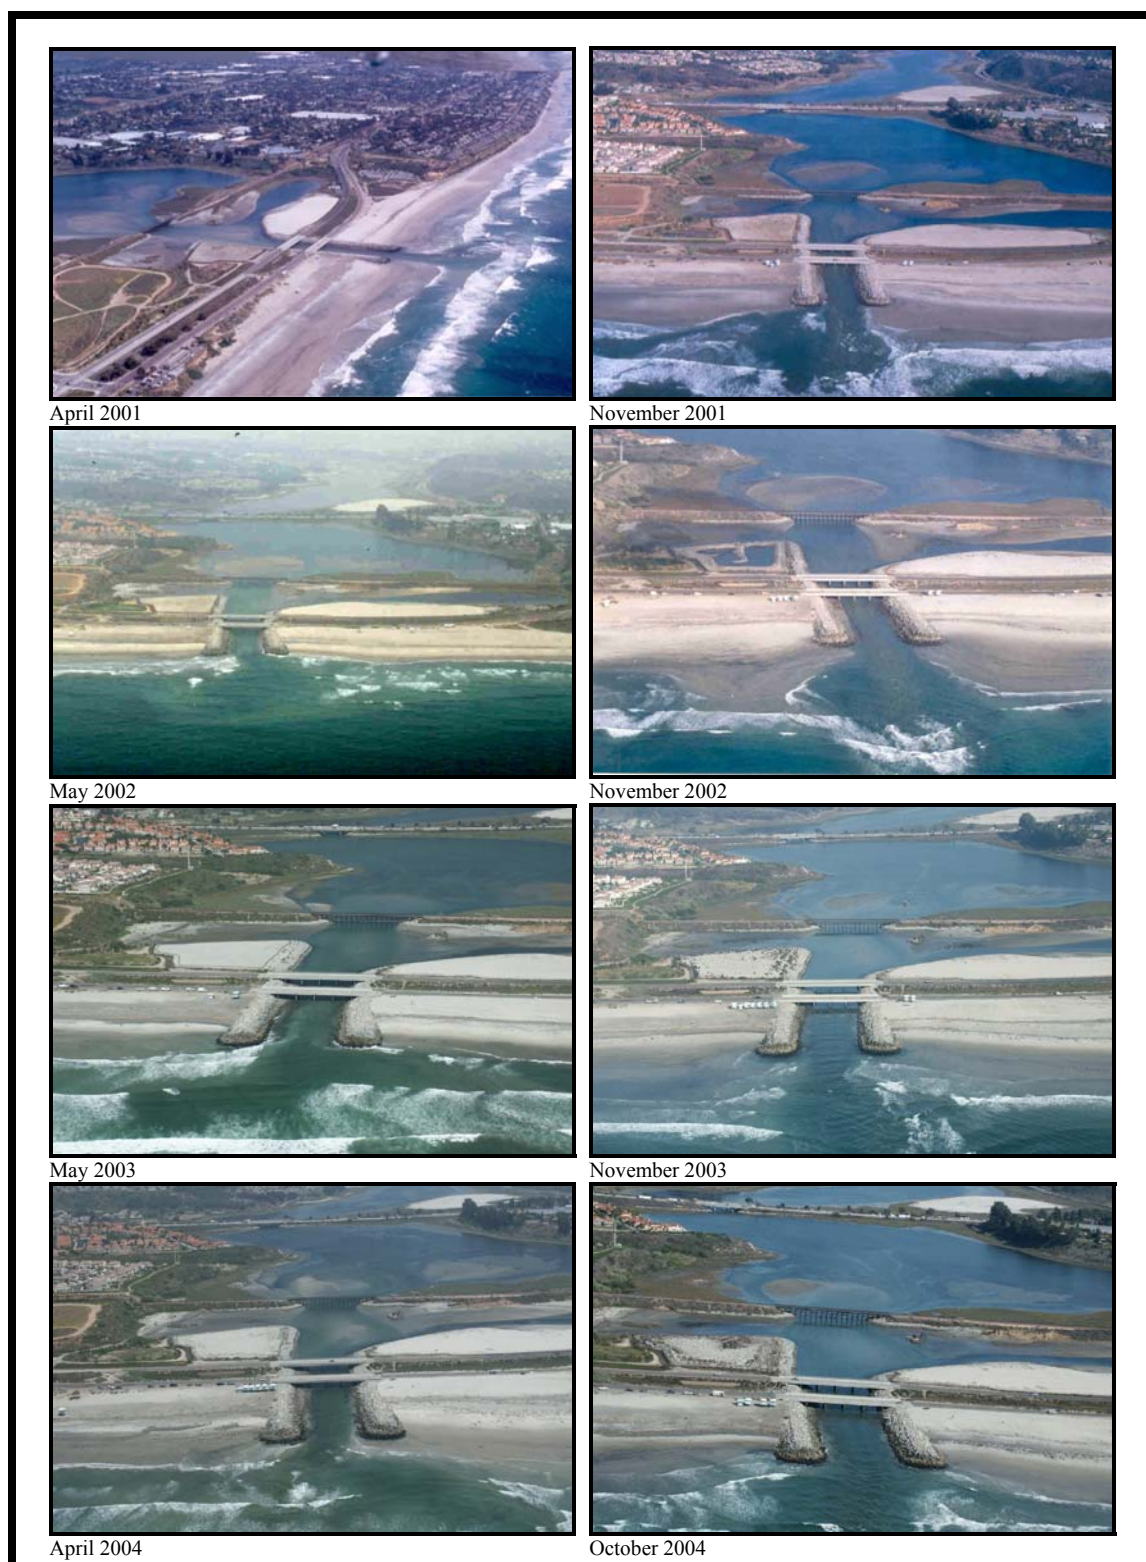
**Plate 14. Batiquitos Lagoon Entrance, April 2001 through October 2004**

Plate 14 illustrates the condition of the Batiquitos Lagoon entrance channel between April 2001 and October 2004. Substantial shoals are evident in the outer and middle basins in all eight photographs, with little change evident over the 42-month period despite the aforementioned dredge programs.

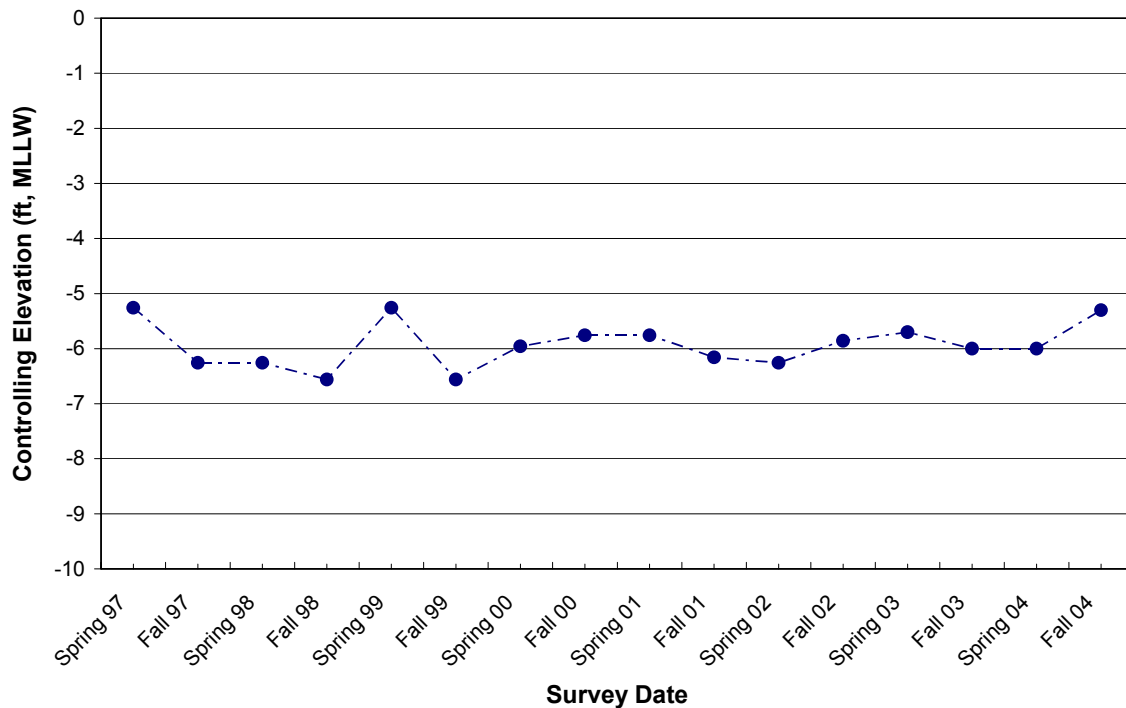
**Figure 40. Controlling Elevation for Tidal Exchange in Batiquitos Lagoon**

Between Spring 1997 and Spring 2001, the controlling elevations in the entrance channel varied between -5.3 and -6.6 ft (Figure 40). The elevations measured after placement of the RBSP nourishment material, -5.3 to -6.3 ft, were within this range.

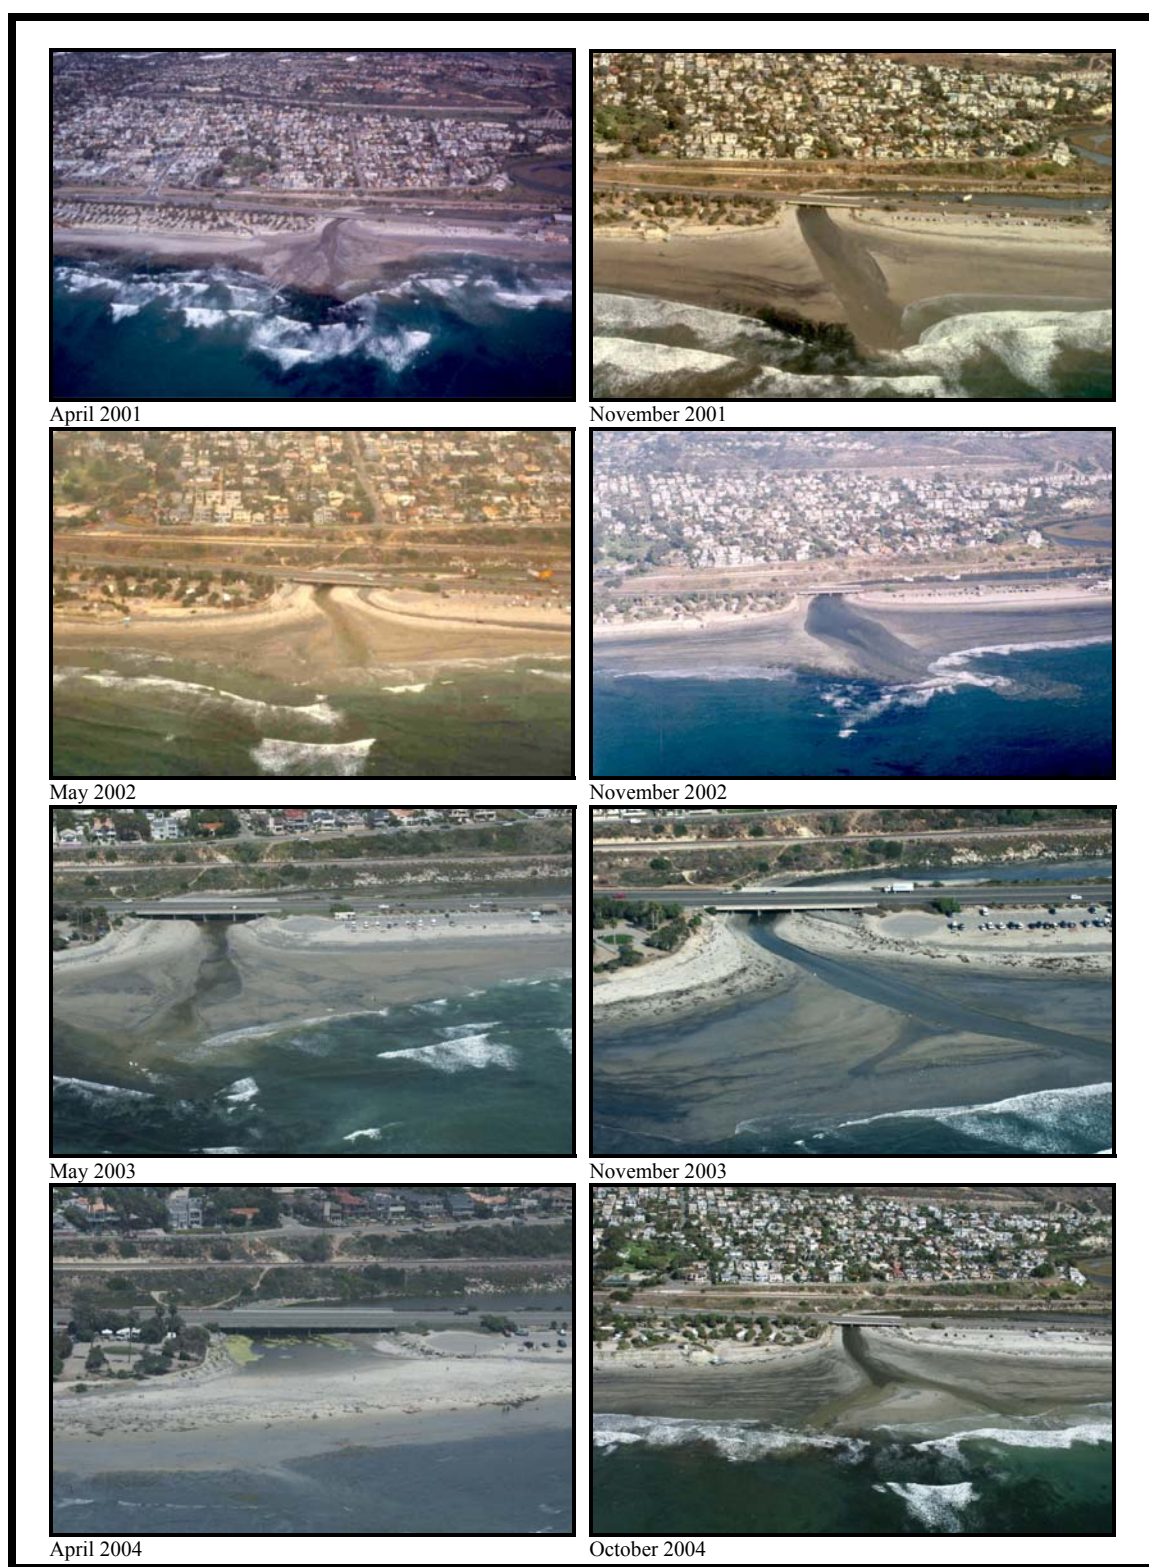
**Plate 15. San Elijo Lagoon Entrance, April 2001 through October 2004**

Plate 15 shows the condition of the San Elijo entrance channel between April 2001 and October 2004. In February 2002, the channel closed for approximately one month before tidal exchange was restored by mechanical means (Figure 38). Mechanical enlargement of the channel was undertaken in July 2002 to increase the flow. The lagoon then closed for eight days in early February 2003 before re-opening naturally. It remained open for the next 11 months, with mechanical enlargements conducted in February and May 2003. During the 2004 Monitoring Year, the lagoon entrance closed on two occasions (mid-January and mid-April). It opened naturally approximately one month after the January closure, but mechanical intervention was required in May to restore tidal access after the second closure. The entrance channel then remained open for the rest of the Monitoring Year.

The lagoon was open 91% of the time during the three-year period following the RBSP (Fall 2001 to Fall 2004), greatly exceeding the historical average of 43%. The occurrence of only four closures during this period (1.3 closures per year) also represents a significant improvement relative to the channel's past history of 4.4 closures per year. Similarly, the frequency of channel maintenance (mechanical openings and enlargements) during the post-RBSP period, 1.7 times per year, was well below the historical average of 2.9 times per year. The most plausible explanation for the improved performance of the entrance is the increased dredging within the lagoon made possible by additional funding.

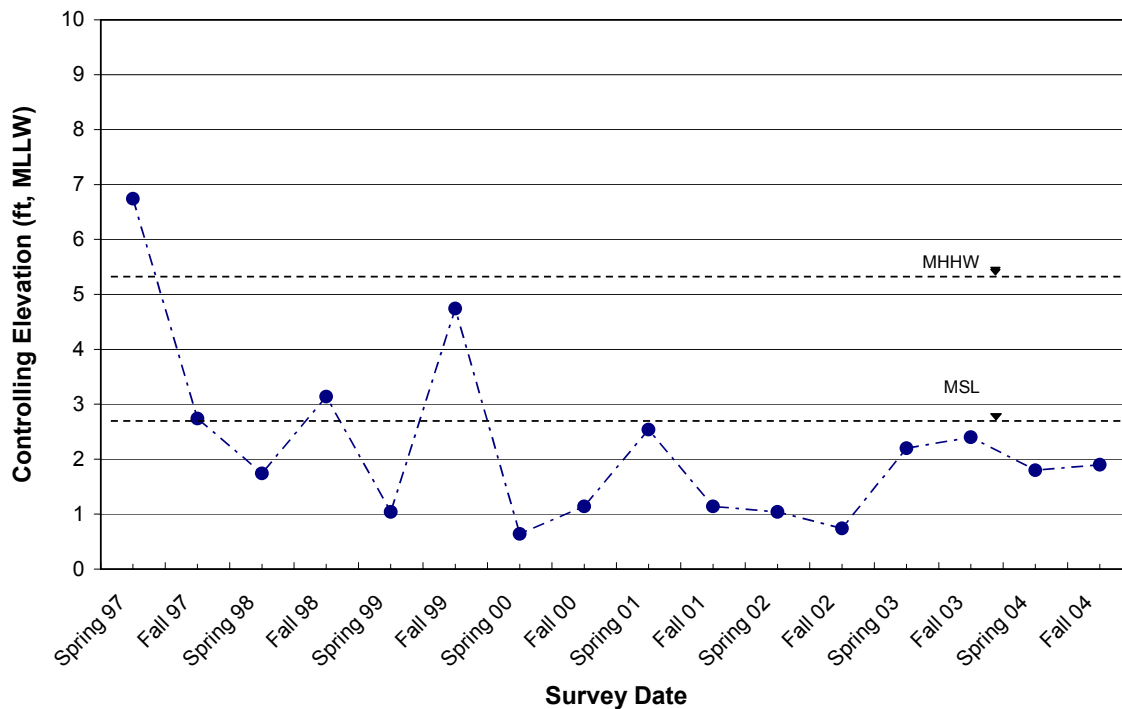
**Figure 41. Controlling Elevation for Tidal Exchange in San Elijo Lagoon**

The controlling elevations noted subsequent to the RBSP nourishment activities (Fall 2001 to Fall 2004) ranged from +0.7 to +2.4 ft, near the bottom of the range that prevailed prior to the RBSP (+0.6 to +6.7 ft; Figure 41).

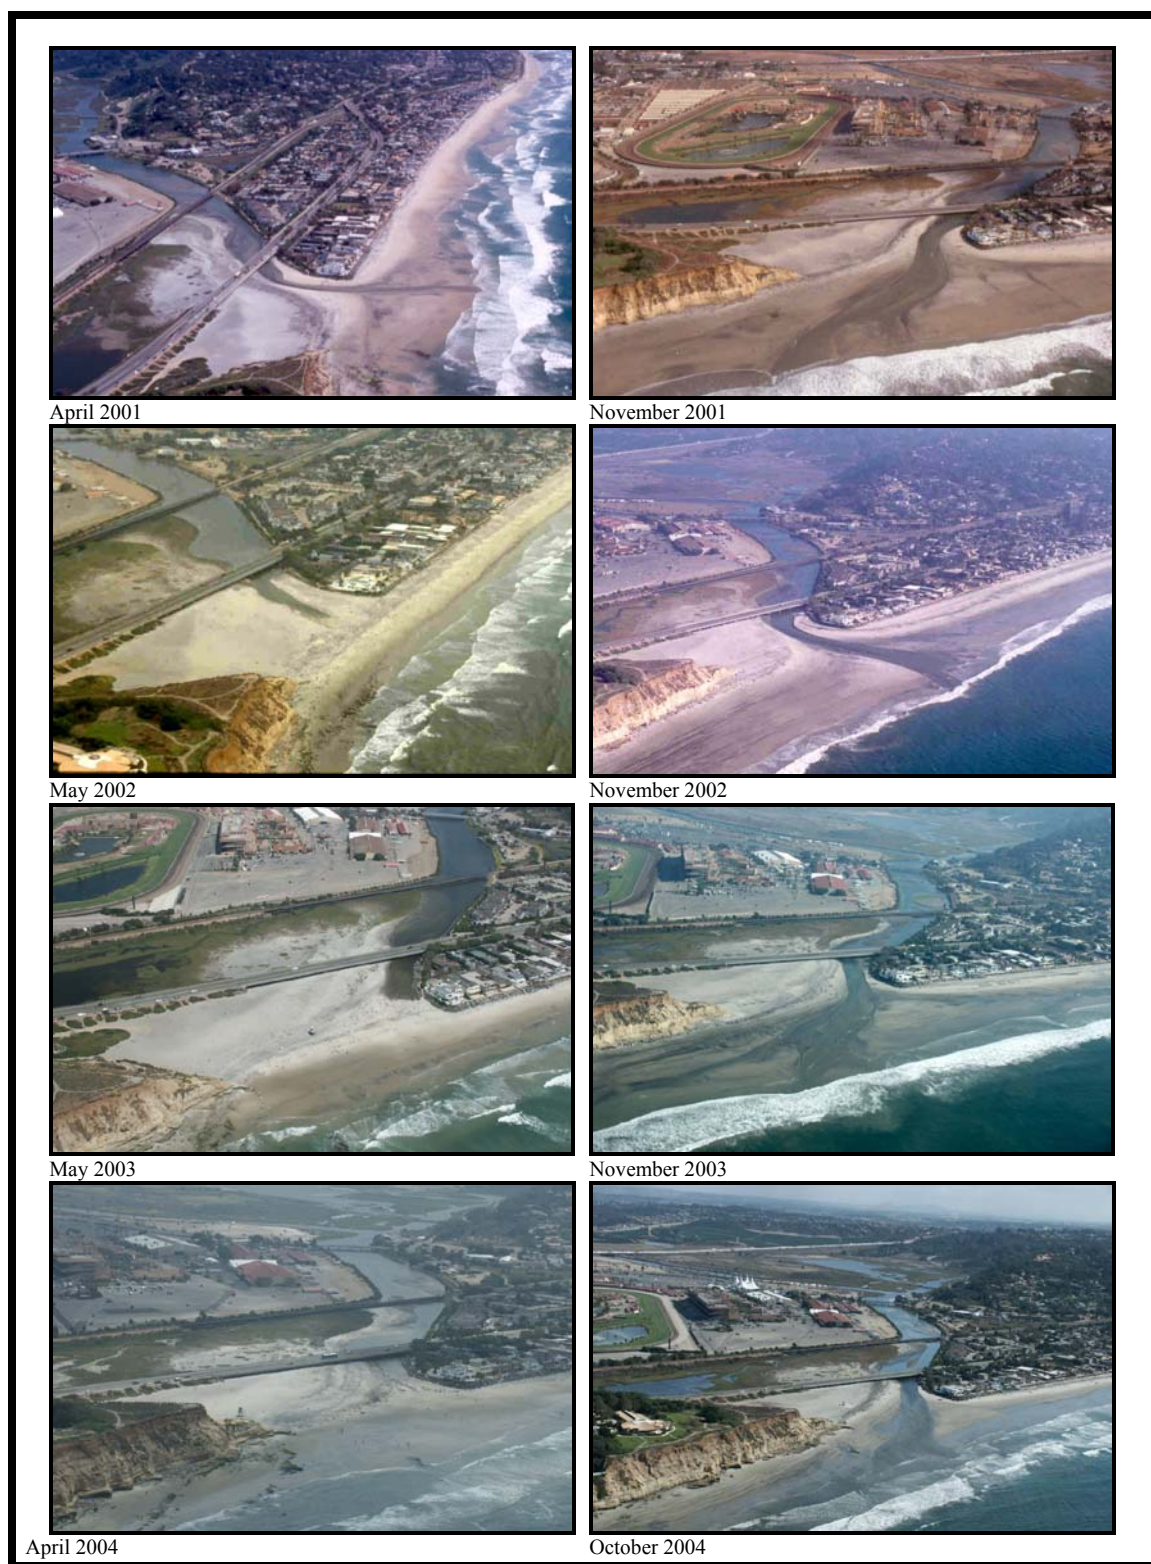
**Plate 16. San Dieguito Lagoon Entrance, April 2001 through October 2004**

The entrance channel (Plate 16) closed on five occasions following the RBSP (Figure 38). The first occurred in late November 2001, approximately six months after fill placement at the Del Mar receiver site. The lagoon remained closed to tidal exchange for more than 10 months before mechanical intervention in October 2002. The blocked entrance channel is shown in the May 2002 photo. The entrance closed on four occasions during the 2003 Monitoring Year, requiring mechanical intervention to restore tidal exchange on three of those occasions (December 2002, April 2003, and September 2003). In one instance (February 2003), the entrance channel opened naturally following a period of high rainfall (Elwany, 2004). No closures were recorded during the 2004 Monitoring Year. The frequencies of channel closure (1.7 times per year) and mechanical opening (1.3 times per year) during the three-year period following the RBSP exceeded the corresponding historical averages (0.6 and 0.6 times per year, respectively).

The monitoring data suggest that the November 2001 closure was caused, at least in part, by the northerly transport of sediment from the nearby Del Mar receiver site. Of particular relevance is an accumulation of sediment noted at the waterline of Transect DM-0590 at the time of the Fall 2001 Survey (Section 5.2.4). This transect lies to the north

of the Del Mar fill, and immediately south of the lagoon entrance channel (Figure 22). A similar accumulation was observed at the time of the Fall 2002 survey, but was absent in Fall 2003 and 2004 – a finding that suggests the Del Mar fill has been dispersed to a large extent by waves and currents, and no longer exerts a significant impact on the condition of San Dieguito Lagoon.

The entrance to San Dieguito lagoon was open 51% of the time subsequent to the RBSP, well below the historical average of 77%. This low percentage resulted in part from the fact that the lagoon was allowed to remain closed for nearly one year (November 2001 to October 2002). It is likely that climatic conditions also played an important role in the disparity between the two percentages, with the past three years characterized by below- to near-average precipitation (Section 2.1.1). In contrast, the pre-RBSP average was derived from a period of above-average precipitation (1979-2001). As discussed in Section 6.1, Elwany, *et al.* (1998) estimated that San Dieguito Lagoon remains open 66% of the time during periods of above-average precipitation and only 12% of the time during periods of below-average precipitation.

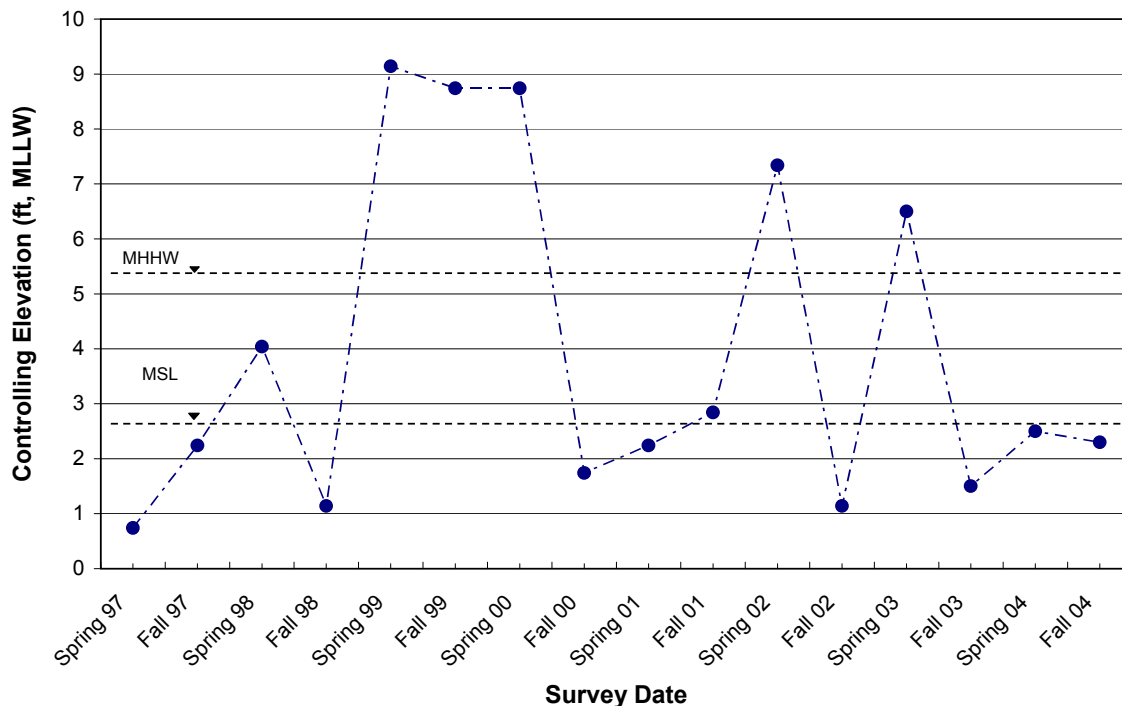
**Figure 42. Controlling Elevation for Tidal Exchange in San Dieguito Lagoon**

Following the RBSP, the controlling elevations in the entrance channel varied between +1.1 ft and +7.3 ft (Figure 42). Although large, this range lies within the elevations measured prior to the RBSP (+0.7 to +9.1 ft).

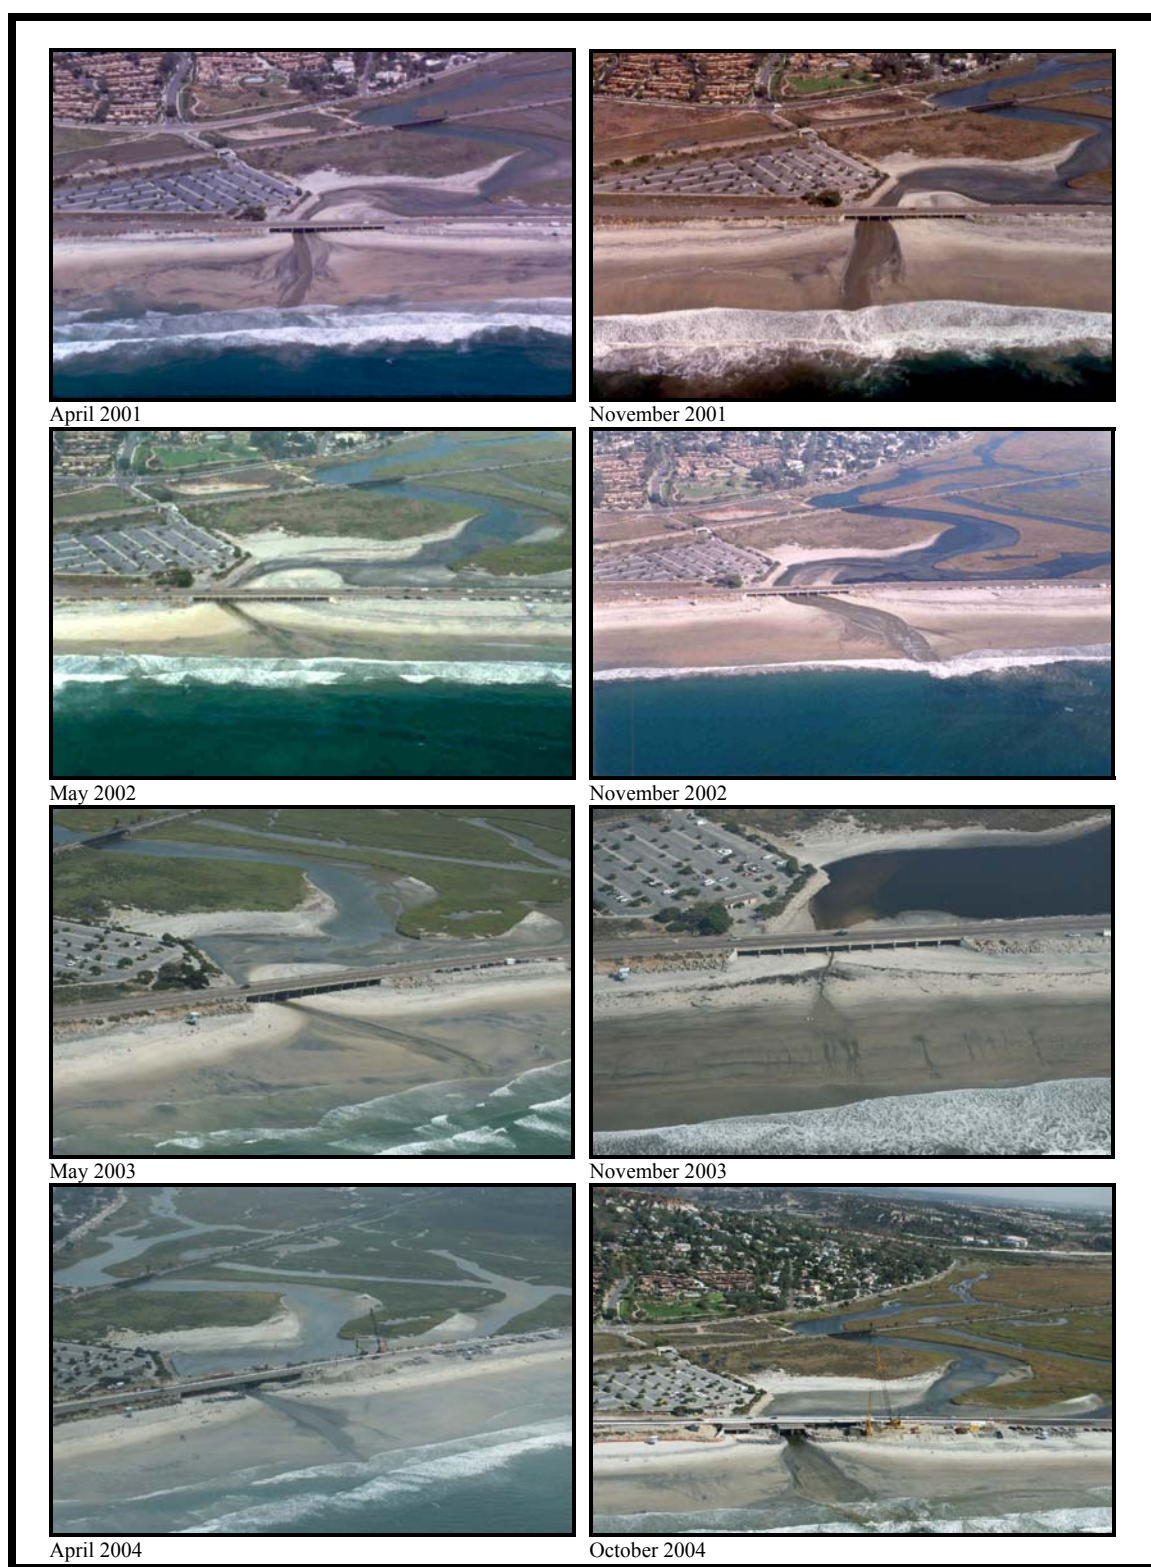
**Plate 17. Los Peñasquitos Lagoon Entrance, April 2001 through October 2004**

The Los Peñasquitos entrance channel closed on three occasions during the 2002 Monitoring Year and four occasions during the 2003 Monitoring Year (Figure 38). The channel opened naturally following four of these closures, but mechanical excavation was required to re-establish tidal exchange on three other occasions (February 2002, June 2002, and February 2003). The most recent closure, occurring in late October 2003, persisted eight days into the 2004 Monitoring Year before the channel opened naturally. The lack of subsequent closures during the 2004 Monitoring Year is likely attributable to construction activities at the PCH bridge, which include a sheetpile structure to confine the lagoon channel. The channel condition at the time of the semi-annual overflights conducted between April 2001 and October 2004 is shown in Plate 17.

The lagoon was open to tidal exchange 86% of the time following the RBSP, closely approximating the historical average of 93%. The frequency of channel closure during this period (2.3 times per year) was identical to the historical average, while the frequency of mechanical opening (1.3 times per year) was slightly lower than the historical average (1.6 times per year).

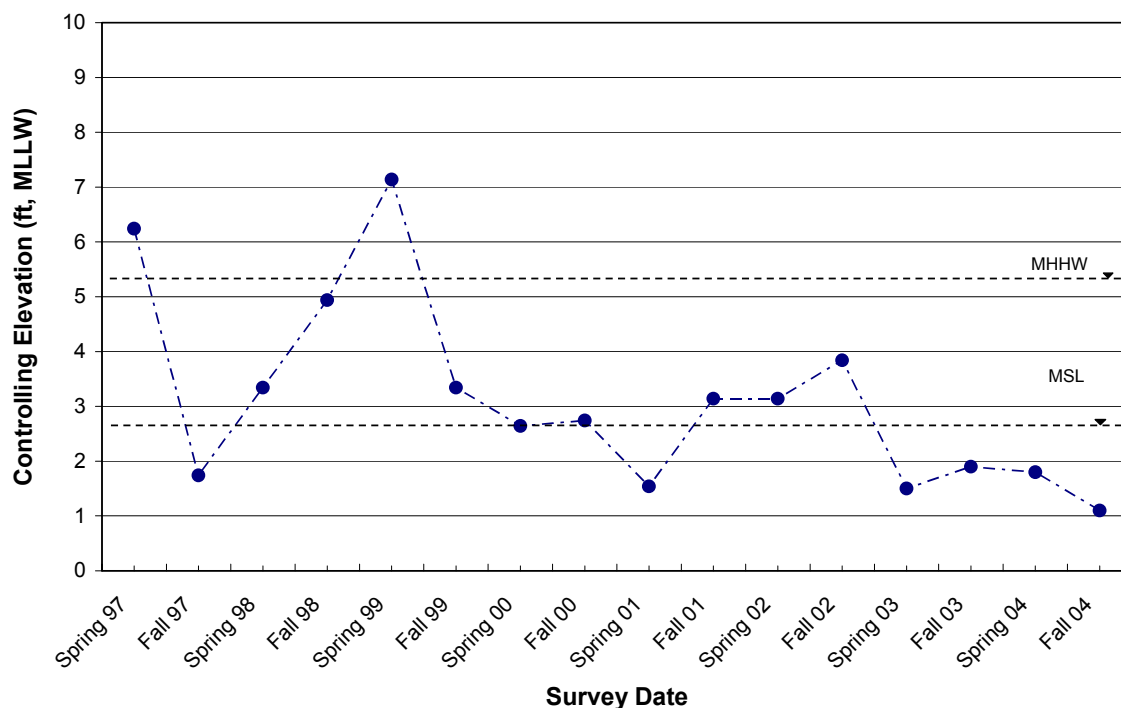
**Figure 43. Controlling Elevation for Tidal Exchange in Los Peñasquitos Lagoon**

The controlling elevations in the entrance channel measured subsequent to the RBSP nourishment activities ranged from +1.1 to +3.8 ft. Prior to the RBSP, the range was higher: +1.5 to +7.1 ft (Figure 43). The elevation change data in Appendix H indicate that the entrance channel survey area lost 4,000 cy between Fall 2003 and Spring 2004, and gained 6,000 cy between Spring 2004 and Fall 2004. The net gain for the year was 2,000 cy. During the three-year period following the RBSP, the entrance channel survey area lost 6,000 cy.
